TECHNICAL INFORMATION LETTER

TIL N° T-139-22-001

SUBJECT: Tail Rotor Drive Line (TRDL) bearing support panel reinforcement

Helicopters Affected: AW139 helicopters

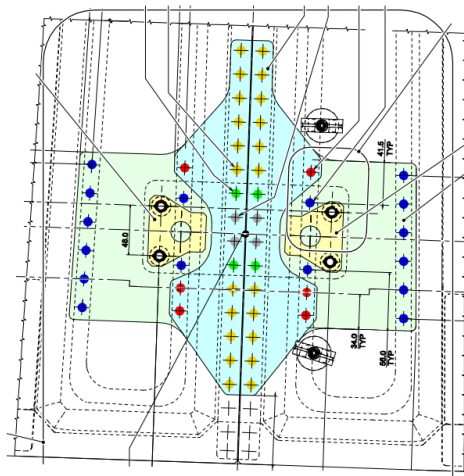
Figure 1

Monitoring the affected in-service fleet by means of SB139-467, it was recorded that cases of cracks on the support bracket, and on the bearing support panels as well, were limited to helicopters not equipped with Tail Boom Assy having bearing support panels not reinforced with an increased thickness (design improvement introduced with Tail Boom Assy P/N 3G5350A00136).

▪ Tail Rotor Drive Retromod P/N 3G5350P00311

This retromod allows the installation of doublers and shims on the upper side of right and left tail panels (Figure 1) and it is composed by:

- ✓ a basic design applicable to structures not already repaired;
- ✓ specific part to adapt the retromod to the existing repairs performed in-service in the affected area, if present.
