## TECHNICAL INFORMATION LETTER

TIL N° T-139-23-002

**SUBJECT: Main Rotor Pitch Link Installation Check**

Helicopters Affected: All AB/AW139 helicopters

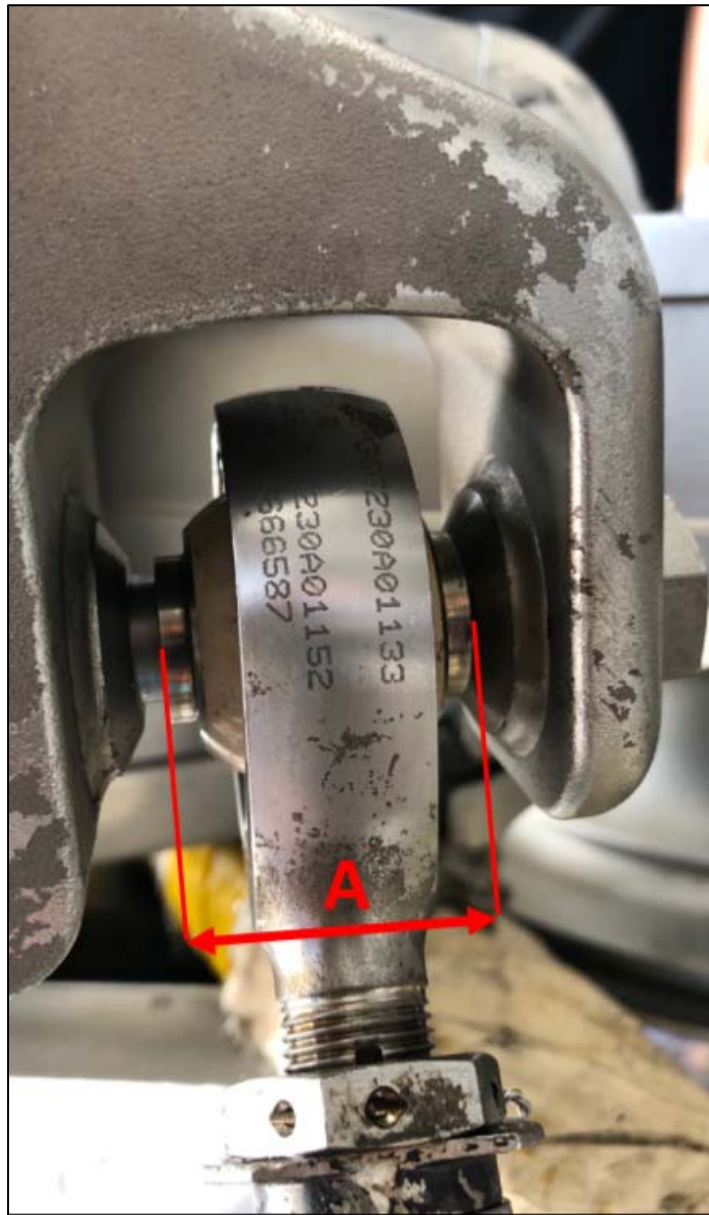
**Figure 1** – Example of measurement

A single case of excessive play was identified during the installation of a spare Main Rotor Pitch Link Upper Rod End Assembly P/N 3G6230A01133. After a dimensional check, it was discovered that the excessive play was caused by an incorrect bearing installation made during components' manufacturing.

A: Thickness of the Upper Bearing Rod End

As precautionary measure, LH is going to release the EASB 139-754 prescribing a one off inspection with a tight compliance that requires a dimensional check of the bearing installed in the Upper Rod End Assembly P/N 3G6230A01133 on a batch of S/Ns potentially affected.

In order to perform this check, Vernier Caliper Gauge with long jaws will be needed to measure the thickness of the bearing installed in the Upper Rod End (Refer to Annex A Figure 1 for example of the dimensional check requested).
