TECHNICAL INFORMATION LETTER

TIL N° T-139-23-006

SUBJECT: Emergency Floatation System – Unintentional activation of guarded float pushbutton

Helicopters Affected: All AB/AW139

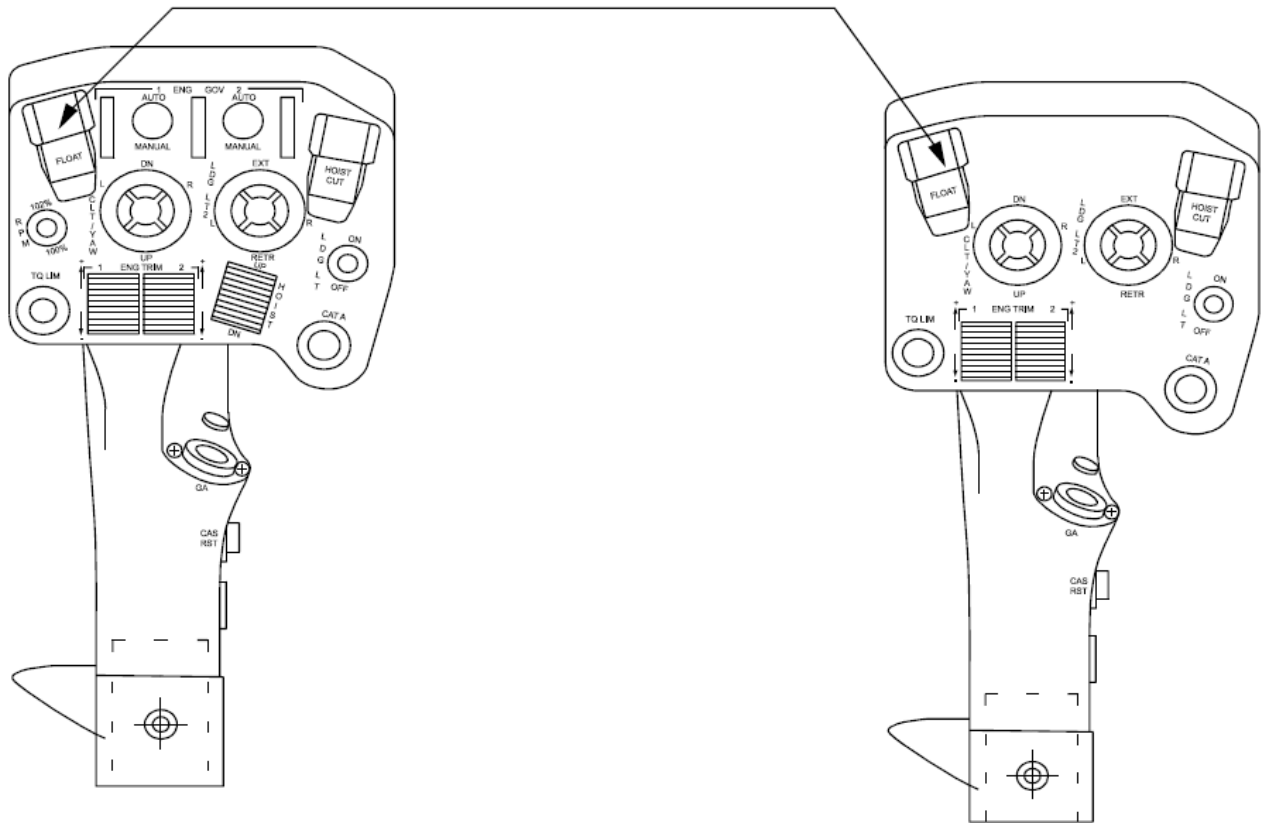
Figure 1

Since 2022, few cases of inadvertent float deployment have been recorded on AW139 fleet due to unintentional activation of float system on Pilot or Copilot collective grip (Ref. Figure 1).

Float Guarded Pushbutton Switch (Pilot and Copilot Collective Grips)

With the present communication Leonardo Helicopters (LH) would like to highlight the importance to carefully handle the guarded float pushbutton on either the Pilot or Copilot collective grip during flight operations or maintenance activities, strictly following the RFM and AMP procedures in order to avoid any inadvertent floats deployment both in flight or on ground.

The floatation system is designed to deploy automatically the floatation bags by water sensors in case of ditching when the OFF/ARMED switch on the FLOATS EMER control panel mounted in the interseat console is set to ARMED. The guard of the FLOAT pushbutton on either the Pilot or Copilot collective grip shall be lifted only in case a manual floatation inflation is deemed necessary (for reference see RFM Supplements 9 and 95).
