TECHNICAL INFORMATION LETTER

TIL N° T-139-23-006

SUBJECT: Emergency Floatation System – Unintentional activation of guarded float pushbutton

Helicopters Affected: All AB/AW139

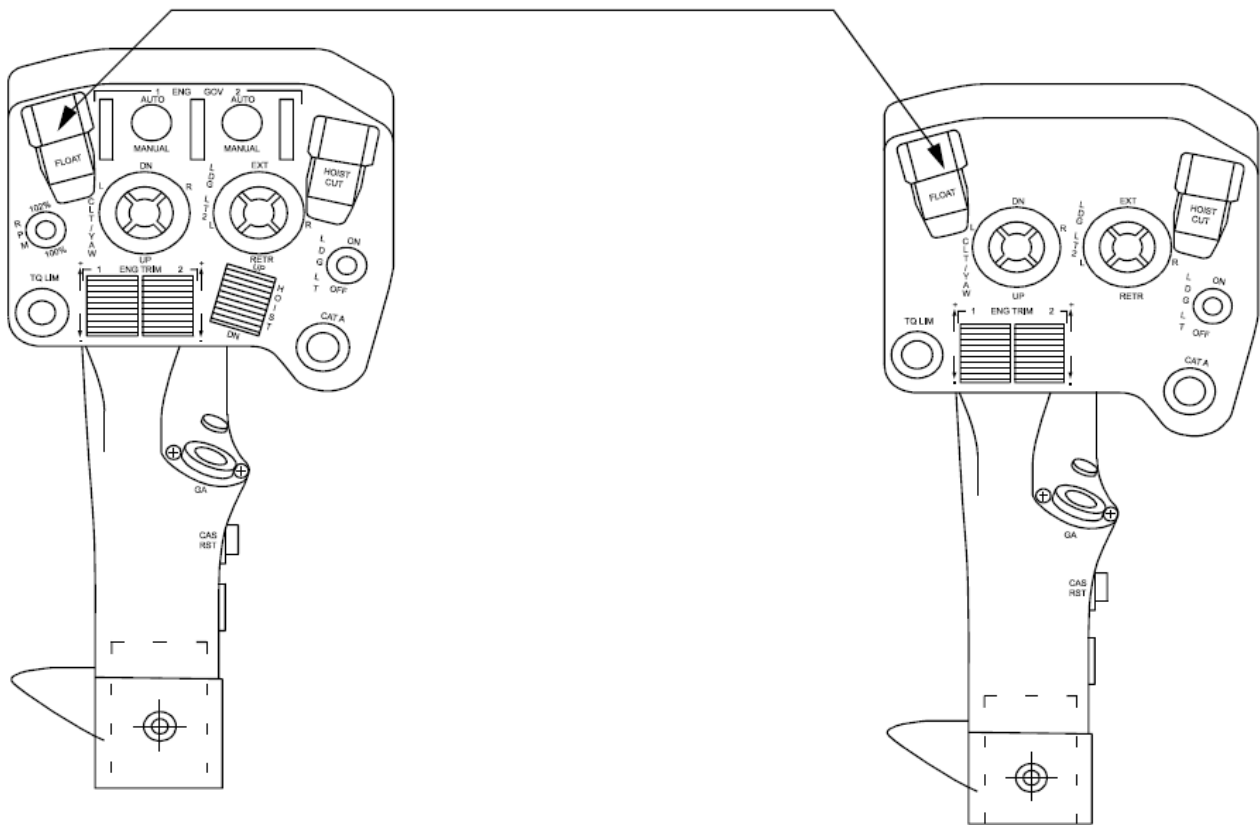
Figure 1

Since 2022, few cases of inadvertent float deployment have been recorded on AW139 fleet due to unintentional activation of float system on Pilot or Copilot collective grip (Ref. Figure 1).

Float Guarded Pushbutton Switch (Pilot and Copilot Collective Grips)

With the present communication Leonardo Helicopters (LH) would like to highlight the importance to carefully handle the guarded float pushbutton on either the Pilot or Copilot collective grip during flight operations or maintenance activities, strictly following the RFM and AMP procedures in order to avoid any inadvertent floats deployment both in flight or on ground.
