TECHNICAL INFORMATION LETTER

TIL N° T-189-24-003

**SUBJECT: Frame STA 5700, MLG Slant Beam Attachment
Inspection**

Helicopters Affected: All AW149/AW189 helicopters

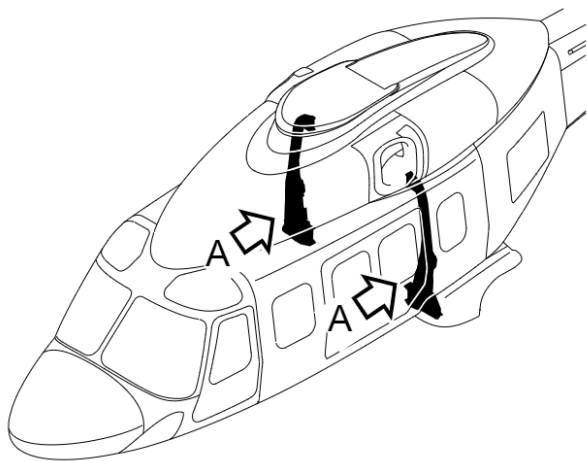
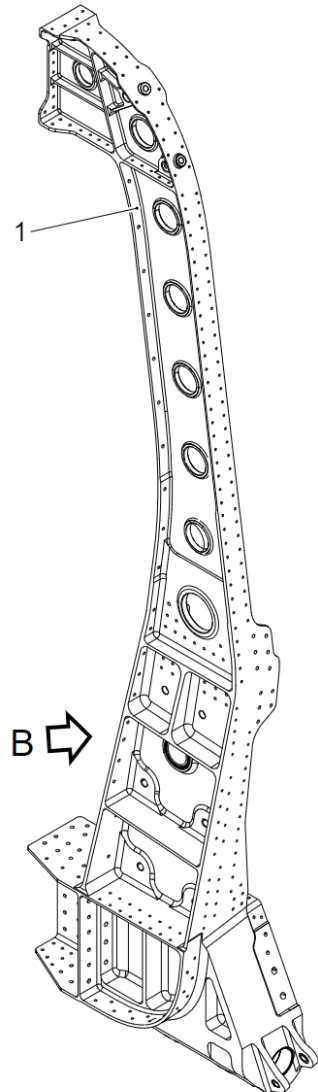
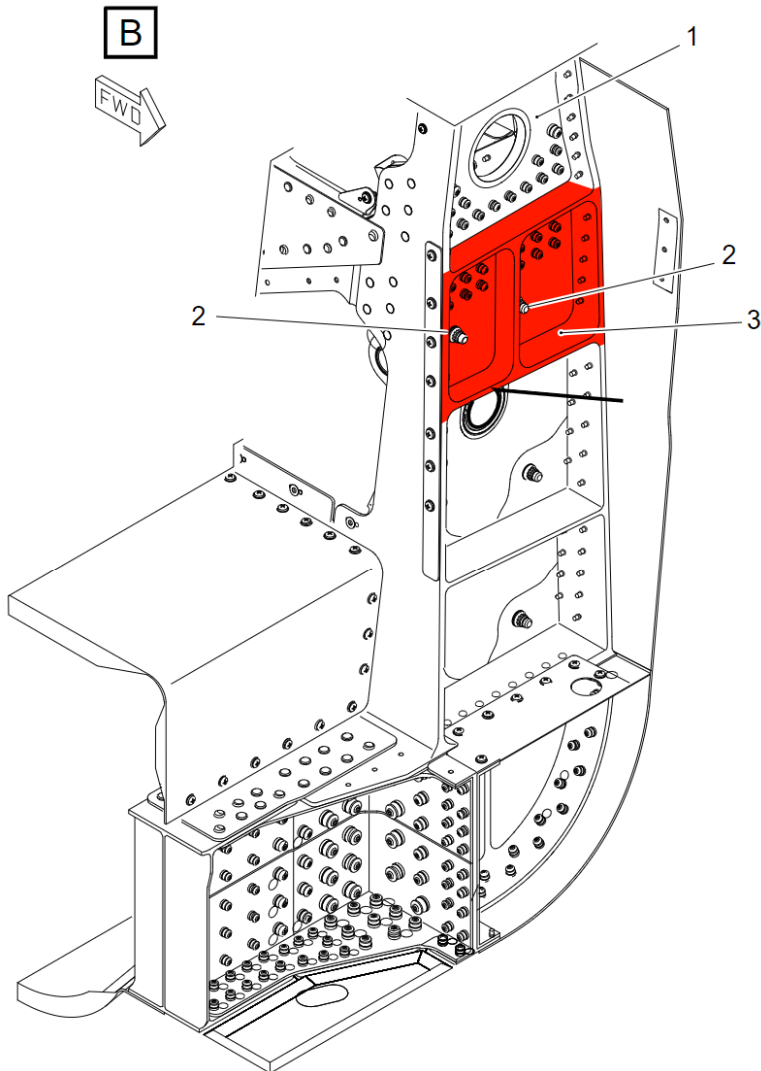
Following a recent review of Mandatory Inspection (MI) requirements for Main Cabin Assy, a dedicated inspection affecting the area highlighted in Annex A is required. This Inspection is applicable to those helicopters that have reached 14765 landings and needs to be repeated regularly after having reached this value.

- **EASB189-397** that is going to be released will provide the instructions to perform the detailed inspection for cracks of the areas (3) shown in Figure 1 of Annex A. No special tool is required.
- A new Mandatory Inspection will be included in the relevant Aircraft Maintenance Planning Information (AMPI) at the first favourable occasion.

Forward section - Left/right frame at STA5700 - Detailed inspection
