TASK CARD NO. 0068/BOC
 WORK ORDER NO. NIL
 MAN HOURS
 DATE RAISED 28.02.19

AIRCRAFT TYPE:	AW139	ENGINE NO.1	TSN:	2446-3	TSO:	NEW
AIRCRAFT REGN:	9M-BOC	ENGINE NO.2	TSN:	2446-3	TSO:	NEW
AIRCRAFT S/N:	31289	*SYSTEM	BASIC	✓	OVER & ABOVE	
AF HOURS:	2446-3	*DUP. INSP REQUIREMENT	YES		NO	✓

DESCRIPTION	CORRECTIVE ACTION
SB(A)139-569 REV. A DTD 27.02.2019 (EASA AD2018-0292 DTD 28.12.18)	CARRIED OUT DETAIL INSP. ON TAIL ROTOR SLIDER ASSY. FOR CORROSION
ATA 64 - TAIL ROTOR SLIDER ASSY DETAILED	AS PER SB(A)139-569 REV A DTD
INSPECTION (PART 1 - BEFORE EXCEEDING 2450 FH)	27-02-2019 (EASA AD2018-0292 DTD 28-12-18)
*REFER ATTACHED EI139-0011/BOC	FOUND: SATISFACTORY.

TITLE: ATA 64 – TAIL ROTOR SLIDER ASSY DETAILED INSPECTION (PART I)

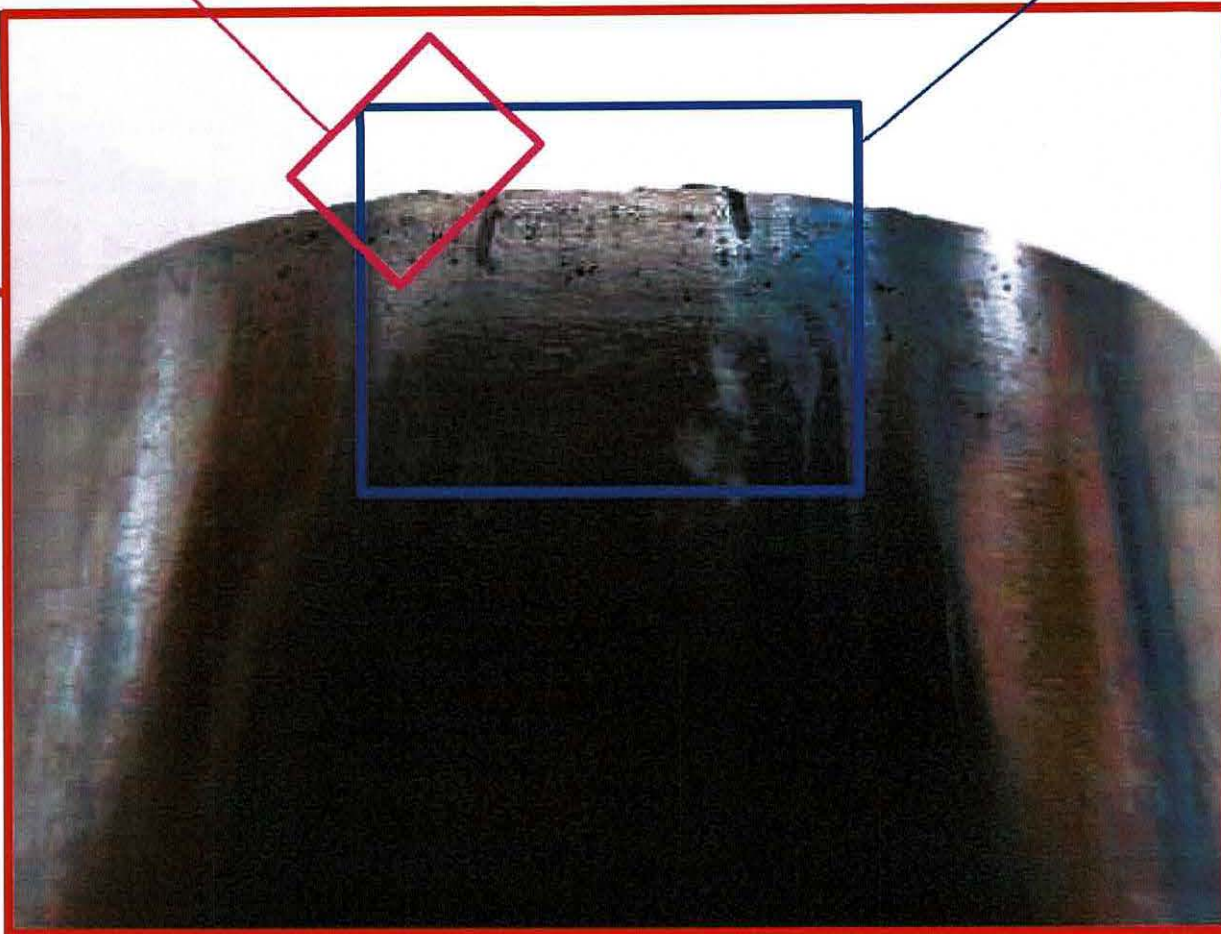
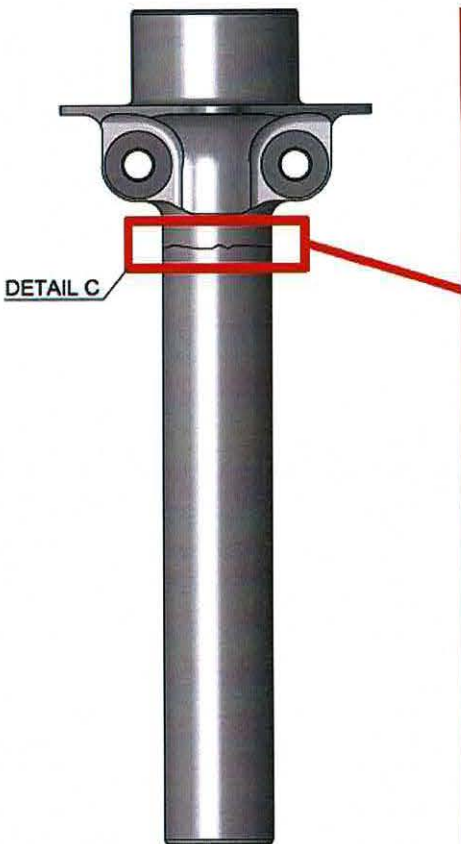
Figure 2

Corroded area of the Slider stem near the fracture surface.

The corrosion craters tend to originate along finishing signs compatible with sanding operations.

It is to be noted the high distribution of quite circumferential signs and the low distribution of craters visible on the thin edge of the fracture surface.
