TECHNICAL INSTRUCTION COMPLIANCE		TIC REF NO. TIC-A109E-20-032	
				DATE ISSUE 12 NOVEMBER 2020	
A. TECHNICAL PUBLICATION (To Fill Up as Necessary)					
PUBLICATION TITLE	LEONARDO HELICOPTERS - A109E ALERT SERVICE BULLETIN ATA 53 - CENTRAL FUSELAGE FRAME ASSY AT STA 1815, INSPECTION AND REPAIR OF				
REV. NO	ASB NO. 109EP-173, NEW ISSUE	REV. DATE	10 NOVEMBER 2020		
APPLICABLE TO	<input checked="" type="checkbox"/> AC TYPE: A109E	<input checked="" type="checkbox"/> AC S/N: 11212	<input type="checkbox"/> ENG. TYPE:	<input type="checkbox"/> ENG. S/N:	
	<input type="checkbox"/> COMPONENT:		<input type="checkbox"/> EQUIPMENT:		
DISTRIBUTIONS	<input checked="" type="checkbox"/> OPERATOR <input checked="" type="checkbox"/> AMO <input checked="" type="checkbox"/> CAMO <input type="checkbox"/> QUALITY <input type="checkbox"/> OTHER:

N° **109EP-173**

ATA 53 - CENTRAL FUSELAGE FRAME ASSY AT STA 1815, INSPECTION AND REPAIR OF

S.B. N°109EP-173 ALERT
DATE: November 10, 2020
REVISION: /

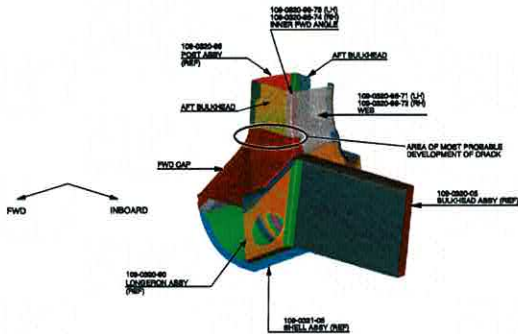
Figure 1

Some occurrences of cracks have been found in the fuselage of the Leonardo S.p.a. A109E helicopters at the intersection of the lateral pylon with the floor spar at the STA 1815, either in the LH and RH side.

6. If necessary, clean the inspection areas using a soft lint-free cloth (not soaked) and cleaning solvent MIL-PRF-680 Type II or equivalent.
 7. With reference to Figure 1, using a bright source of light, visually inspect the whole zone of intersection between the lateral post and the floor spar, on both sides of the fuselage, for evidence of cracks. Pay particular attention to the forward area of the post (toward cockpit) and to inboard side of the post.

- 9.1 If the length of crack(s) does not exceed the boundaries of the FWD CAP, FWD bulkhead or WEB (ref. Figure 1) proceed in accordance with PART II (LH side of fuselage) or PART III (RH fuselage) of this Service Bulletin before the next flight.

- 9.2 If the length of the cracks exceeds the boundaries of the FWD CAP, FWD bulkhead or WEB (ref. Figure 1), the repair scheme reported in this Service Bulletin could not be applicable. In this case contact Leonardo Engineering Dept. engineering_support_lhd@leonardocompany.com.

A
INSPECT FORWARD AND EXTENSION SIDE OF
INTERRUPTION JOINT BETWEEN FRONT ASSEMBLY
AND LOCOMOTION ASSEMBLY

8. In case of no findings, reinstall all the component removed from Step 3 to Step 5 and proceed to Step 10.
 9. In case of findings, in accordance with CSRP standard repair procedures perform a fluorescent liquid penetrant inspection of the crack to determine the exact extent, then stop-drill at both ends of crack to relieve the stresses in the extremities and to prevent any further propagation.
