## TIC-AS350-24-0121

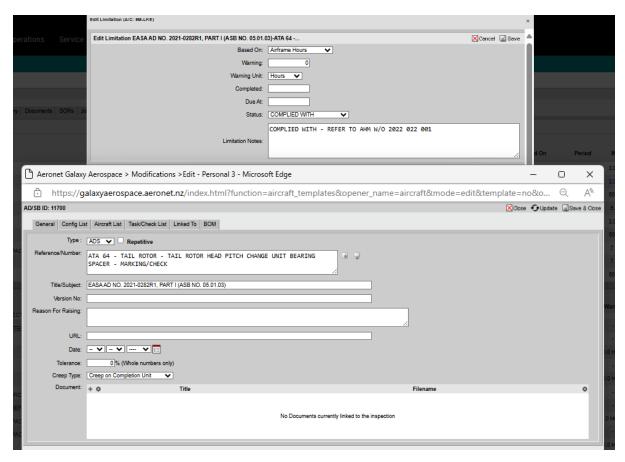
Figure 1: AD 2021-0282R1 PART 1 HAS BEEN UPDATED IN AERONET

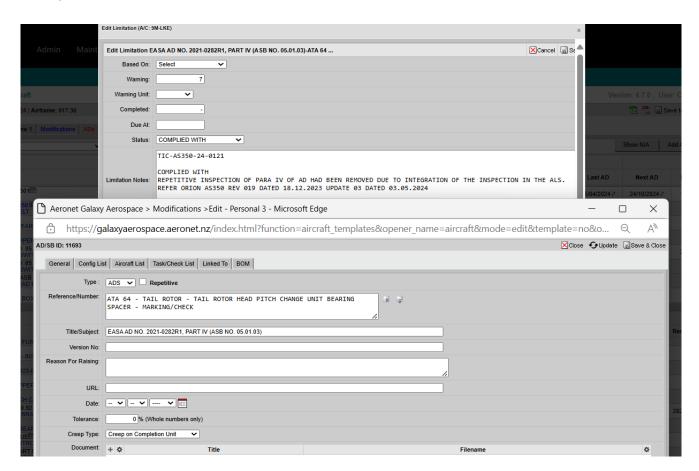
Figure 3: AD 2021-0282R1 PART IV HAS BEEN UPDATED IN AERONET
