Temporary Maintenance Instruction  
TMI109-405 Rev. A

Tail Gearbox –  
Special Inspection

A109E / A109K2 / A109C / A109A/AII /  
A109S/AW109SP Helicopters

2021-08-09

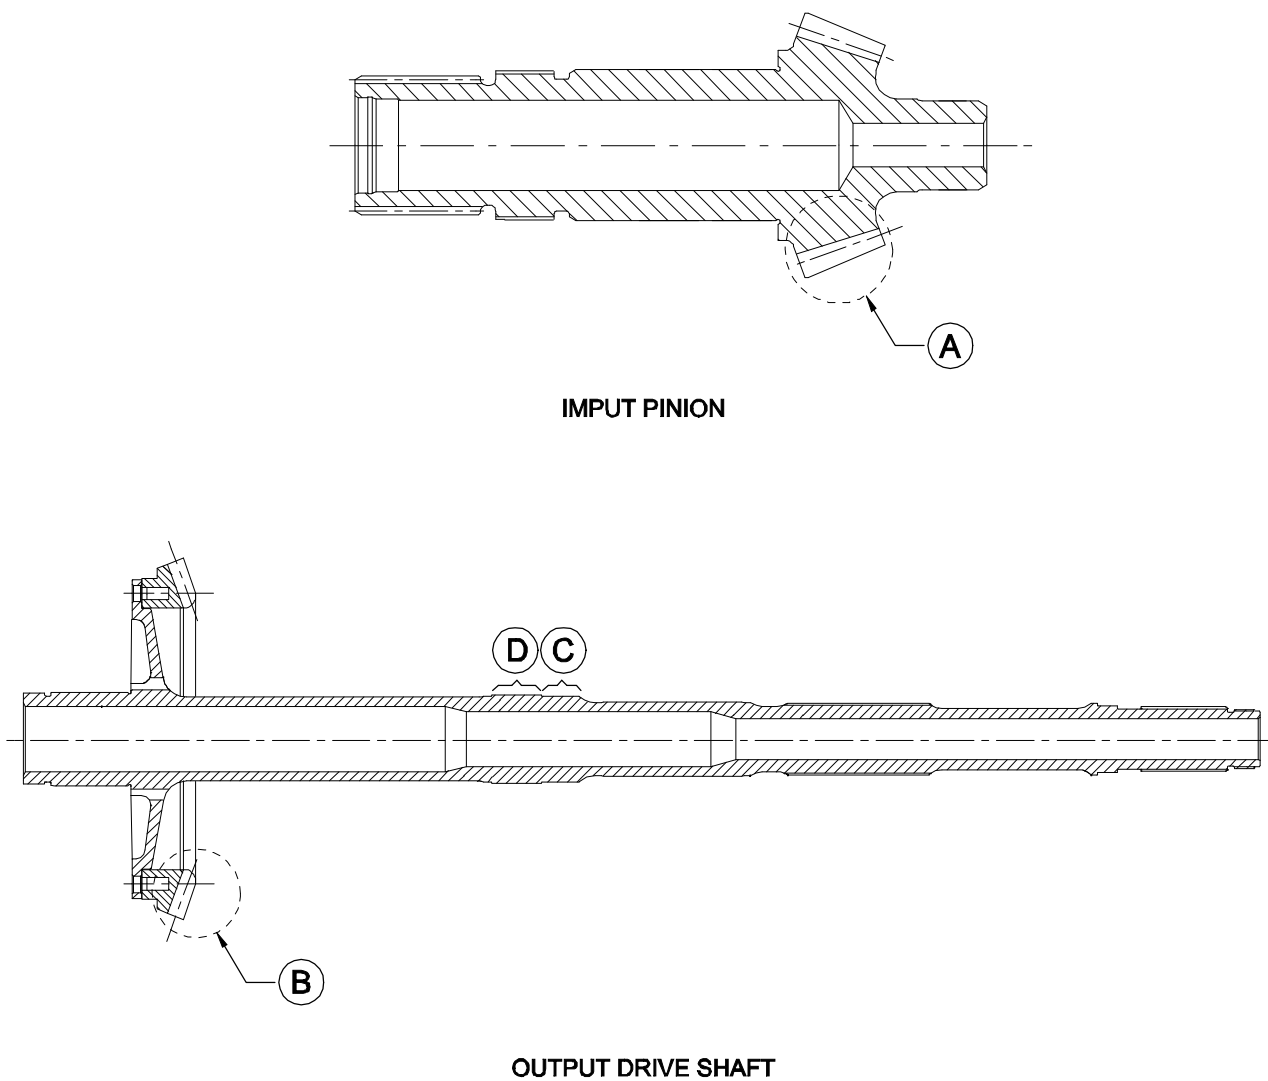
3. Inspect pinion teeth and surrounding areas (A, Figure 2) for unusual prints (see Figure 4), deep scratches, flaking, pitting, scoring, chipping, spalling, overheating color and cracks. The presence of such damage is cause for pinion replacement. It is admitted a light bright line on the bottom of the tooth; this line is acceptable provided that the manufacturing signs are visible with a 10-power magnification lens.

6. Inspect teeth and surrounding areas (B, Figure 2) on Gleason gear for unusual prints (see Figure 4), deep scratches, flaking, scoring, pitting, chipping, spalling, overheating color and cracks. The presence of any type of damage is cause for rejection. It is admitted a light bright line on the bottom of the tooth; this line is acceptable provided that the manufacturing signs are visible with a 10-power magnification lens.

7. Inspect the shaft near to the seal contact surface (C) for wear, grooving and scoring. Grooving greater or equal to 0,05 mm in depth is cause for shaft replacement.

8. Inspect seat (D) of roller bearing for wear, stepping, nicks, pitting, chipping, overheating color, brinelling, seizing and heavy circumference mark or wide slight mark. The presence of any of the above defects is cause for shaft rejection.

Figure 2 - 90-degrees gearbox – Inspection areas.

**NOTE:** In case of a negative result during at least one of the previous inspections, send the 90-degree gearbox to the Manufacturer or to an authorized repair station for a specific repair.

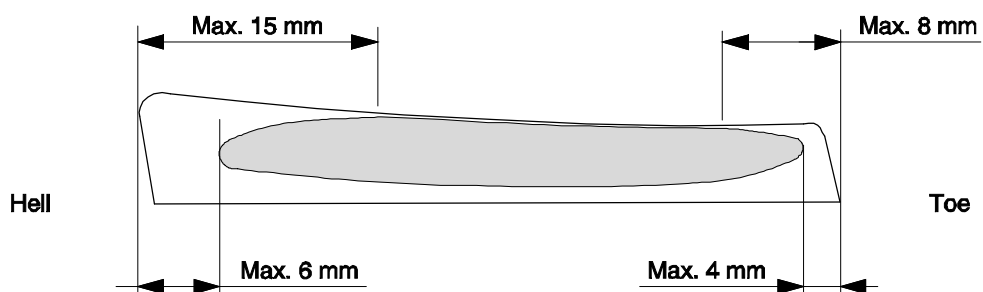
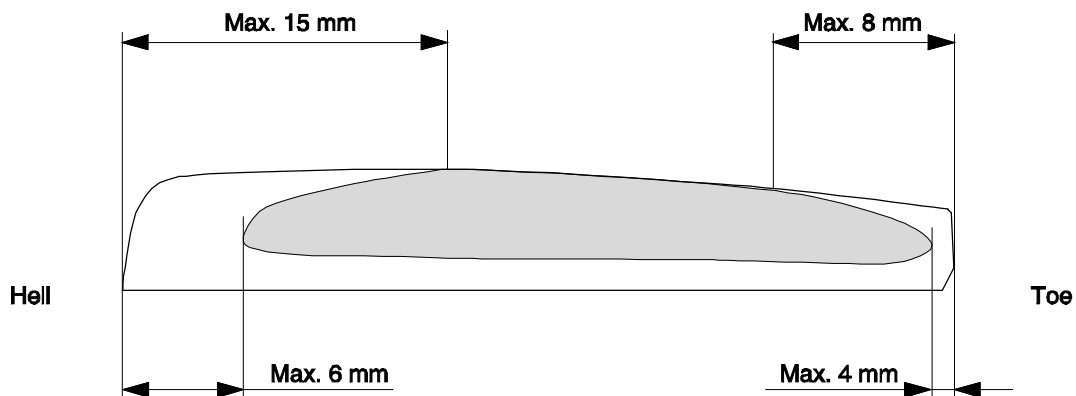
GLEASON GEAR

GLEASON PINION

Figure 4 - 90-degrees gearbox – Allowed Gleason gear/pinion patterns.
