Temporary Maintenance Instruction TMI 139-487 **Rev B**

Tail section - Tail gearbox attachment structure - Detailed inspection

All AW139 Helicopters

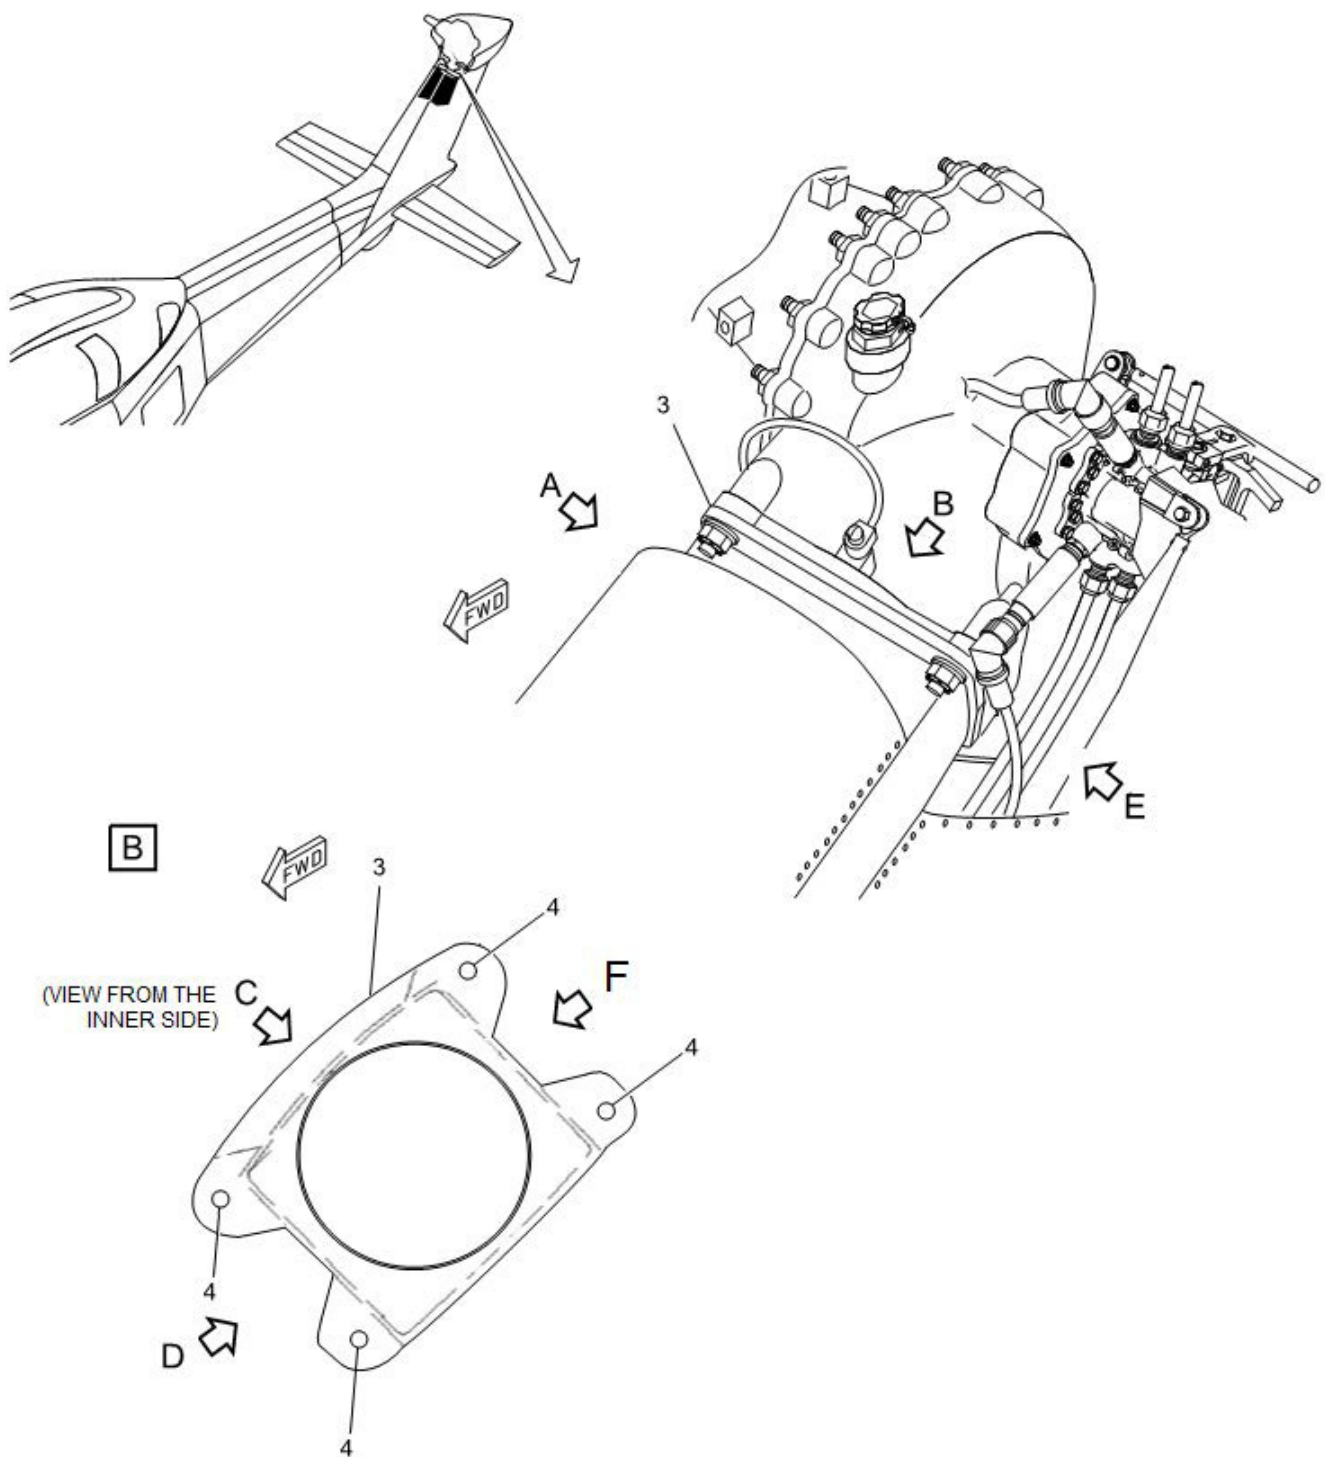
Figure 1 Tail section - Tail gearbox attachment structure - Detailed inspection (Sheet 1 of 5)

- 3 Get access to the external right side of the fin (1) as shown in Figure 1 detail A.
- 4 Clean the area to inspect with the Cheesecloth (C028) and the Aliphatic naphtha (C059) or the Cleaning solvent (C010) or equivalent .

- 5 Accurately examine the area around the right forward and rear holes (4) on the external right side of the tail gearbox attachment-fitting (3) as shown in Figure 1 detail B. Make sure that there are no crack damages.

- 8 If you find crack damage tell the Manufacturer.
- 9 Examine the external area around the vertical and horizontal row of fastener holes (2) of the external right side of the tail gearbox attachment-fitting (3), as shown in Figure 1 detail A. Make sure that there are no crack damages.

- 10 If you find crack damage tell the Manufacturer.
- 11 Examine the external area around the vertical and horizontal row of fastener holes (6) of the external forward side of the tail gearbox attachment-fitting (3), as shown in Figure 1 detail D. Make sure that there are no crack damages.

- 6 If you find crack damage tell the Manufacturer.
- 7 Accurately examine the frontal and right side of the body of the tail gearbox attachment-fitting (3). Make sure that there are no crack damages.

- 12 If you find crack damage tell the Manufacturer.

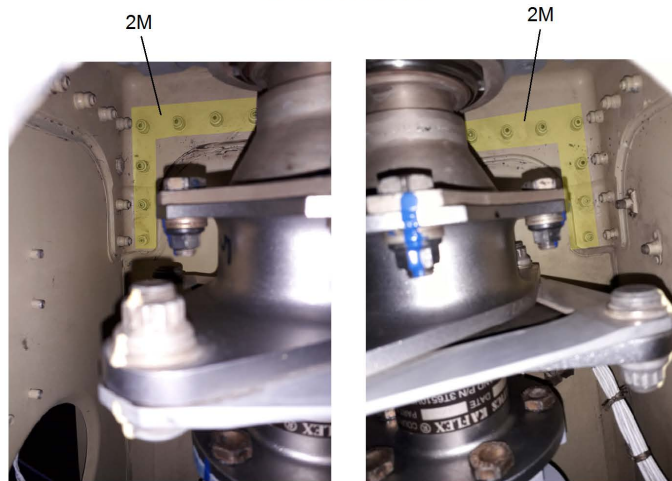
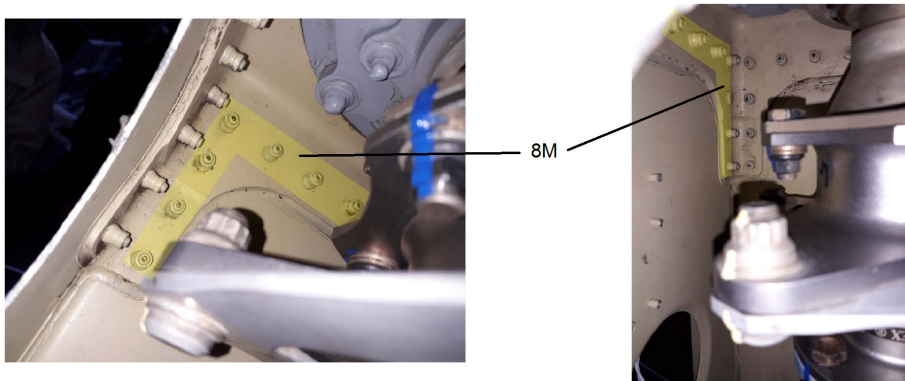
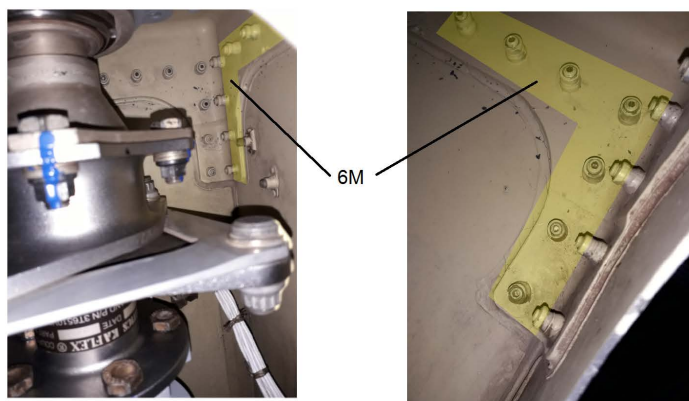
Figure 1 Tail section - Tail gearbox attachment structure - Detailed inspection (Sheet 3 of 5)

- 15 Examine the inner area around the vertical and horizontal row of fastener holes (2M) of the inner left side of the tail gearbox attachment-fitting (3) as shown in Figure 1 sheet 3. Make sure that there are no crack damages.

- 16 If you find crack damage tell the Manufacturer.
- 17 Examine the area around the vertical and horizontal row of fastener holes (8M) of the inner rear side of the tail gearbox attachment-fitting (3) as shown in Figure 1 sheet 3. Make sure that there are no crack damages.

- 18 If you find crack damage tell the Manufacturer.
- 19 Accurately examine the area around the vertical and horizontal row of fastener holes (6M) of the forward side of the tail gearbox attachment-fitting (3) as shown in Figure 1 sheet 3. Make sure that there are no crack damages.

- 20 If you find crack damage tell the Manufacturer.
- 21 Accurately examine the area around the vertical and horizontal row of fastener holes (7M), of the inner right side of the tail gearbox attachment-fitting (3) as shown in Figure 1 sheet 4. Make sure that there are no crack damages.

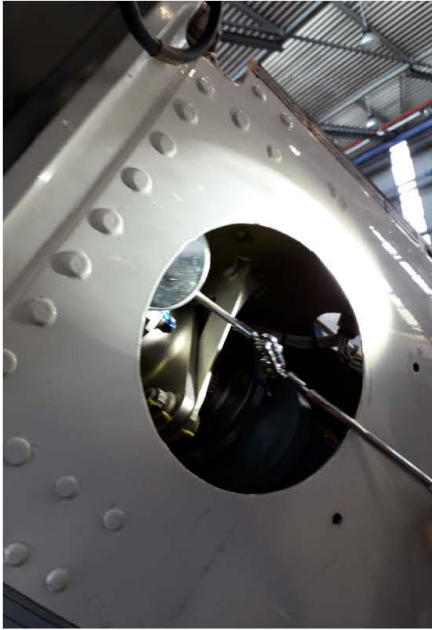
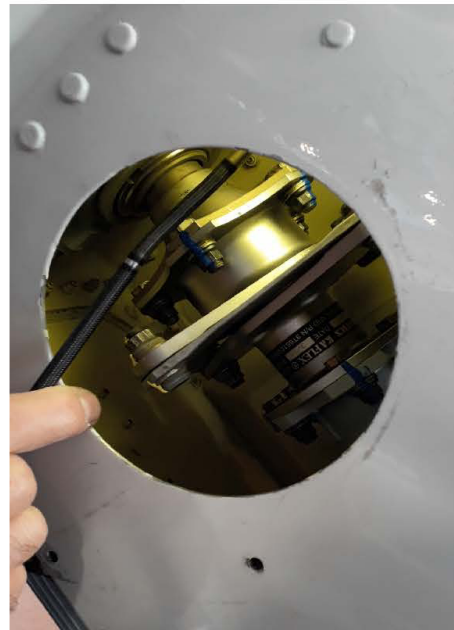
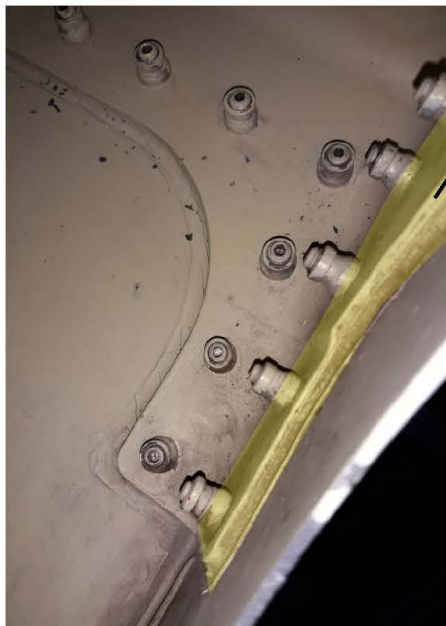
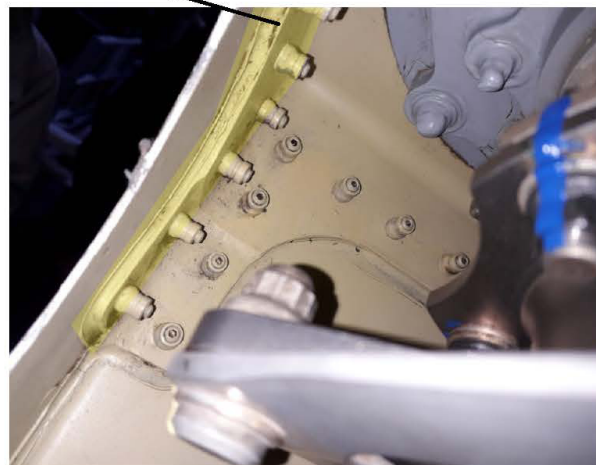
Figure 1 Tail section - Tail gearbox attachment structure - Detailed inspection (Sheet 4 of 5)

- 13 Get access to the inner right side of the fin (1) as shown in Figure 1 sheet 4.
- 14 Clean the area to inspect with the Cheesecloth (C028) and the Aliphatic naphtha (C059) or the Cleaning solvent (C010) or equivalent .

- 22 If you find crack damage tell the Manufacturer.
- 23 Get access to the external left side of the fin (1) as shown in Figure 1 detail E.
- 24 Clean the area to inspect with the Cheesecloth (C028) and the Aliphatic naphtha (C059) or the Cleaning solvent (C010) or equivalent .

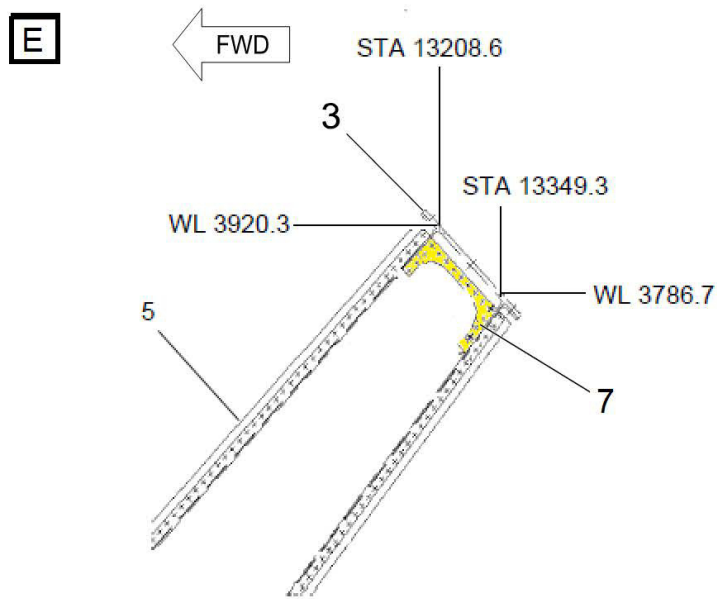
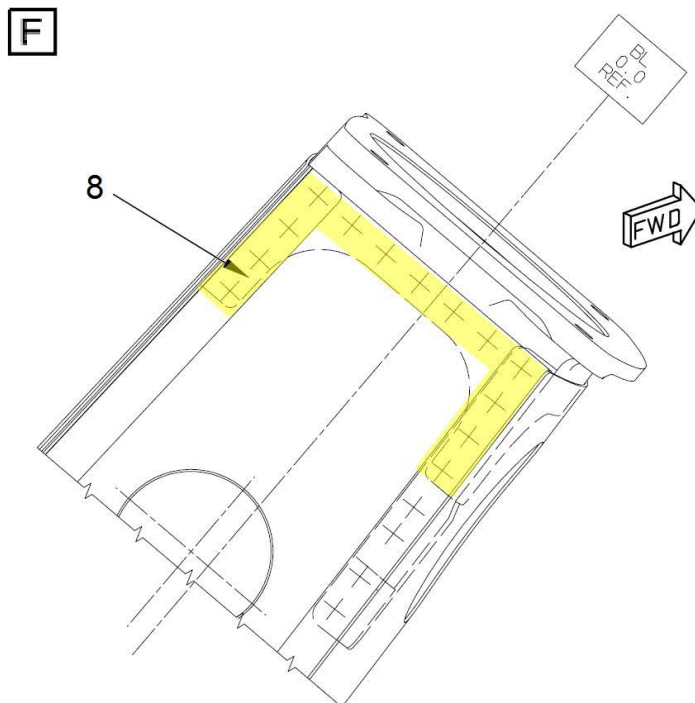
Figure 1 Tail section - Tail gearbox attachment structure - Detailed inspection (Sheet 5 of 5)

- 29 Examine the external area around the vertical and horizontal row of fastener holes (7) of the external left side of the tail gearbox attachment-fitting (3) as shown in Figure 1 detail E. Make sure that there are no crack damages.
- 30 If you find crack damage tell the Manufacturer.
- 31 Examine the external area around the vertical and horizontal row of fastener holes (8) of the external rear side of the tail gearbox attachment-fitting (3) as shown in Figure 1 detail F. Make sure that there are no crack damage.
- 32 If you find crack damage tell the Manufacturer.
