**R66 SERVICE BULLETIN SB-41**

**SUBJECT:** Tail Rotor Blade Inspection and Replacement

**EFFECTIVITY:** P/N F029-1 tail rotor blade S/Ns 3099 and prior (F029-1 REV F and prior).

**SPECIAL TAIL ROTOR TIP PREFLIGHT INSPECTION**

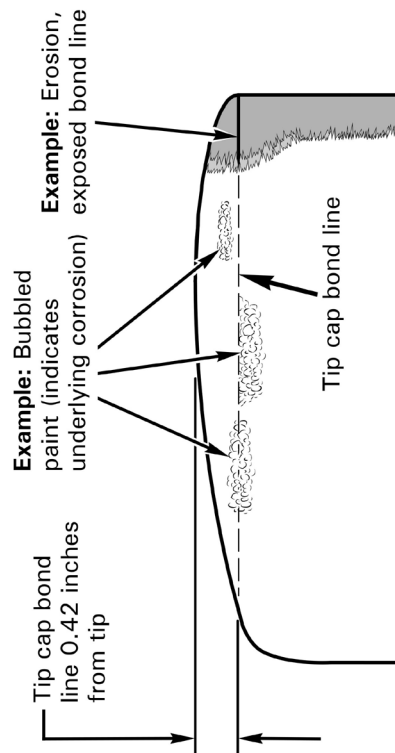
**BACKGROUND:** RHC has received reports of tail rotor blade tips coming loose due to corrosion at the bond. Helicopters operating near saltwater are particularly susceptible to corrosion, especially if stored outdoors. A debonded tip can cause severe vibration and possible failure of the tail rotor gearbox housing. F029-1 revision I blades have tip caps with an alternate alloy to reduce the likelihood of corrosion.

To be performed before the first flight of each day. May be performed by pilot or mechanic. Conduct visual inspection of tail rotor tip area. If bubbled paint or other evidence of corrosion is observed at or adjacent to tip cap bond line or if any portion of tip cap bond line is exposed, do not fly helicopter. Comply with latest revision of R66 SL-40 prior to further flight.

**PART B:** Replace each affected tail rotor blade per R66 Maintenance Manual (MM) § 64-20 and install tail rotor assembly per MM § 64-10. Enter new blade serial numbers in aircraft maintenance records.
