SAFETY INFORMATION NOTICE

Good practices to prevent hoist incidents

SERVICE INFORMATION LETTER

763XX-25-0R

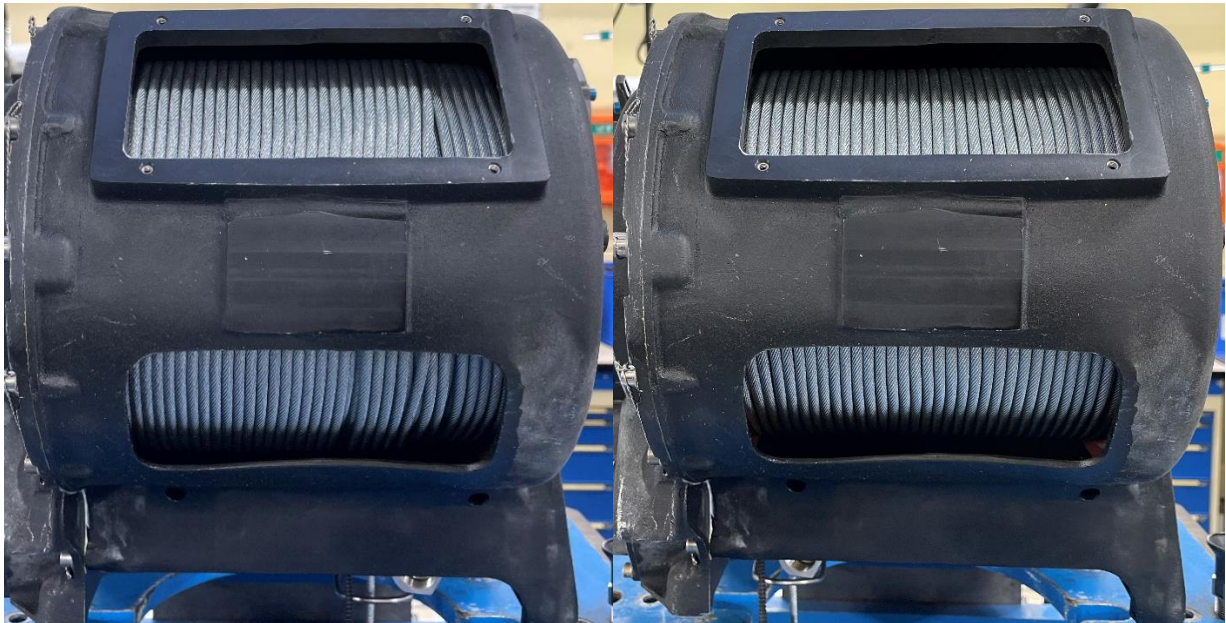
It is reminded that, during loading, it is possible for the cable to penetrate into the lower layers. This phenomenon occurs more, if an unloaded winding is performed previously, as the lower layers are wound on the drum with less tension.

Cable penetration during loading is a normal and unavoidable phenomenon on all hoists. This can lead to gaps between the turns and cable slamming, as illustrated in Figure 1, left.

Figure 1 : On the left, example of a winding showing gaps following cable penetration. On the right the same hoist wound with a load to tighten the turns of the lower layers.

Gaps between the coils can be eliminated by carrying out a loaded winding (pre-tensioning or conditioning), as illustrated in Figure 1, right.

This is why, **to determine if a hoist is correctly wound, it is necessary to perform a loaded winding before making any decisions** (see paragraph 4.D regarding pre-tensioning and conditioning).

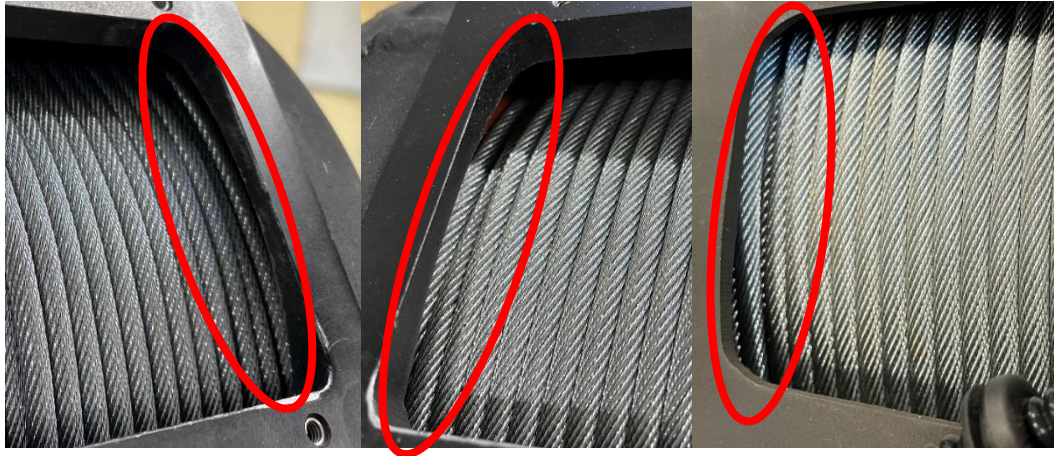
On the other hand, even after loaded winding, defects (purely cosmetic) may be present in the cable guide reversal zones (layer change zone). As these defects are acceptable, the hoist should not be returned for winding faults. Figure 2 shows examples of acceptable reversal defects.

Figure 2: Examples of acceptable defects at reversal zones (Layer changes).

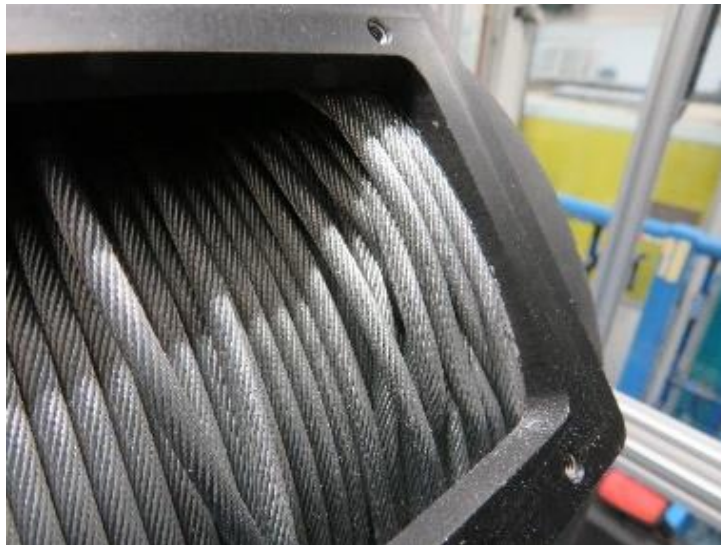
Figure 3: Example of an anarchic winding

Possible causes of an anarchic winding:

- If a load is attached to cable, anarchic winding may occur on following case:
 - Loss of synchronization of the cable guide with the drum (damaged winding screw or guiding fork, or shift of synchronization during the cable replacement operation).
- If the cable is unloaded, anarchic winding may occur on following cases:
 - Also, through loss of cable guide synchronization
 - Or loss of cable extraction function (rollers or extraction bar not functioning).

NOTE: In the event of a component blocking the translation of the cable guide, the guiding system (winding screw and guiding fork) may be damaged, potentially leading to anarchic winding and complete jamming of the hoist.

In the event of hoist jamming or anarchic cable winding, stop any action that results in cable winding or unwinding, and prioritize the safety of hoisted personnel.

If the hoist is found jammed or with an anarchic winding, it must be returned for repair.

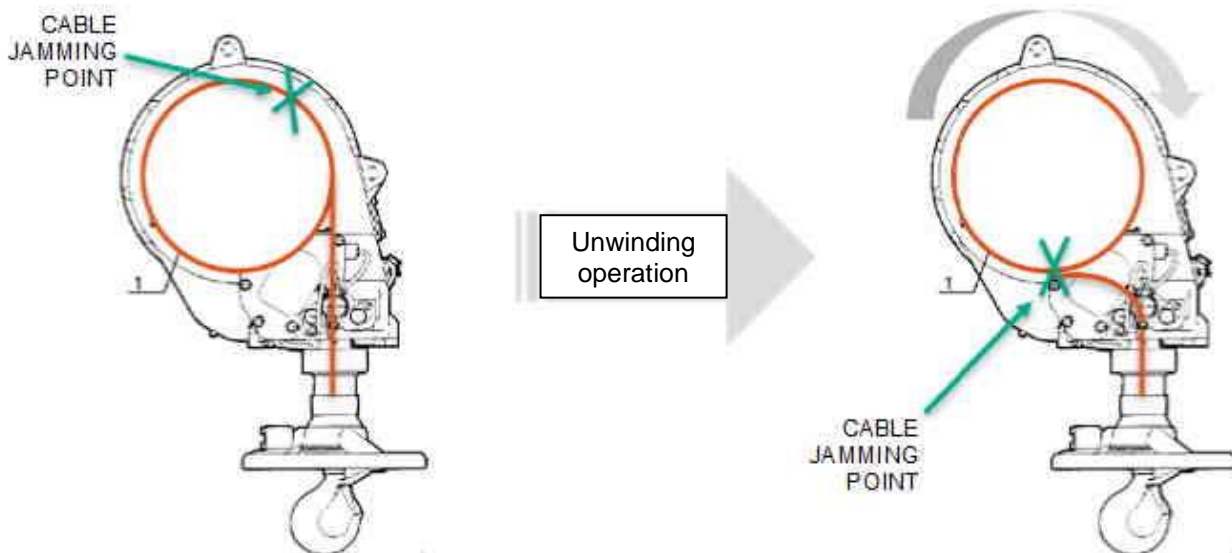
In fact, following an unloaded winding operation, the cable may be trapped in the lower layers when stopping at up travel limit (due to important tension in cable at up travel limit).

Hoist extraction function may then not be sufficient to release the cable, it may stay stuck inside lower layers during unwinding, causing kinking and sometimes even anarchic winding.

Figure 4: Cable jamming if manual tensioning procedure is not followed

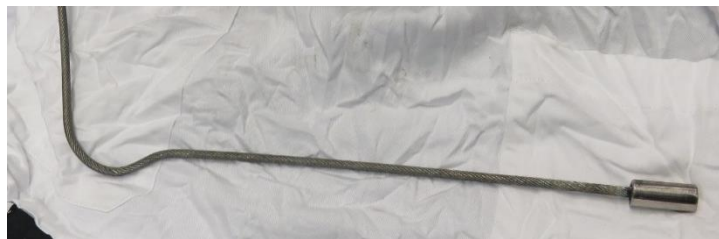
Failure to comply with this instruction may result in damage to the cable with an S-bend, that may lead to anarchic winding of the hoist.

Figure 5: "S"-shaped bend in the cable following failure to apply manual tension to the first 50 cm of cable

- The cable is anarchically wound and is blocking the hoist: send the hoist for repair.
- The cable is bent in an "S" shape, but manages to get out of the hoist: replace the cable before putting the hoist back into service, and remind operators of the manual pulling instruction for the first 50 cm.

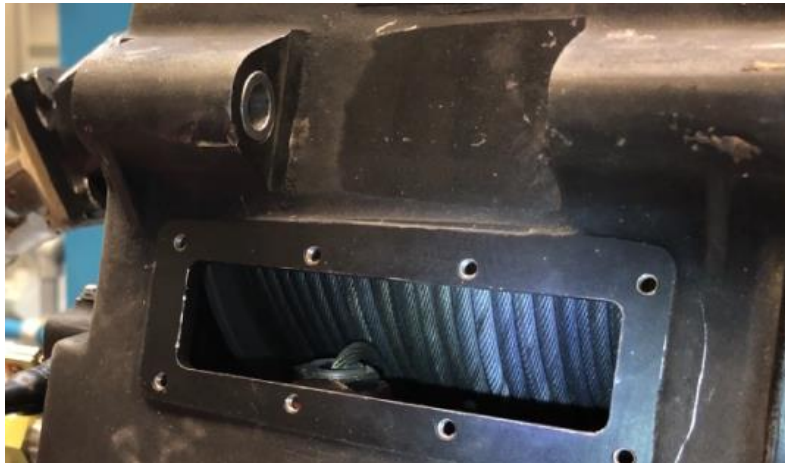
Figure 6 : Example of a cable reversed in the opposite direction because it was jammed in the drum after the first 50 cm of cable not tensioned by hand
