**No. AS365-01.00.67**

# ALERT SERVICE BULLETIN

### LIMITATIONS - Control rod double bearing Tail Gearbox (TGB)

- Periodic replacement of the TGB control rod double bearing on PRE MOD 07 65B63 TGBs.
- Pending the next replacement of the control rod double bearing, reducing the inspection interval for the TGB magnetic plug to ensure that there are no particles, and removing the control shaft/rod assembly once or twice (depending on the case) to inspect the double bearing.
- Maintaining the TGB operating oil at the maximum level.  
Compliance with this ALERT SERVICE BULLETIN supersedes the instructions specified in AS365 ALERT SERVICE BULLETIN No. 05.00.61.
- It is not permitted to fly with the TGB PRE MOD 07 65B63 from 1<sup>st</sup> January 2029.

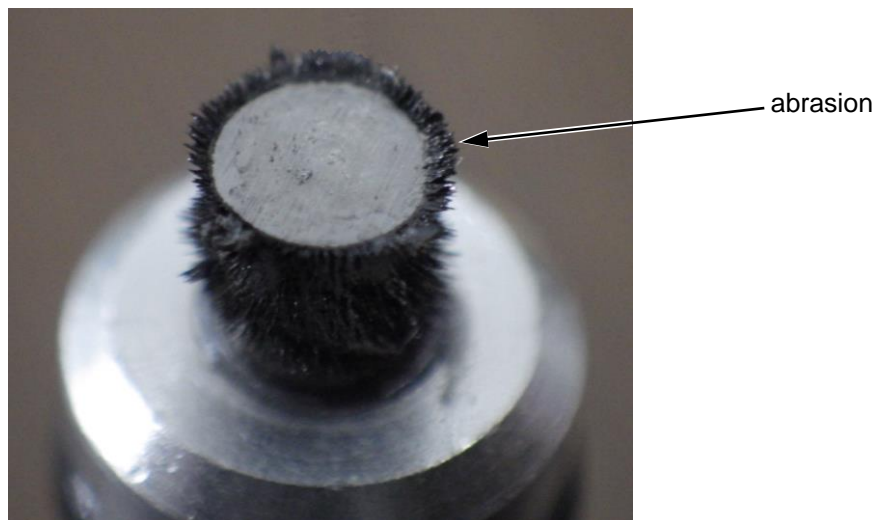
**IN THE FLOW CHART, THE ABRASION PARTICLES (CLASS g AS PER MTC) MUST BE TAKEN INTO ACCOUNT IN ADDITION TO THE PARTICLE TYPES USUALLY TAKEN INTO ACCOUNT.**

Figure 1: Example of abrasion on the magnetic plug

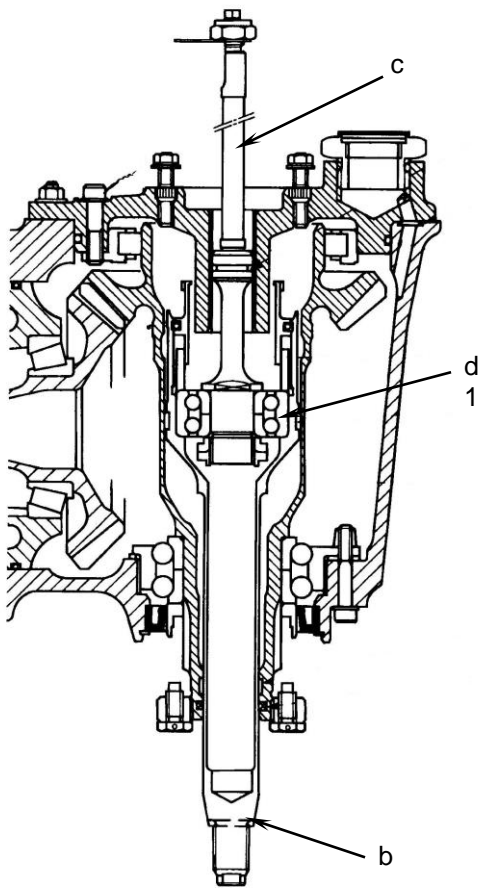
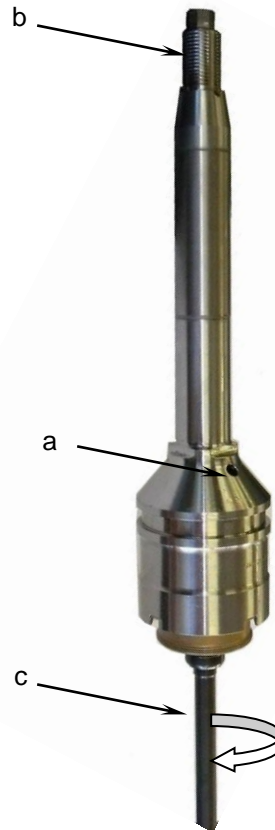
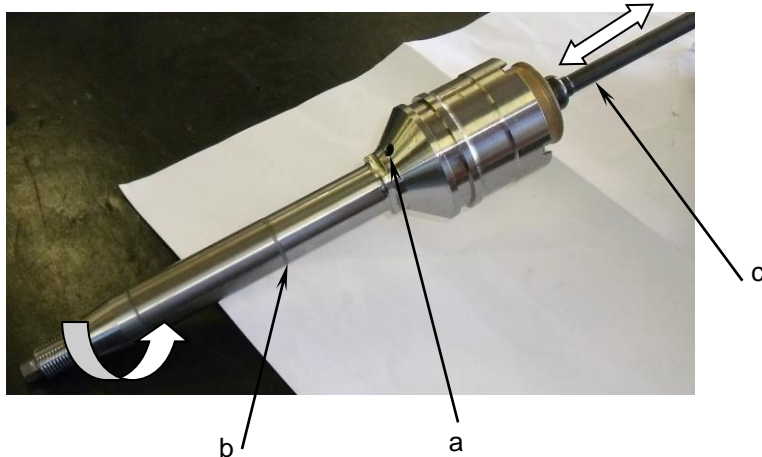
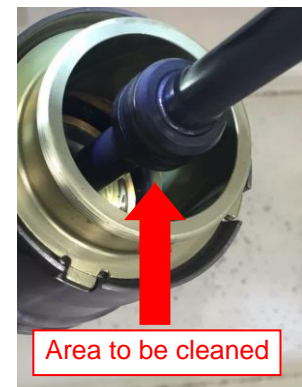
Figure 2

#### 3.B.3. Checking the play in the double bearing of the TGB control shaft/rod assembly ([Figure 2](#))

- Remove the control shaft/rod assembly as per paragraph [3.B.4.a.](#)
- Carry out a tactile check to ensure that there is no axial play in double bearing (d) (Figure 2):
  - . Apply an alternating manual axial load to control rod (c) whilst turning control shaft (b) (**See [DETAIL A Figure 2](#)**).

- Clean the control shaft/rod assembly using WHITE SPIRIT (2) as per Work Card 20-04-01-102 (MTC):
  - 1) Inject WHITE SPIRIT (2) under pressure (for example using a can) into hole (a) of control shaft (b). (**See [DETAIL B Figure 2](#)**).

- . Hold shaft (b) in the vertical position pointing upwards.
    - . Turn control rod (c) several times by hand to rinse double bearing (d) by draining the WHITE SPIRIT (2) through the bearing. (**See [DETAIL B Figure 2](#)**)

*Make sure that the area pointed out in [DETAIL C Figure 2](#) is clean.*

- Replace double bearing (d) ([Figure 2](#)) with a double bearing (1) as per Work Card 65-21-00-702 (MRM).
- Install the control shaft/rod assembly as per paragraph [3.B.4.b.](#):
  - . **Inform the Airbus Helicopters Customer Service Technical Support Department in accordance with paragraph [2.B.](#)**
  - . **Comply with paragraph [2.D.](#)**
