ALERT SERVICE BULLETIN

TITLE: Servo-control system - Check of the connection between the upper ball bearing end and the main rotor servo-control

Model:	AS365
Helicopters affected:	F , Fi , Fs , K , K2 , N , N1 , N2 , N3
Component affected:	SC8031 and SC8031-1 and SC8031-2 and SC8031A and SC8032 and SC8032-1 and SC8032-2 and SC8033-1 and SC8033-2 and SC8034-1 and SC8034-2

The purpose of this ALERT SERVICE BULLETIN is to check the nut tightening torque of the upper ball bearing end of the main rotor servo-controls.

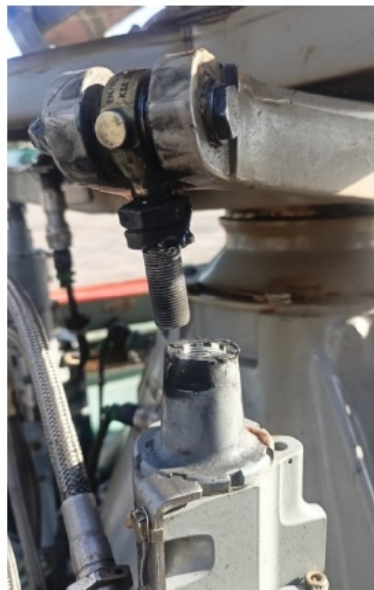
1. REASON

Airbus Helicopters was informed of two cases of loss of tightening torque between an upper ball bearing end and a main rotor servo-control. One case led to the disconnection of these two parts. In this case, the crew detected a vibration and hardening of the collective pitch lever on the ground when the collective pitch was increased.

After investigation, it turns out that there is no requirement to monitor the tightening torque of the upper ball bearing end in service.

Consequently, the purpose of this ALERT SERVICE BULLETIN is to check the nut tightening torque of the upper ball bearing end of the main rotor servo-controls and to collect information regarding the fleet status.

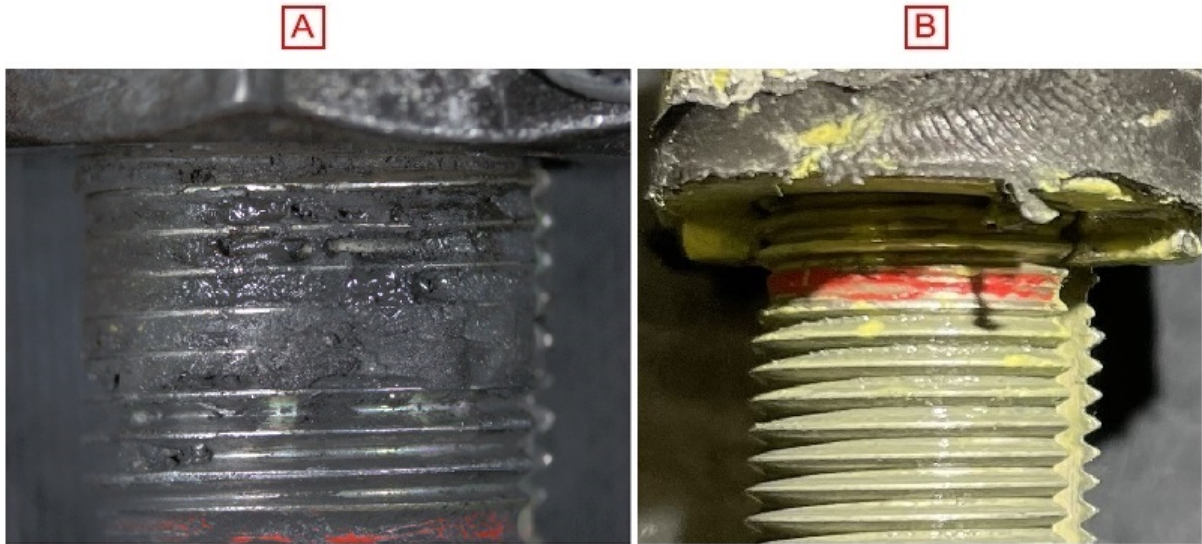
Figure 2

- 4.3.3. Do a detailed visual inspection of threads of the Ball bearing end EMRL8RSP3D (1) or Ball bearing end EMRL8RSP3C (2) or Ball bearing end 6701800800 (3) (Figure 2).

- 4.3.3.1. If there is no dirt, no corrosion and no damaged threads (Figure 2, Detail B):
- Clean the Ball bearing end EMRL8RSP3D (1) or Ball bearing end EMRL8RSP3C (2) or Ball bearing end 6701800800 (3) with Cleaning agent CM 208. Refer to Work Card Use of cleaning products on individual parts and on helicopters - Cleaning [MTC 20-04-01-102](#) Cleaning agent

- Keep the removed Ball bearing end EMRL8RSP3D (1) or Ball bearing end EMRL8RSP3C (2) or Ball bearing end 6701800800 (3).
- 4.3.3.2. If there is dirt (Figure 2, Detail A), corrosion or damaged threads:

- Do photos of the threads
 - Discard the Ball bearing end EMRL8RSP3D (1) or Ball bearing end EMRL8RSP3C (2) or Ball bearing end 6701800800 (3).
