ALERT SERVICE BULLETIN

TITLE: Servo-control system - Check of the connection between the upper ball bearing end and the main rotor servo-control

ASB AS365-67-30-0001

Issue 001 2024-04-18
Issue 002 2024-05-15

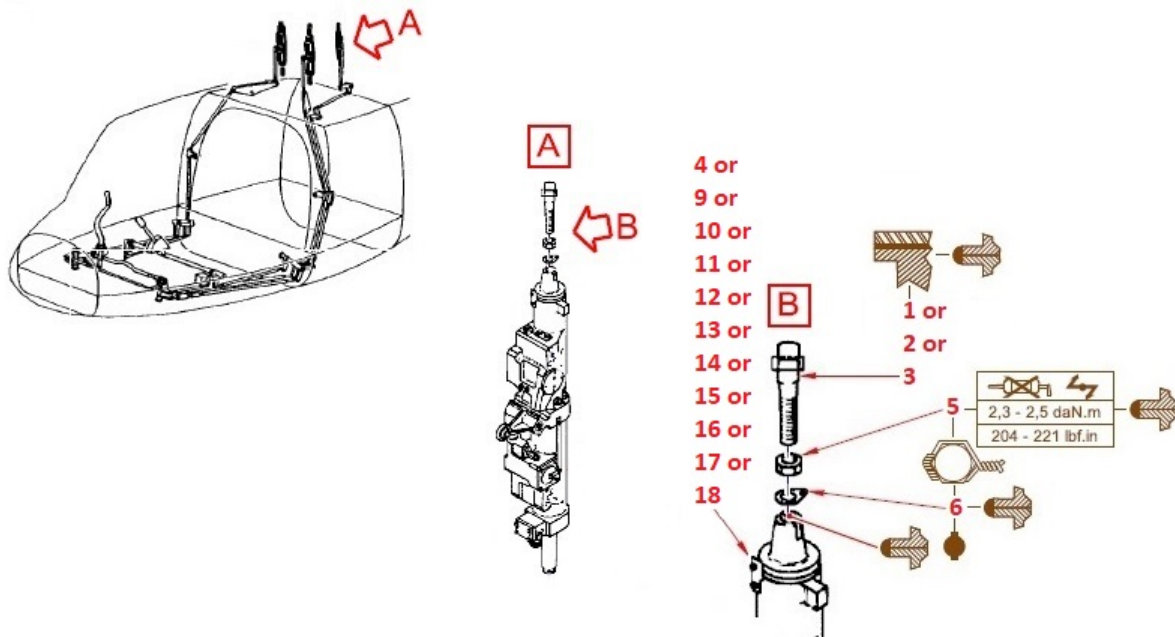
Figure 1

- 4.2. Do a check of the nut (5) tightening torque of the Ball bearing end EMRL8RSP3D (1) or Ball bearing end EMRL8RSP3C (2) or Ball bearing end 6701800800 (3) of the Main rotor servo-control SC8034-2 (4) or Main rotor servo-control SC8034-1 (9) or Main rotor servo-control SC8033-2 (10) or Main rotor servo-control SC8033-1 (11) or Main rotor servo-control SC8032-2 (12) or Main rotor servo-control SC8032-1 (13) or Main rotor servo-control SC8032 (14) or Main rotor servo-control SC8031A (15) or Main rotor servo-control SC8031-2 (16) or Main rotor servo-control SC8031-1 (17) or Main rotor servo-control SC8031 (18)(Figure 1). Refer to Work Card Assembly by screws and nuts - Joining [MTC 20-02-05-404](#).

- The nut (5)
 - The nut retainer (6)
 - The Lock-wire CM776.
 - Comply with paragraph 4.5.
- 4.2.2. If the tightening torque value is more than or equal to 2 daN.m (177 lbf.in) and less than 2.3 daN.m (204 lbf.in) when you get to the alignment of the marks (corresponds to a loss of tightening torque less than 15% of the minimum torque value):

- The nut (5)
 - The nut retainer (6)
 - The Lock-wire CM776.
 - Comply with paragraph 4.5.
- 4.2.3. If the tightening torque value is less than 2 daN.m (177 lbf.in) when you get to the alignment of the marks (corresponds to a loss of tightening torque more than 15% of the minimum torque value):

- 4.2.1. If you get to the minimum torque 2.3 daN.m (204 lbf.in) value before the marks align:
- Torque until the marks align but do not torque to more than the max torque value given in figure 1

- Use Lock-wire CM 776 to safety the nut (5) with the nut retainer (6).
 - Apply a bead of Sealing compound CM 6068 to:
 - The upper end of the Main rotor servo-control SC8034-2 (4) or Main rotor servo-control SC8034-1 (9) or Main rotor servo-control SC8033-2 (10) or Main rotor servo-control SC8033-1 (11) or Main rotor servo-control SC8032-2 (12) or Main rotor servo-control SC8032-1 (13) or Main rotor servo-control SC8032 (14) or Main rotor servo-control SC8031A (15) or Main rotor servo-control SC8031-2 (16) or Main rotor servo-control SC8031-1 (17) or Main rotor servo-control SC8031 (18)

- Torque the nut (5) to the nominal values given in Figure 1.
 - Use Lock-wire CM 776 to safety the nut (5) with the nut retainer (6).
 - Apply a bead of Sealing compound CM 6068 to:

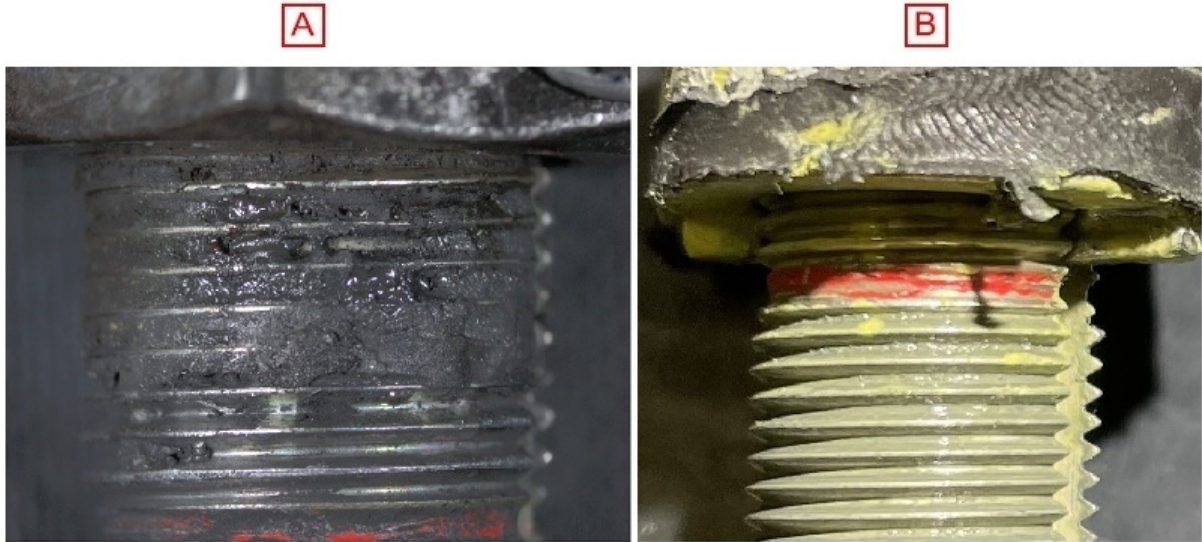
Figure 2

- 4.3.3. Do a detailed visual inspection of threads of the Ball bearing end EMRL8RSP3D (1) or Ball bearing end EMRL8RSP3C (2) or Ball bearing end 6701800800 (3) (Figure 2).

- 4.3.3.1. If there is no dirt, no corrosion and no damaged threads (Figure 2, Detail B):
- Clean the Ball bearing end EMRL8RSP3D (1) or Ball bearing end EMRL8RSP3C (2) or Ball bearing end 6701800800 (3) with Cleaning agent CM 208. Refer to Work Card Use of cleaning products on individual parts and on helicopters - Cleaning [MTC 20-04-01-102](#) Cleaning agent

- Keep the removed Ball bearing end EMRL8RSP3D (1) or Ball bearing end EMRL8RSP3C (2) or Ball bearing end 6701800800 (3).
- 4.3.3.2. If there is dirt (Figure 2, Detail A), corrosion or damaged threads:

- Do photos of the threads
 - Discard the Ball bearing end EMRL8RSP3D (1) or Ball bearing end EMRL8RSP3C (2) or Ball bearing end 6701800800 (3).

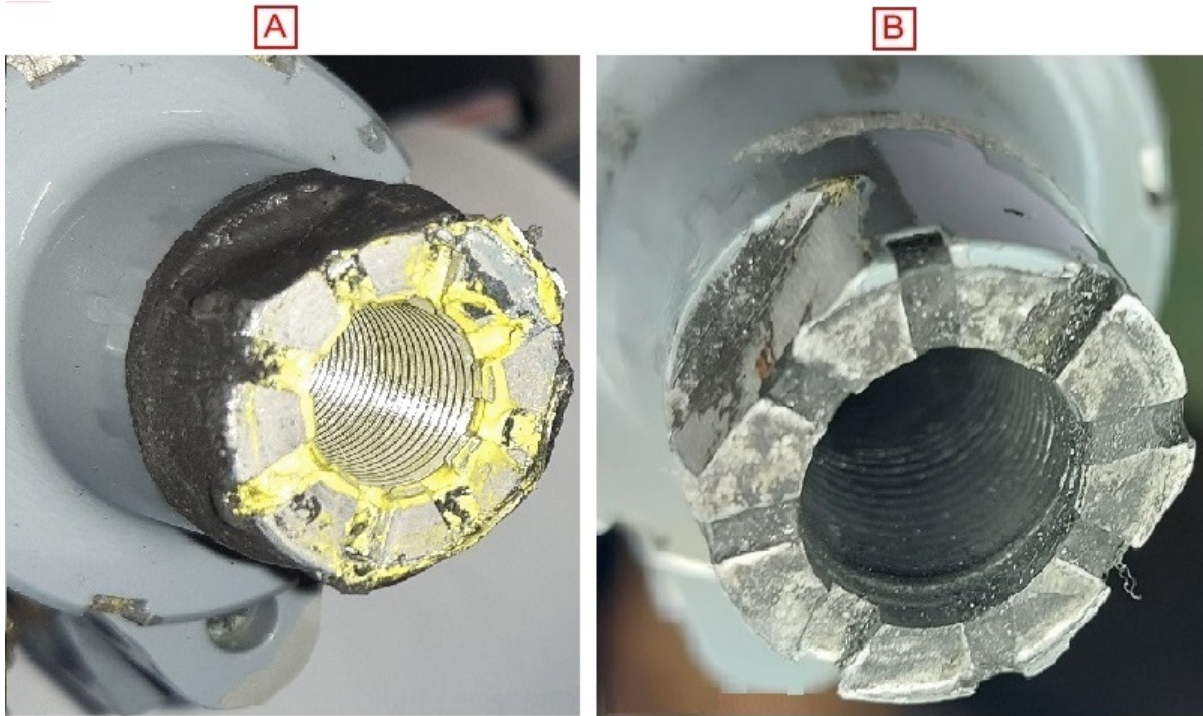
Figure 3

- 4.3.4. Do a detailed visual inspection of the threads on the inner surface of the upper end fitting of the Main rotor servo-control SC8034-2 (4) or Main rotor servo-control SC8034-1 (9) or Main rotor servo-control SC8033-2 (10) or Main rotor servo-control SC8033-1 (11) or Main rotor servo-control SC8032-2 (12) or Main rotor servo-control SC8032-1 (13) or Main rotor servo-control SC8032 (14) or Main rotor servo-control SC8031A (15) or Main rotor servo-control SC8031-2 (16) or Main rotor servo-control SC8031-1 (17) or Main rotor servo-control SC8031 (18) with the Flashlight (7) (not shown) and the Articulated mirror (8) (not shown):

- Do photos of the threads after cleaning.
- 4.3.4.1. If there is oxidation, corrosion or damaged threads (Figure 3, Detail B), comply with paragraph 4.4.

- 4.3.4.2. If there is no oxidation, no corrosion and no damaged threads (Figure 3, Detail A), comply with paragraph 4.3.5.

- Do photos of the threads
 - Clean the threads on the inner surface of the upper end fitting of the Main rotor servo-control SC8034-2 (4) or Main rotor servo-control SC8034-1 (9) or Main rotor servo-control SC8033-2 (10) or Main rotor servo-control SC8033-1 (11) or Main rotor servo-control SC8032-2 (12) or Main rotor servo-control SC8032-1 (13) or Main rotor servo-control SC8032 (14) or Main rotor servo-control SC8031A (15) or Main rotor servo-control SC8031-2 (16) or Main rotor servo-control SC8031-1 (17) or Main rotor servo-control SC8031 (18) with Cleaning agent CM 208. Refer to Work Card Use of cleaning products on individual parts and on helicopters - Cleaning [MTC 20-04-01-102](#)
