No. AS365-05.00.70

SERVICE BULLETIN

SUBJECT: TIME LIMITS - MAINTENANCE CHECKS - Checking interval

Transmission deck, inspection of beams X3826 and X4338
 Corresponds to ATA 53

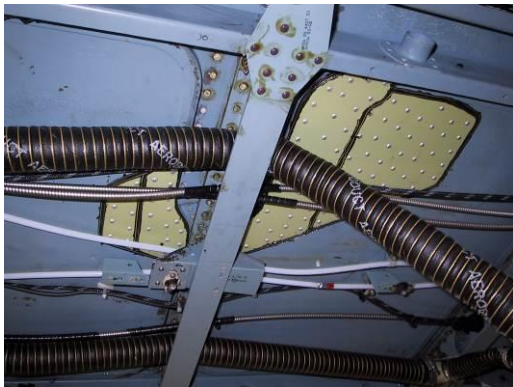
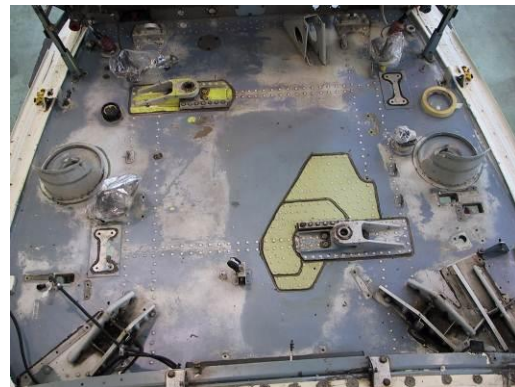
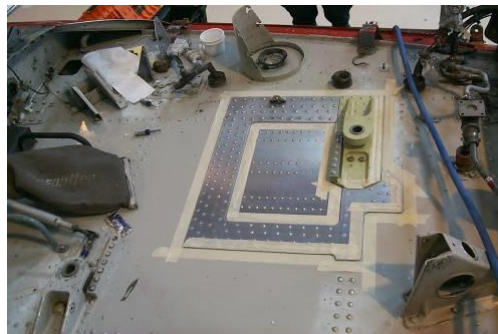
Helicopters on which the transmission deck has been repaired due to cracks in the area of the roving bar attachment fittings.

(See example of repaired transmission decks below)
