SERVICE BULLETIN

N° **139-783**

ATA 32 – MLG SHOCK ABSORBER INSPECTION

INSPECTION OF SHOCK ABSORBER PISTON ROD EYE END

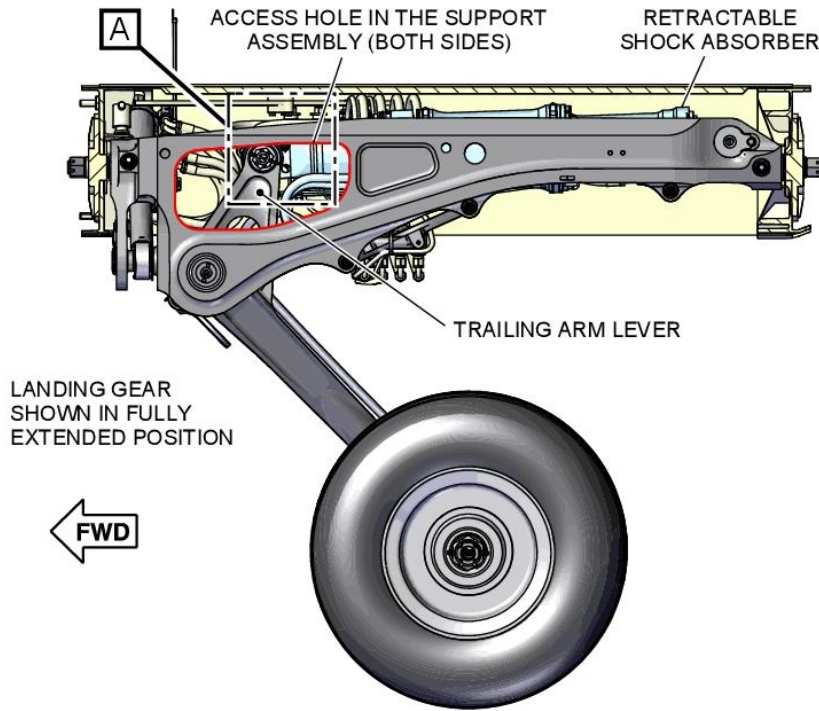
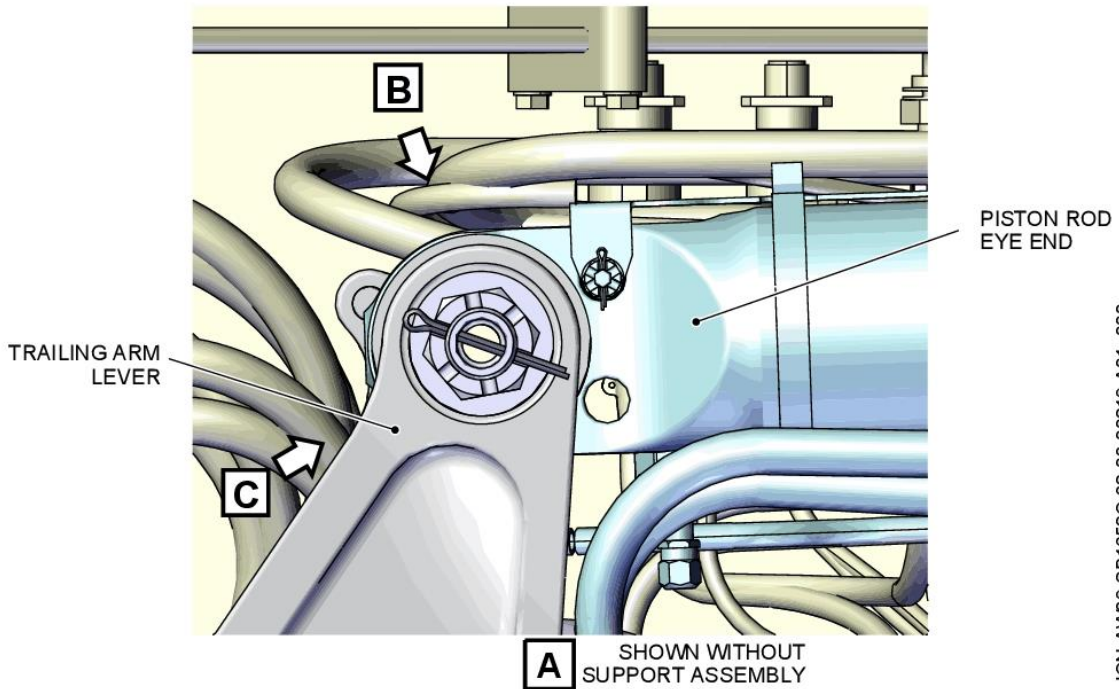
Inspection Area
(Sheet 1 of 2)
Figure 2

- (a) The Inspection Area is defined in [Figure 2](#) and [Figure 3](#). Two separate Inspection Areas are to be observed, one at the UPPER side and one at the LOWER side of the piston rod eye end. With the landing gear installed on the helicopter the Inspection Area is partially obstructed by surrounding structure. An inspection mirror and an inspection flashlight is inevitable to gain visibility access to the Inspection Area.

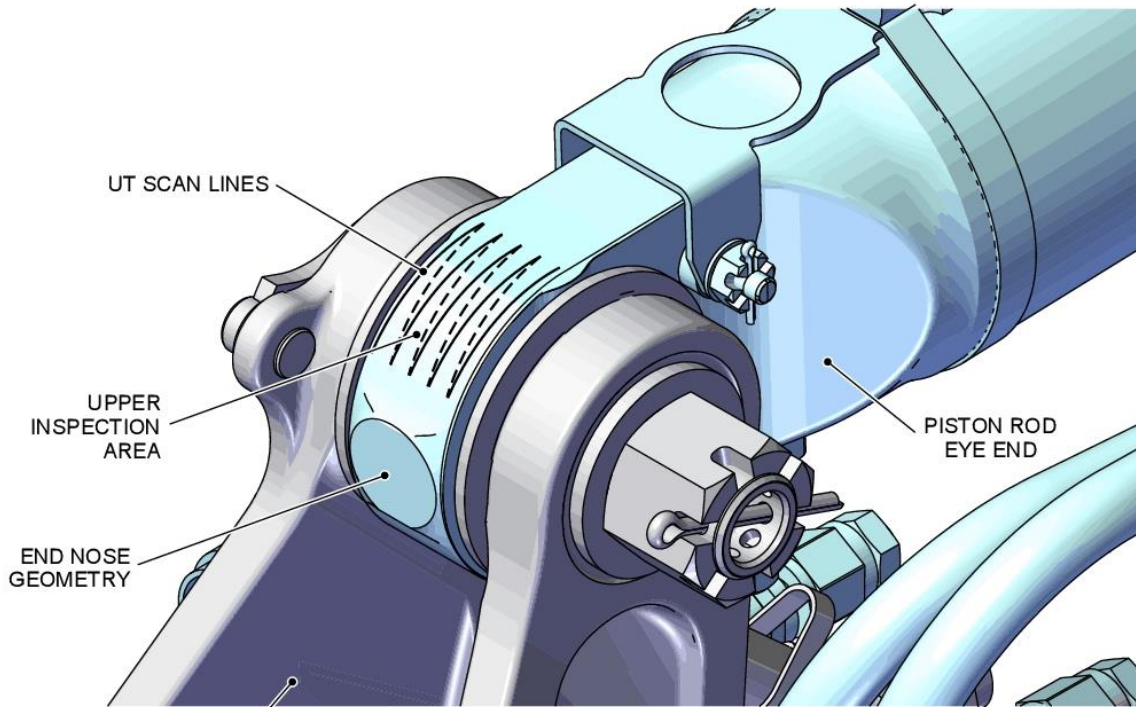
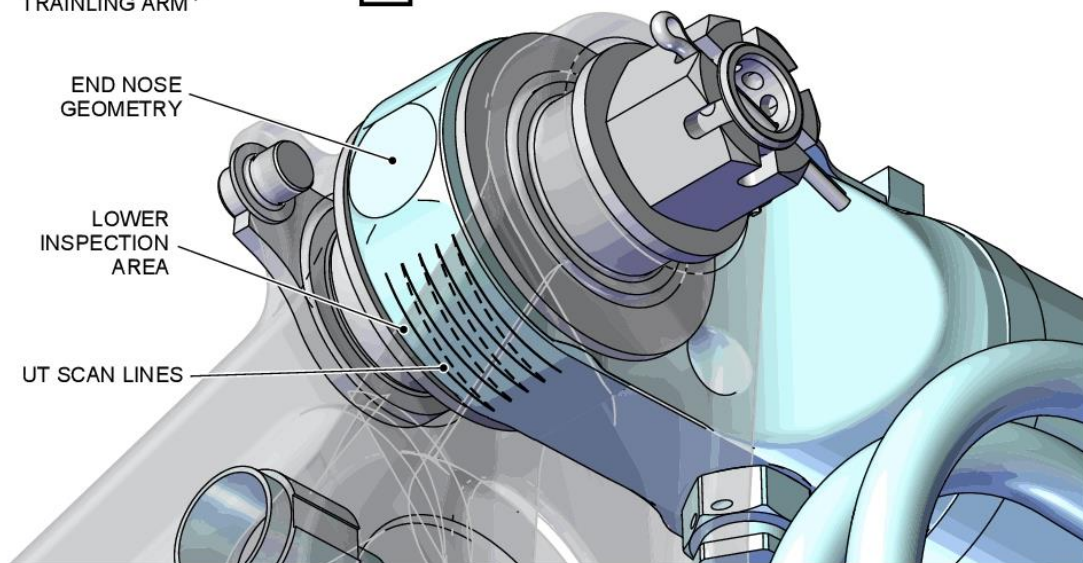
Inspection Area
(Sheet 2 of 2)
Figure 2

- 12 Make sure that you do the UT inspection on both, the UPPER and LOWER inspection area. Refer to [Figure 2, Sheet 2](#).
- 13 Check the calibration on the Reference Specimen PN 1654A0100-01W02 to verify that the amplitude of the notch indication is 80% FSH. If the check fails, repeat the sequence of operations in para. 3.C.(3) (a) and 3.C.(3) (b).

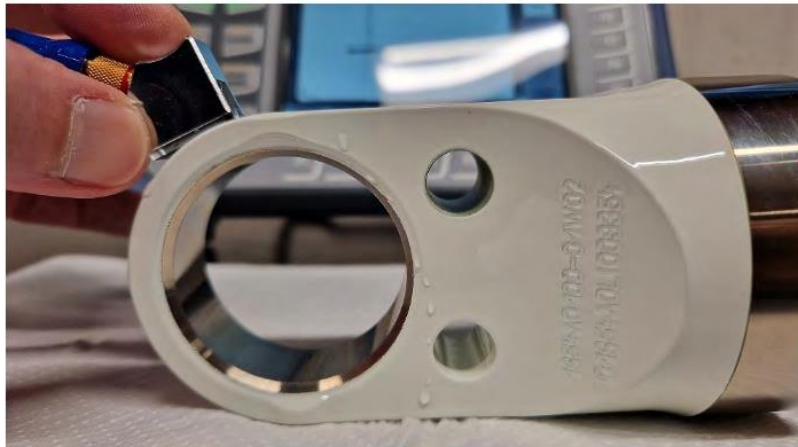
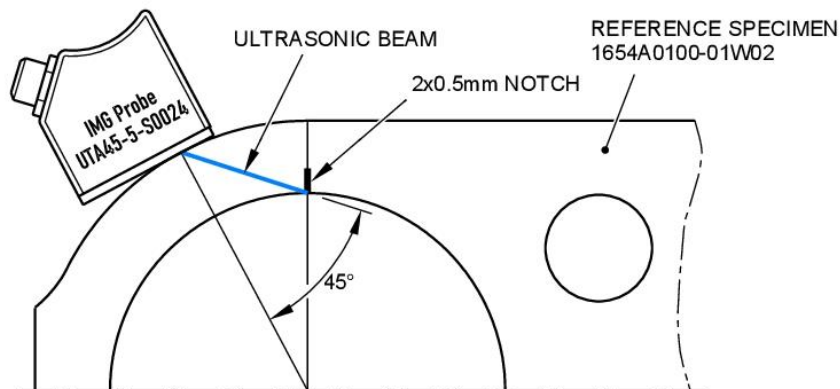
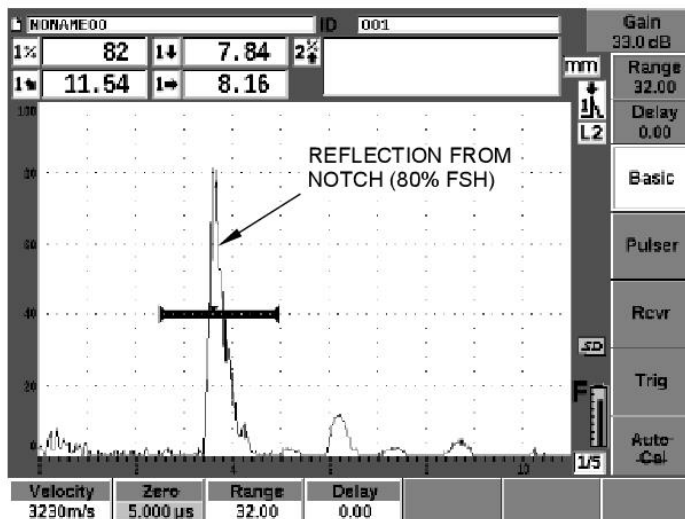
Calibration on the notch of Reference Specimen
Figure 4

The Reference Specimen has two notches inside the main bore, one at the UPPER side and one at the LOWER side of the eye end. Each notch simulates a potential crack at the expected location. However, only one of the two notches is required for UT calibration purposes. The other notch is for back-up purposes only. The UT inspection of the Reference Specimen leads to an ultrasonic echo indication as shown in [Figure 4](#).

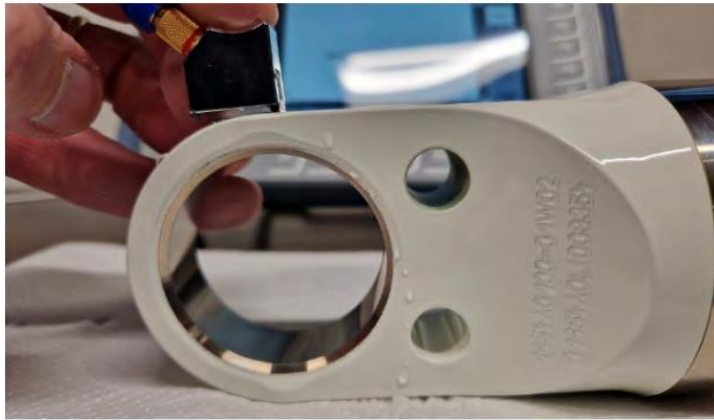
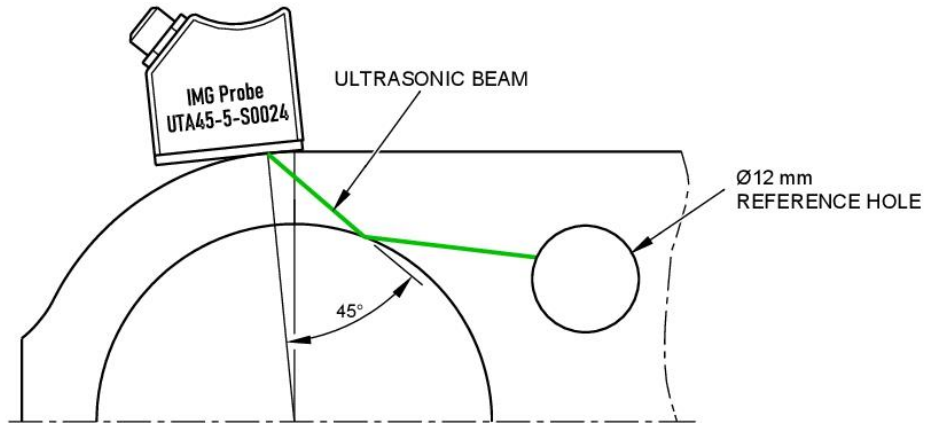
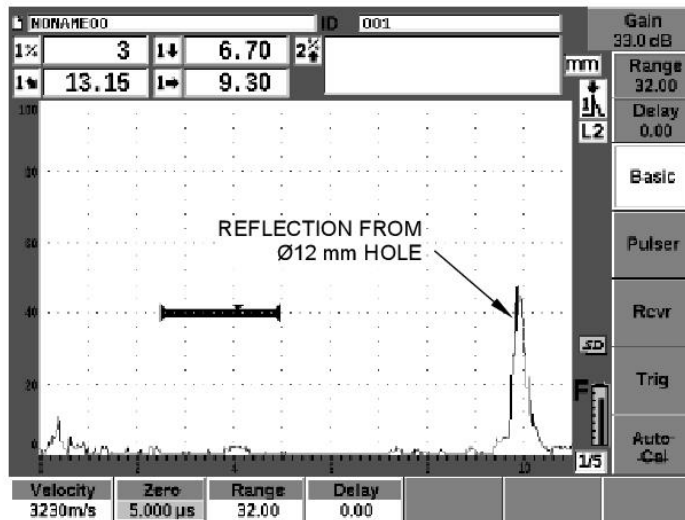
Ultrasonic indication from the 12 mm hole (starting point)
Figure 5

- 11 Do the UT Inspection moving the sensor back and forth from the 12-mm hole indication (starting point) ([Figure 5](#)) to the end nose of the piston rod eye end ([Figure 7](#)) to detect a potential crack at the expected location (within the recording gate) on the Piston Rod PN 1654A0100-01. Observe the display of the Flaw Detector for indications within and above the Recording Gate.

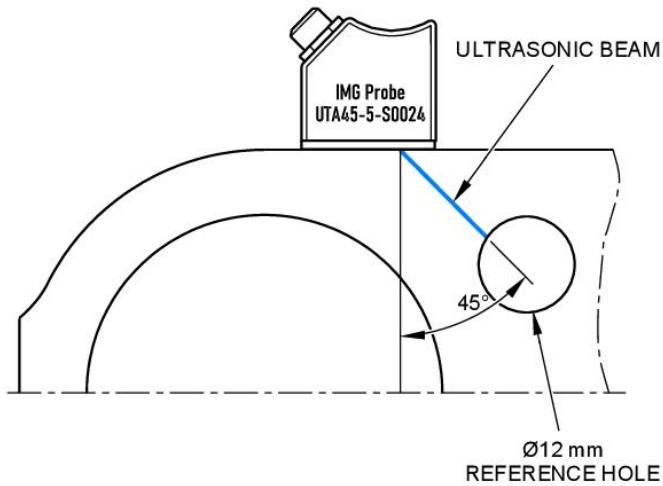
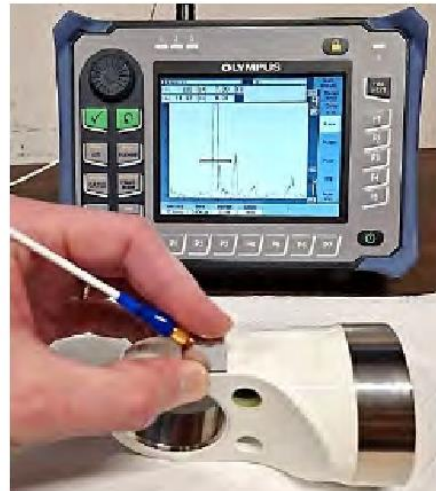
Example of wrong signal
Figure 6

WARNING:
PROBE BEYOND SCANNING AREA
(FLAT AREA)

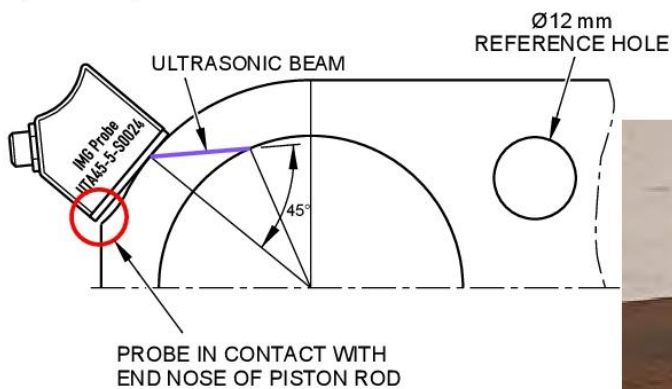
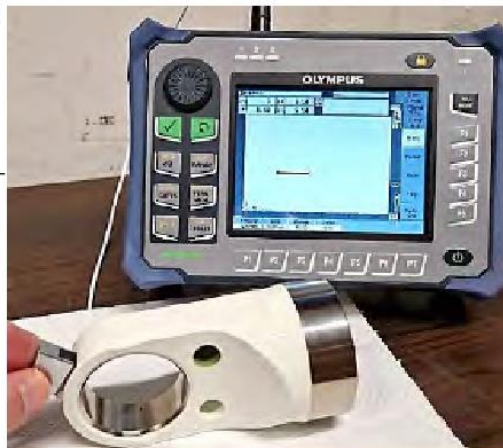
Probe in contact with the nose (End point)
Figure 7

NOTE:
END POINT OF SCANNING AREA
(NOSE END)
