# SERVICE BULLETIN No. 292 72 2236

**Subject:**  
Module M01 - Modification to the roughness on the starter gear and to the module M01 axial clearance.  
Modification TU 236.

APPLICABLE ENGINE / VARIANT(S)	EFFECTIVITY CODE	MAINTENANCE LEVEL	CONDITION OF APPLICATION	EFFECT ON OPERATION
ARRIEL 2 B, B1, B1A, C, C-PM, C1, C2, C2-CG, D, E, H, L2, N, S1, S2	2-A-3	1, 2, 3	Application upon customer request	Replacement of module M01
		4	Application upon first return to an approved Repair Center, if the repair/overhaul gives access to the starter gear

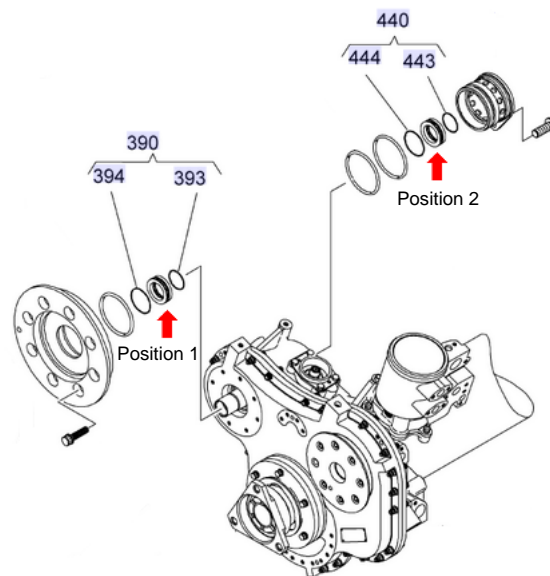
**Figure 1**
**1.1.2. Analysis**

Operators of ARRIEL 2 engines reported oil leaks on the magnetic seal assemblies (See figure 1, Position 1 and Position 2) installed on the starter gear of the accessory gearbox module (Module M01).

Investigations of magnetic seal assemblies installed on the starter gear done by Safran Helicopter Engines (and shared with the supplier of these magnetic seal assemblies) determined that the origins of the observed leaks are different. They are related among others to:

- a separation of the two rings that make the magnetic seal assembly. This separation can be the result of an excessive axial clearance on the starter gear line.
- damage to the o-ring of the rotor section of the magnetic seal assembly. This damage can be the result of a not sufficient rotational drive capability of the friction ring of the magnetic seal assembly. It is possible to get a better drive capability with a higher roughness on the starter gear.
