SERVICE BULLETIN

No.**292 73 2092**

ARRIEL 2 B - B1 - C - C-PM - C1- C2 - S1

Subject: Hydromechanical Metering Unit (HMU). LP fuel pressure switch with dual sealing diaphragm.**Application of modification TU 92.**

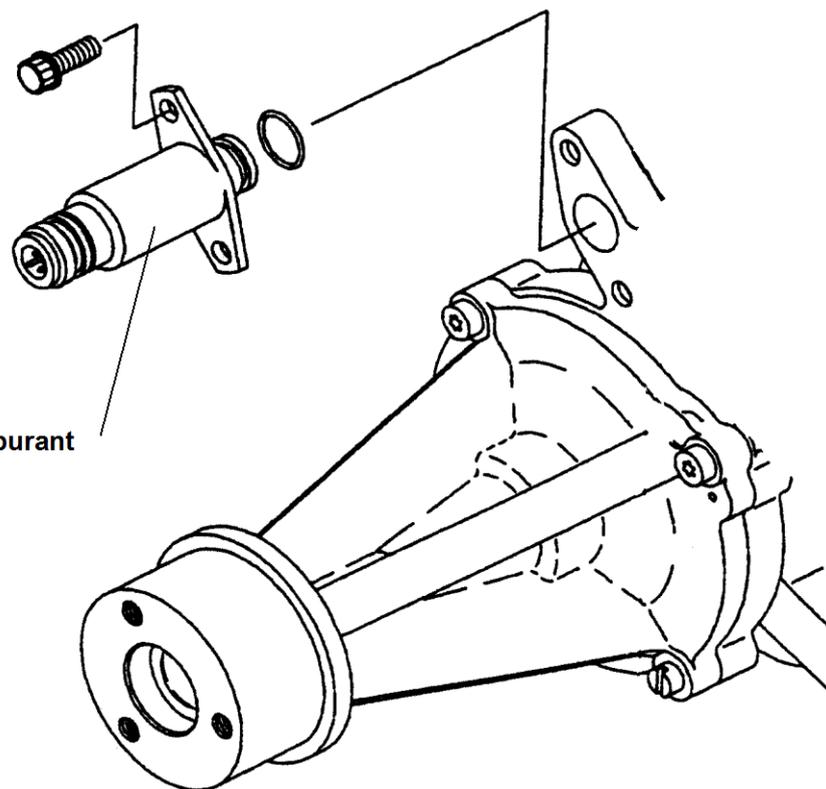
ANNEXE 2 / APPENDIX 2

To eliminate the possibility of fuel leaking through the LP fuel pressure switch ventilation hole.

This modification consists of installing a new LP fuel pressure switch. This new switch has undergone the following improvements:

- addition of a restrictor in the adjusting screw,
- application of a dual sealing diaphragm.

Manocontacteur BP carburant
LP fuel pressure switch
