P&WC S.B. No. 41020R2

PT6C-72-41020

TURBOSHAFT ENGINE ELECTRONIC ENGINE CONTROL - REPROGRAMMING/REPLACEMENT OF

Summary: To meet customer requirements, introduce new Engine Electronic Control (EEC) software with improved training logic, start logic and category "A" features.

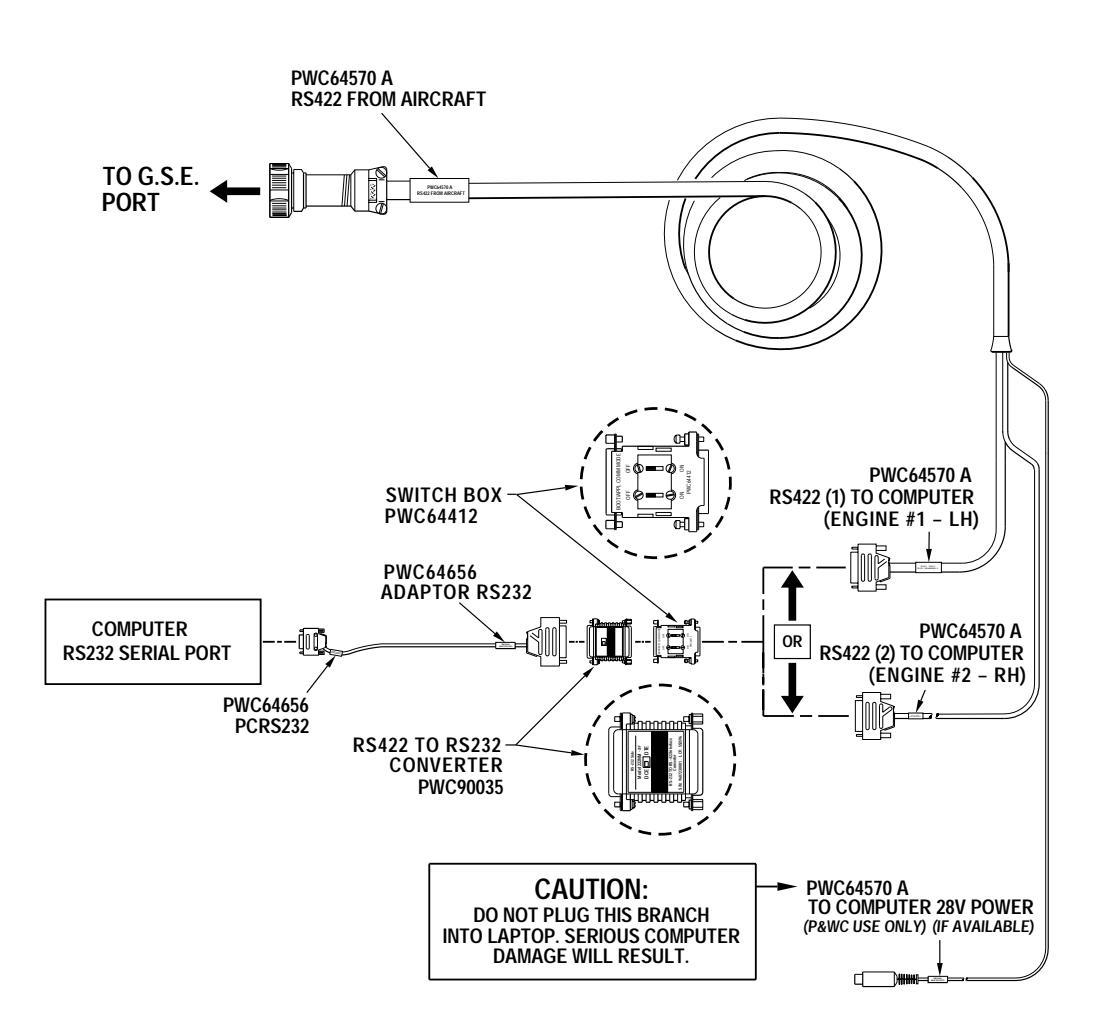
Tools Set Up Figure 1

GSE port is located on the bottom hand side of the baggage compartment behind the quick access panel.

- (2) Turn the electrical power supply to the EEC to the OFF position.
    - (3) Set up the tools and do all connections to the EEC and the laptop as shown (Ref. Fig. 1).
