Multi-Engine Turboprop Communiqué

Communiqué ME-TP-0026
July 2021

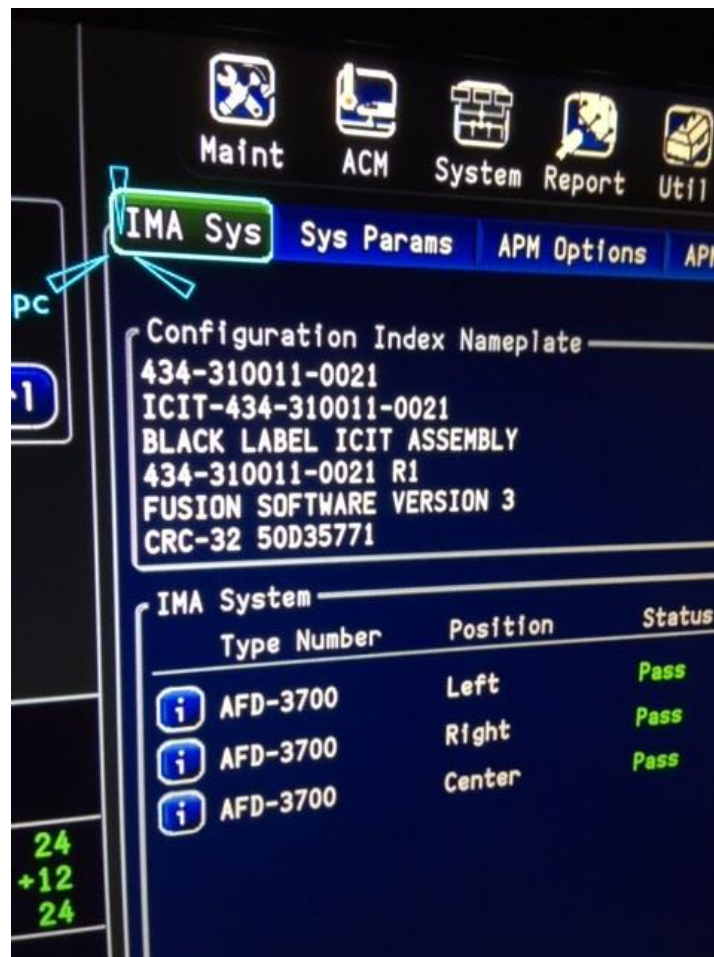
This figure below shows one example of an updated FDSA file. This is for reference only as different serial numbers may require different software levels, refer to FDSA-6500-19-1 for the correct files for your airplane.

To verify the software level of your Fusion System, access the maintenance screen as follows:

1. Set the maintenance page to Advanced Mode.
2. Select the system tab.
3. Select the IMA system configuration page.
