STABILIZERS - HORIZONTAL FASTENER REPLACEMENT

MODEL	SERIAL NUMBERS
B200GT	BY-434 thru BY-444
B300	FL-1301 thru FL-1309
B300C	FM-108, FM-109

MTL-55-02
Page 1 of 6

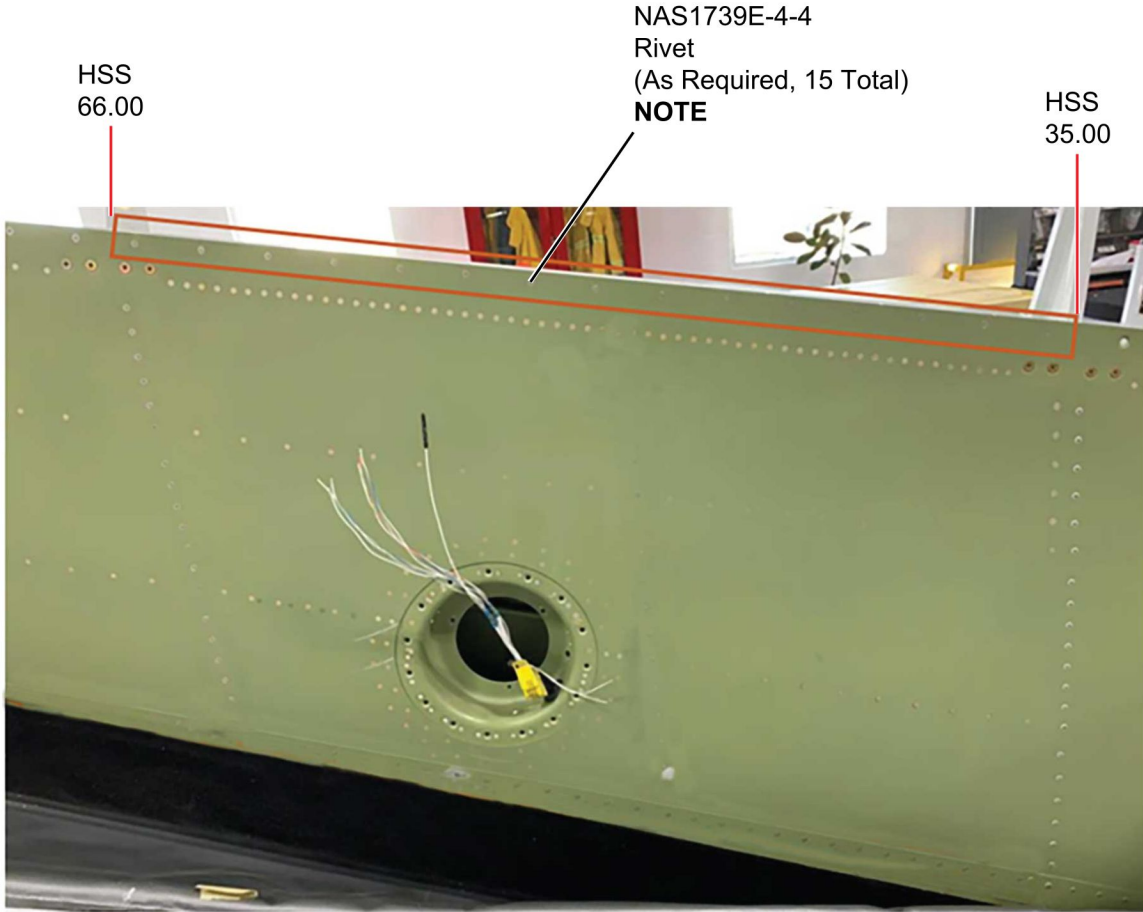
Figure 1. Horizontal Fastener Location (Sheet 2)

DETAIL B

NOTE: Only the rivets that attach the 101-620010-9 Cove Closure needs to be inspected on the upper surface.

- (2) Remove all magnetic fasteners from the left horizontal stabilizer between HSS 35.00 to HSS 74.00. (Refer to the King Air Structural Inspection and Repair Manual, Chapter 20, Fastener Installation and Removal.)
- (3) Remove all foreign object debris (FOD).
- (4) Apply Color Chemical Film Treatment to the rivet holes.
- (5) Apply Corrosion-Resistant Epoxy Primer to the rivet holes.
- (6) (Refer to Figure 1, Sheet 1.) Install either a 132368AD4-4 Rivet or a 132370AD4-4 Rivet as required, into all open rivet holes. (Refer to the King Air Structural Inspection and Repair Manual, Chapter 20, Fastener Installation and Removal.)

- B. For magnetic fasteners on the trailing edge of the left between HSS 35.00 and HSS 66.00 on the trailing edge of the left horizontal stabilizer do as follows:

- (1) Remove the left elevator if required. (Refer to the applicable Maintenance Manual, Chapter 27, Elevator - Removal/Installation.)
- (2) Remove all attach fasteners from the 101-620010-9 Cove Closure. (Refer to the King Air Structural Inspection and Repair Manual, Chapter 20, Fastener Installation and Removal.)
- (3) Remove all foreign object debris (FOD).
- (4) Apply Color Chemical Film Treatment to the rivet holes.
- (5) Apply Corrosion-Resistant Epoxy Primer to the rivet holes.
- (6) Install the 101-620010-9 Cove Closure with a NAS1739E-4-4 Rivet into all open rivet holes. (Refer to the King Air Structural Inspection and Repair Manual, Chapter 20, Fastener Installation and Removal.)
