P&WC S.B. No. 41046R2

# BULLETIN INDEX LOCATOR 77-10-00

TURBOSHAFT ENGINE PT SPEED AND TORQUE SENSOR, LEFT HAND - REPLACEMENT OF

#### PT6C-67C

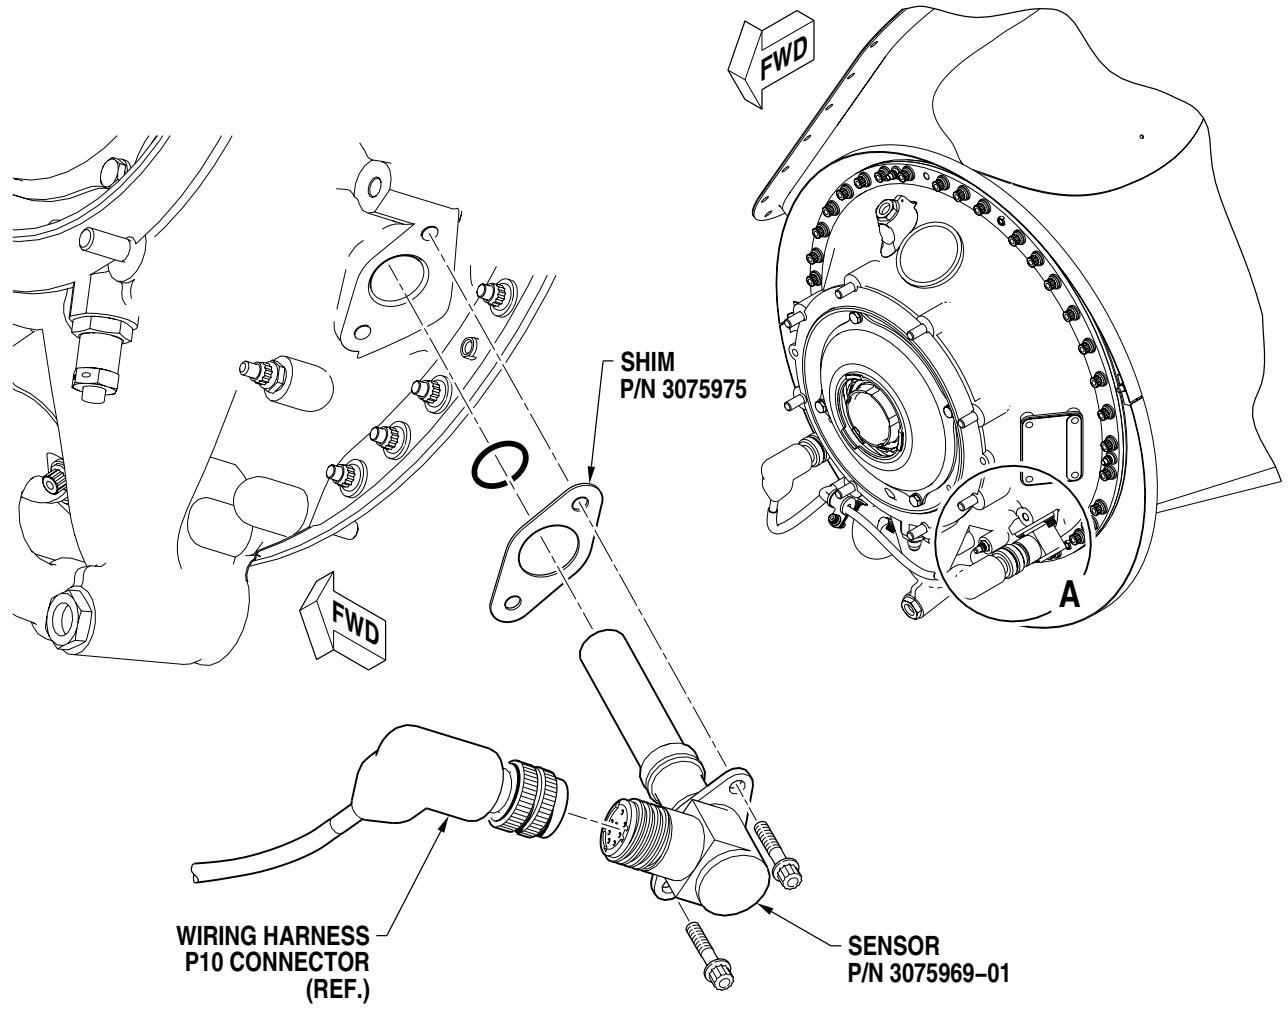
DETAIL A

The gap between the left side torque probe (viewed from accessory gearbox) and the toothed wheel of the torque shaft is not optimal.

PT Speed and Torque Sensor, Left Hand - Installation Figure 2

Introduce a new torque sensor, on the left side, with shims to adjust the gap between the sensor and torque shaft.

Replace the left sensor with a new sensor installed with shims.
