SERVICE BULLETIN

N° 189-256

DATE: March 22, 2023 REV.: /

ATA 71 – ENGINE COWLING LATCH RETROMOD

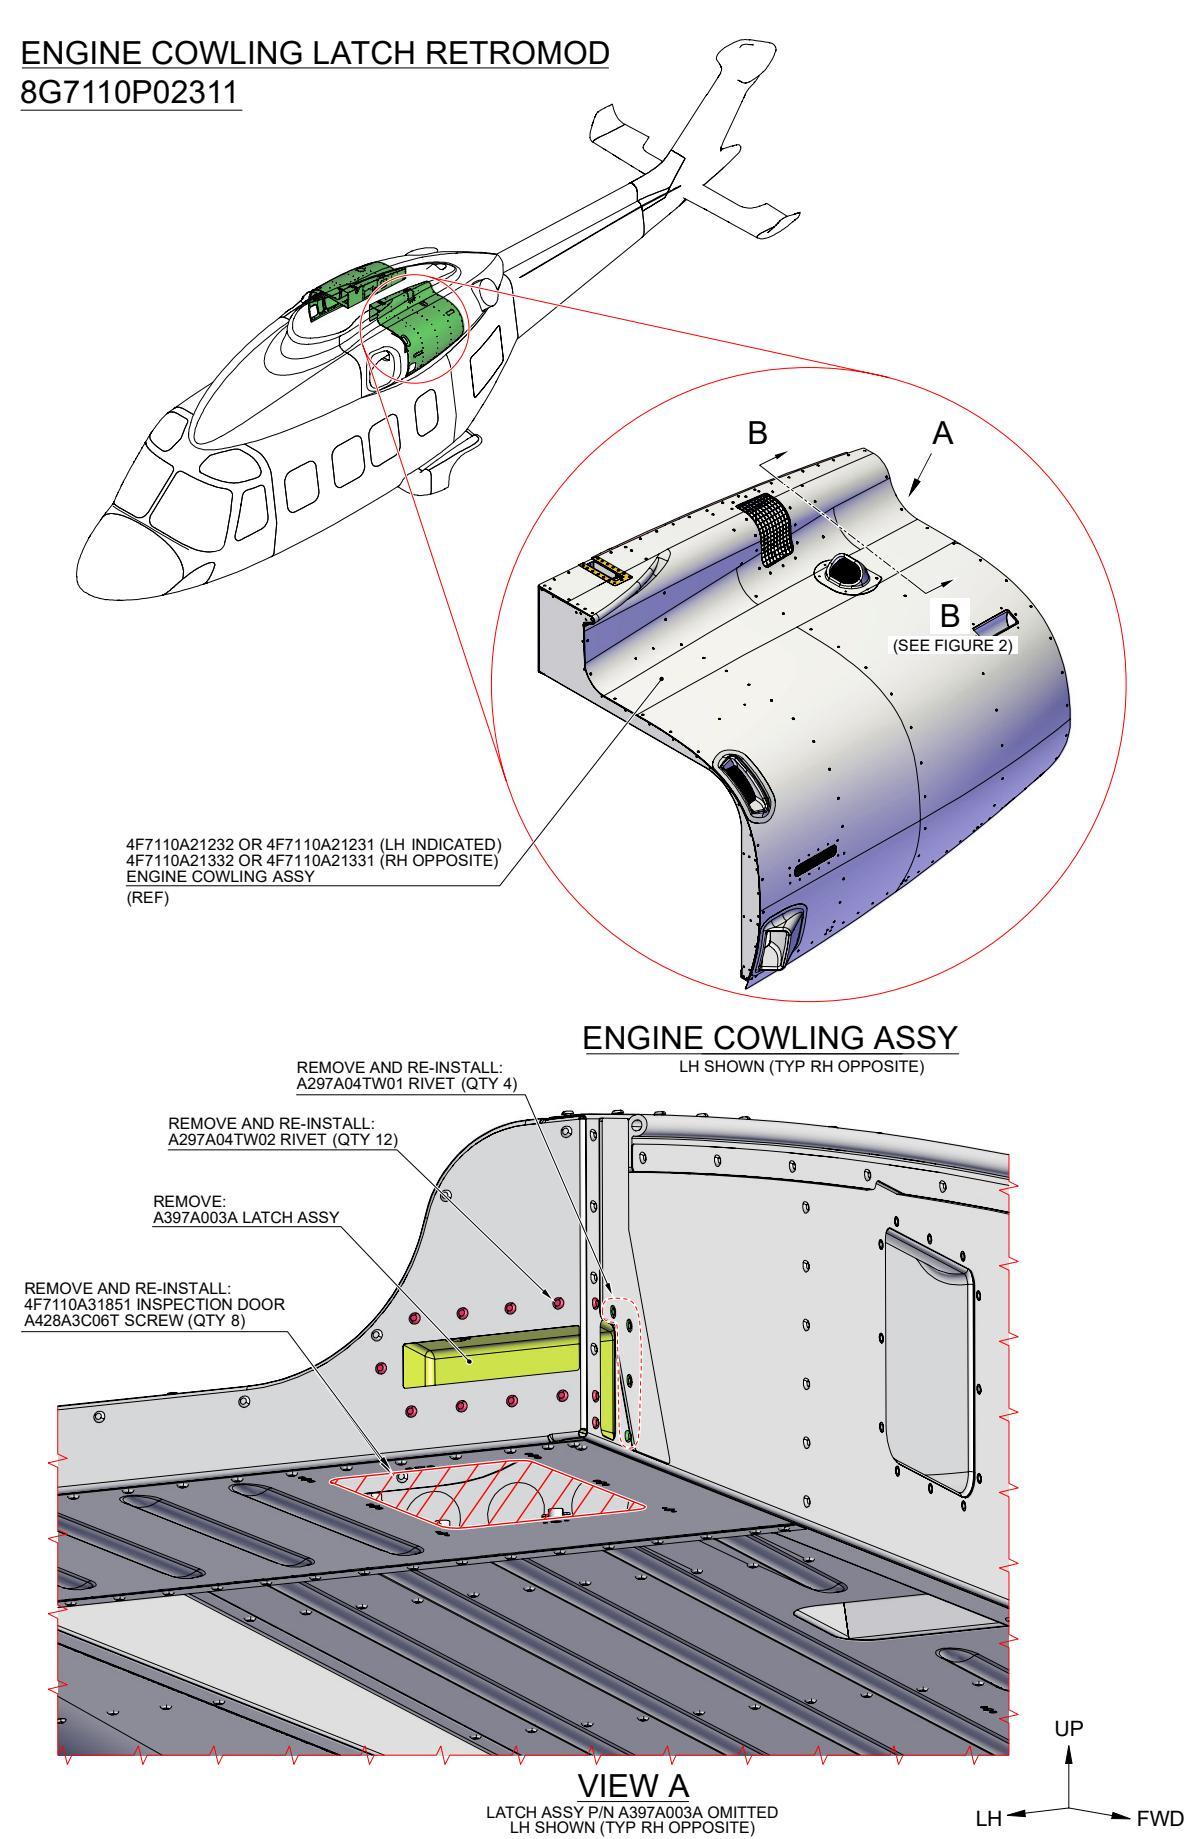
Leonardo Helicopters received reports about damages to the engine cowlings caused by an interference between the latches, when they are in fully opened position, and the cowling structure. The damage can be caused in case the latches were operated with excessive force.

- 2.1.2 In accordance with AMP DM 89-A-06-41-00-00A-010A-A and with reference to Figure 1 View A, remove and retain n°8 screws P/N A428A3C06T and the inspection door P/N 4F7110A31851 (Access panel 461E) from the LH engine cowling assy P/N 4F7110A21232 or P/N 4F7110A21231.

- 2.1.3 With reference to Figure 1 View A, remove n°12 rivets P/N A297A04TW02 and n°4 rivets P/N A297A04TW01 from the LH engine cowling assy P/N 4F7110A21232 or P/N 4F7110A21231.

- 2.1.12 In accordance with AMP DM 89-A-06-41-00-00A-010A-A and with reference to Figure 1 View A, re-install the inspection door P/N 4F7110A31851 (access panel 461E) on the LH engine cowling assy P/N 4F7110A21232 or P/N 4F7110A21231 by means of the n°8 screws P/N A428A3C06T previously removed.

- 2.1.13 With reference to Figure 1 "Engine Cowling Assy" and in accordance with the applicable steps of AMP DM 89-A-71-11-02-00A-720A-A, close the LH engine cowling assy P/N 4F7110A21232 or P/N 4F7110A21231 on the helicopter.
