SERVICE BULLETIN

N° 189-294

DATE: May 31, 2022 REV.: /

ATA 56 - GLASS WINDSHIELD RETROMOD

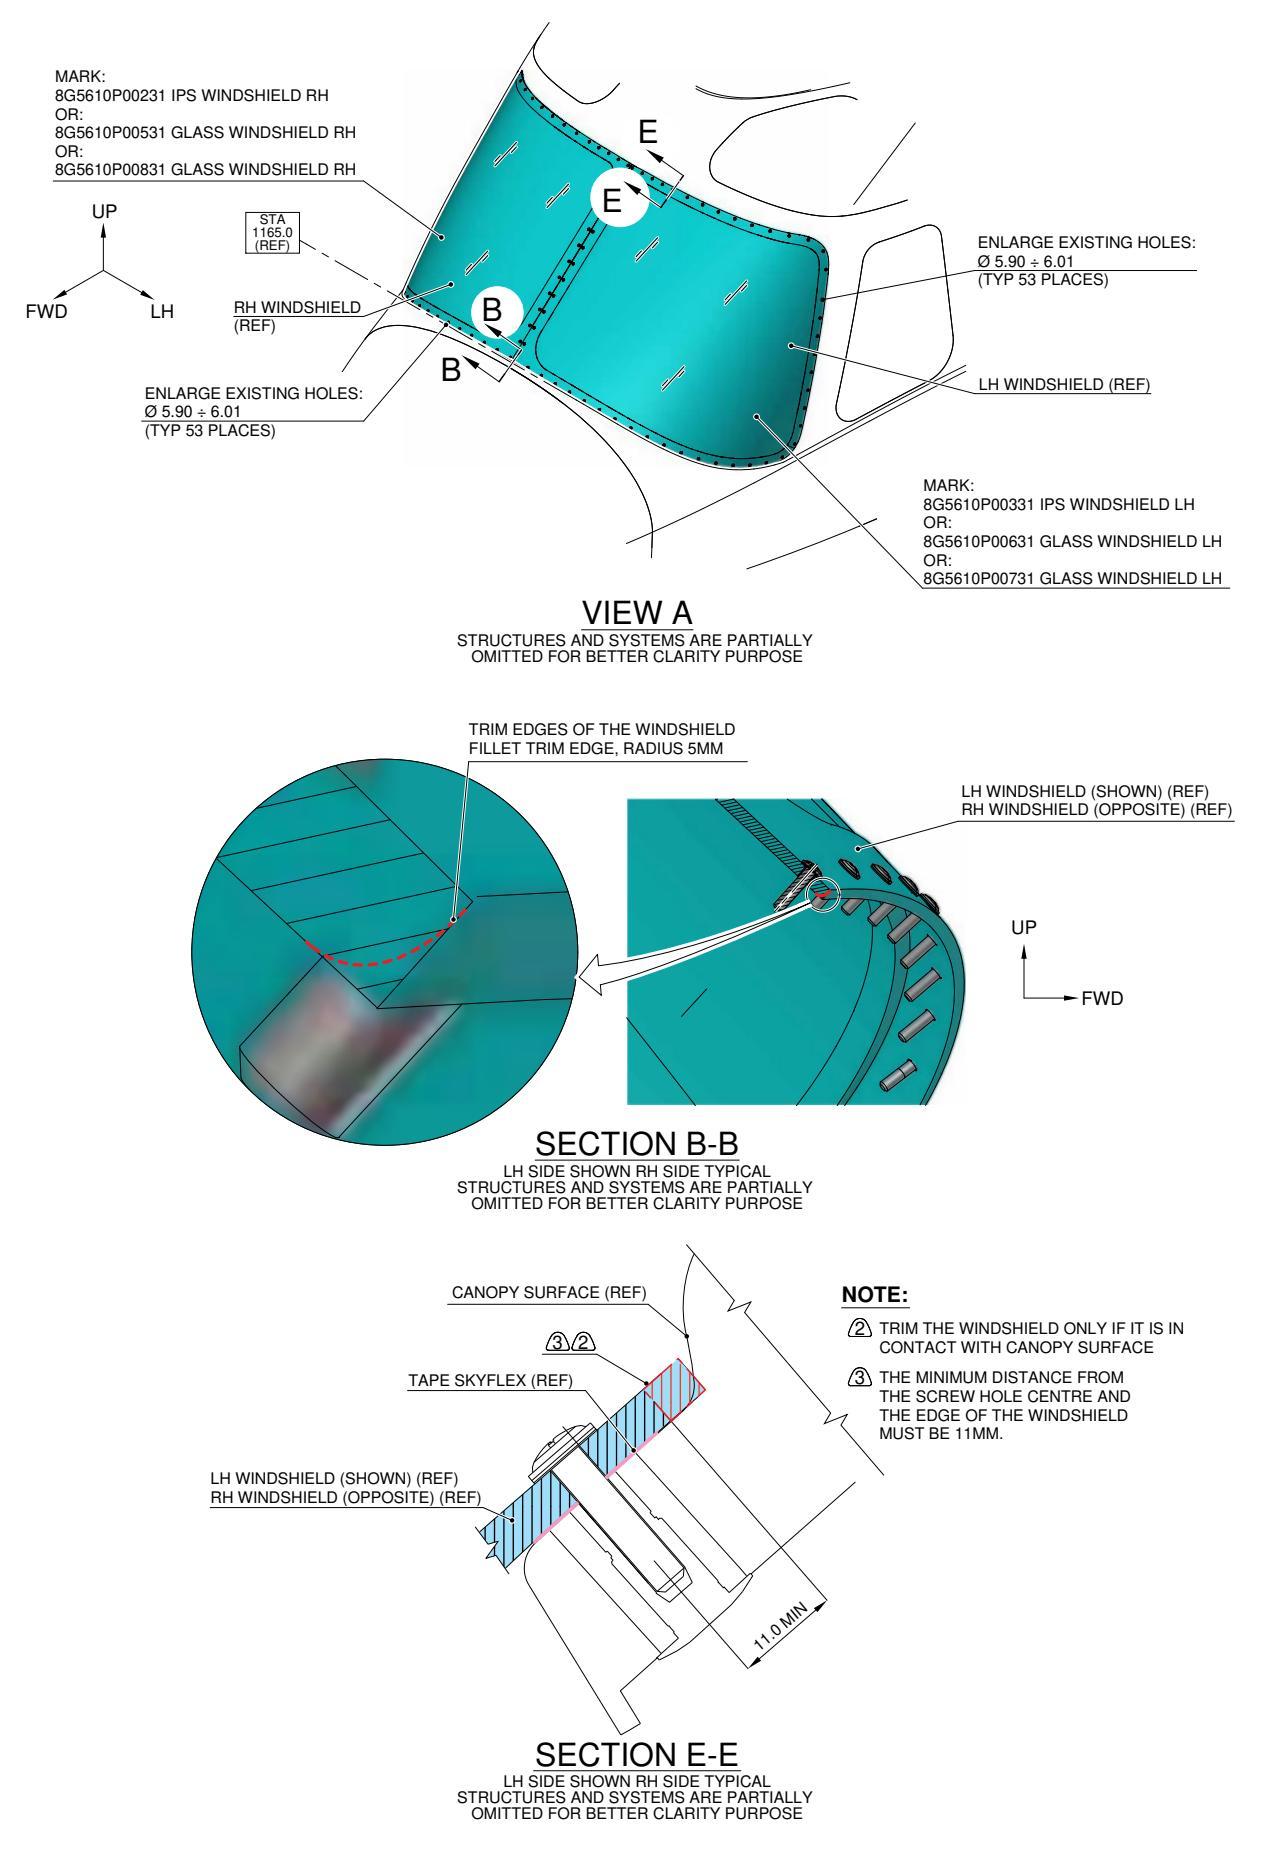
Leonardo Helicopters received various reports of cracks and damages to the glass windshields installed on AW189 helicopters. To increase the reliability of this installation, LHD issued this SB in order to introduce a set of improvements in the windshields and in the installation procedures.

- 4.1 With reference to Figure 2 View A, enlarge n°53 screw holes in the windshield toØ 5.90 6.01. Use the special reamer P/N A05900AAR.
 - 4.2 With reference to Figure 2 Section E-E, verify if the LH windshield is in contact with canopy surface.

4.3 With reference to Figure 2 Section E-E, trim the LH windshield in the position where the windshield is in contact with the canopy structure in order to remove the interference. Use abrasive paper (medium grit).

- 4.4 With reference to Figure 2 Section B-B, to ensure proper windshield seating against canopy structure fillet trim edge radius of 5mm by means of abrasive paper (medium grit).

- 8.1 With reference to Figure 2 View A, enlarge n°53 screw holes in the windshield toØ 5.90 6.01. Use the special reamer P/N A05900AAR.
 - 8.2 With reference to Figure 2 Section E-E, verify if the RH windshield is in contact with canopy surface.

8.3 With reference to Figure 2 Section E-E, trim the RH windshield in the position where the windshield is in contact with the canopy structure in order to remove the interference. Use abrasive paper (medium grit).

- 8.4 With reference to Figure 2 Section B-B, to ensure proper windshield seating against canopy structure fillet trim edge radius of 5mm by means of abrasive paper (medium grit).
- 8.5 With reference to Figure 2 View A, mark on the reworked windshield the following retromod P/N adjacent to the already present P/N. Use an indelible pen.
 - P/N 8G5610P00231 on RH windshield P/N 4G5610V00231;
 - P/N 8G5610P00531 on RH windshield P/N 3G5610V00451;
 - P/N 8G5610P00831 on RH windshield P/N 3G5610V00251.
