No. EC155-24-024

SERVICE BULLETIN

ELECTRICAL POWER - Radome Check for interference between harnesses

Revision No.	Date of issue
Revision 0	2021-04-29

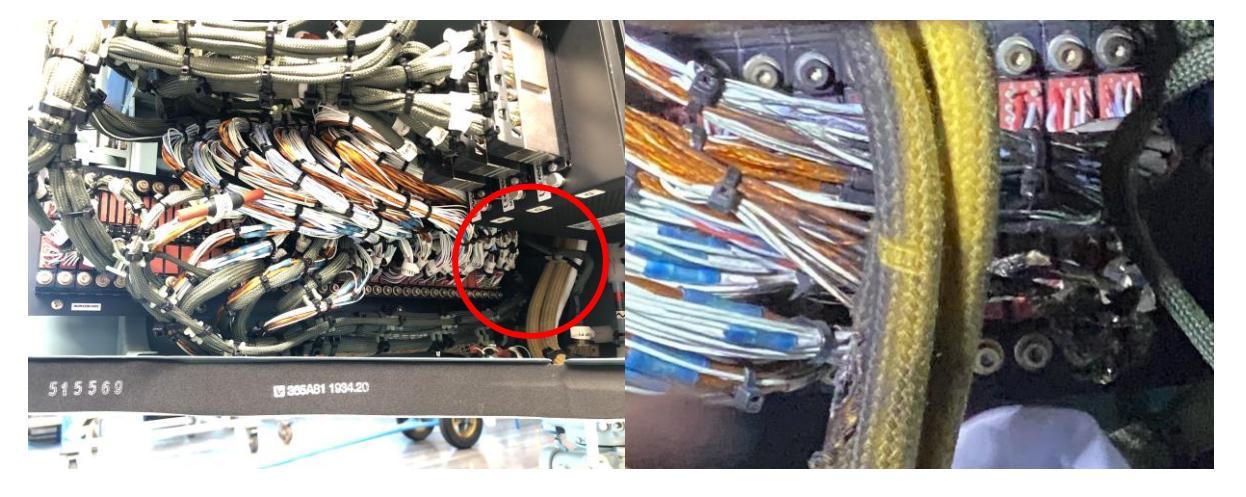
After investigation it was identified cable "1PP33E" damaged due to interference with harness "11D38-BP1". The FADEC was damaged as well.

The rest of the concerned customer fleet was inspected searching similar damage identifying two additional helicopters with marks in the same zone (see example in Picture 1 below).

Picture 1 - General overview "11DEL" Patchboard and "1PP33E" cable

Consequently, Airbus Helicopters recommends checking the cable routing and making sure that there is no damage on the harnesses located in the Radome.

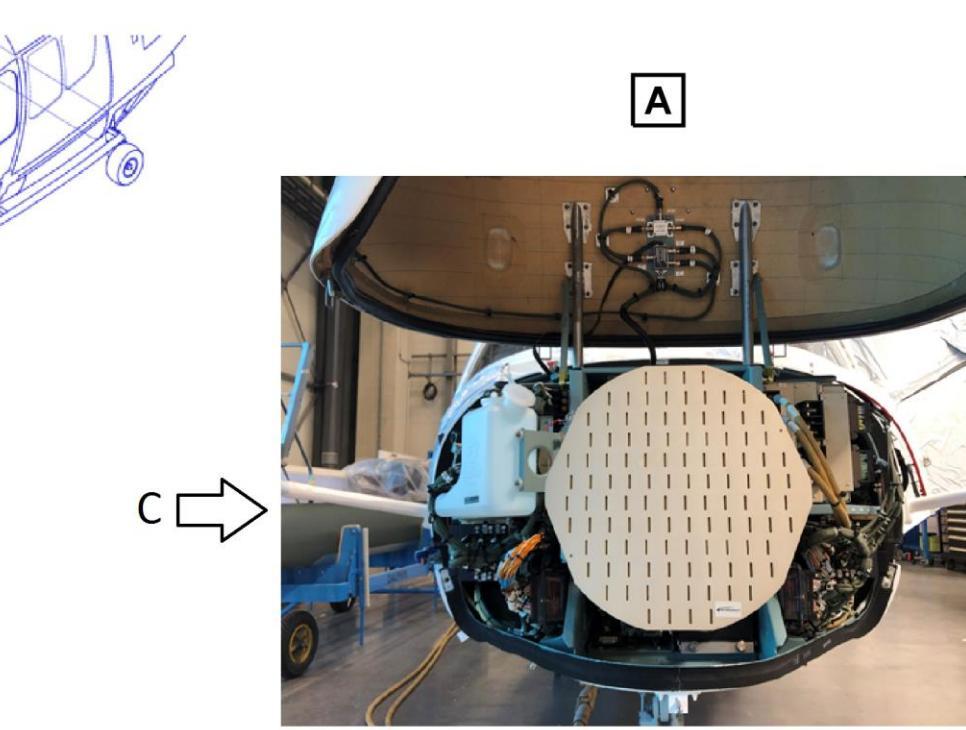
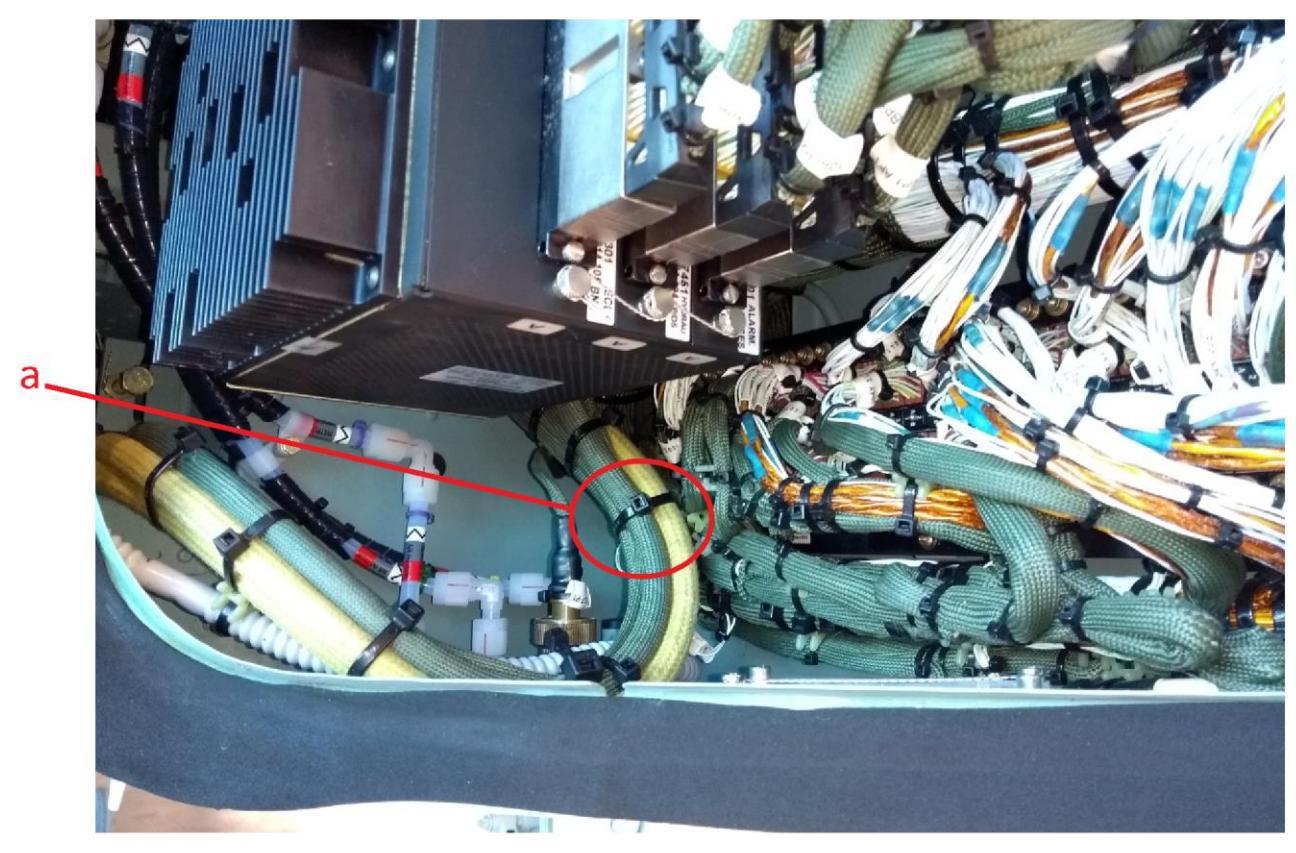
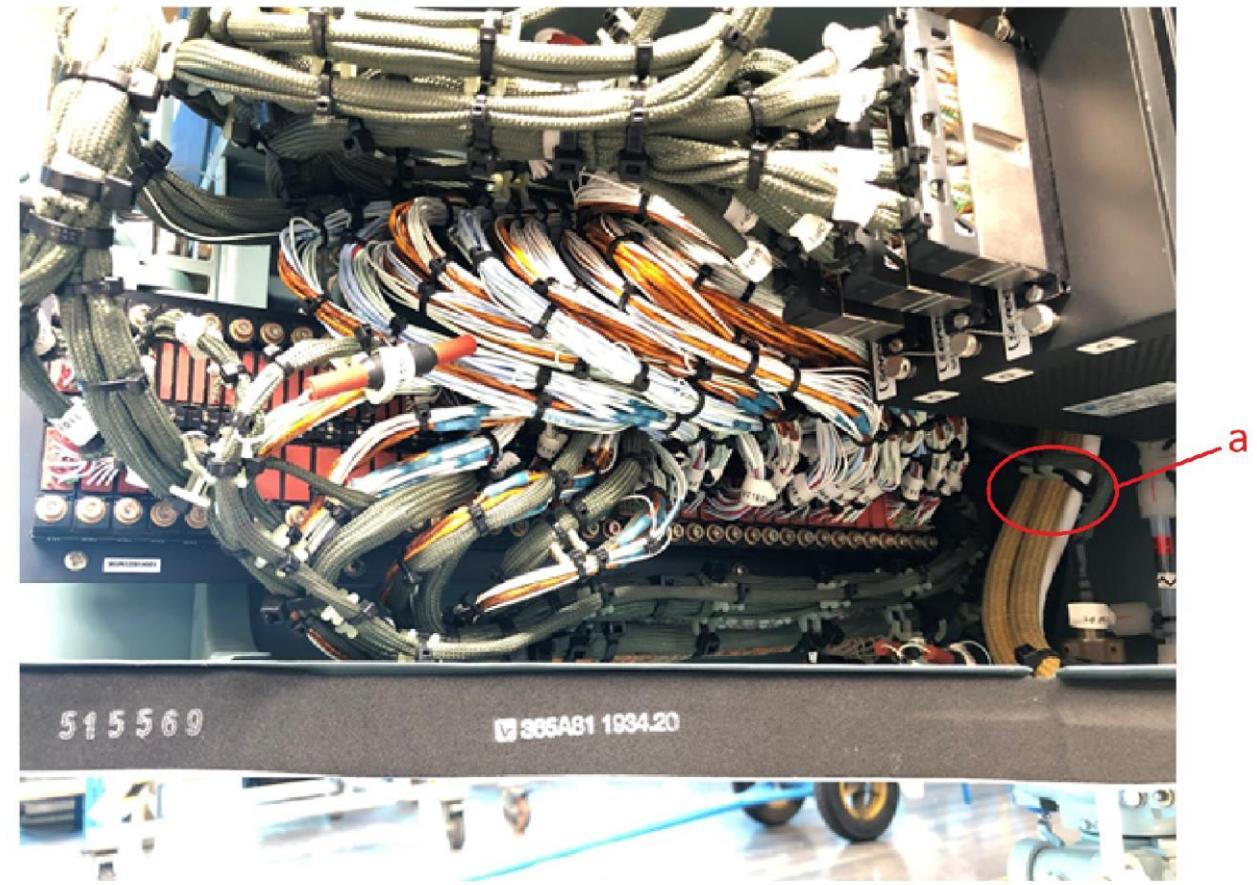
3.B.2.a. Checking for harnesses (Figure 1)

- Identify the cables with large cross-sections (a).
- Perform a visual check of the condition and routing of the cables with large cross-sections (a).
- Make sure that there is no interference between the cables with large cross-sections (a) and the surrounding components.

- 3.B.2.c. Repair and improvement of the harnesses
 - If a cable is deteriorated:
 - . if only the sheath is deteriorated, repair the cable, refer to the Work Cards 20-80-20-103 (MTC) and 20-80-20-443 (MTC),

- . if the sheath and the cable are deteriorated, before resuming flights, contact the Airbus Helicopters Support Department to get an approved repair solution by creating a Technical Event (TE) on WebTEK: <u>https://airbusworld.helicopters.airbus.com</u>

- Improve the cable routing: refer to Work Card 20-80-20-441 (MTC).
 - If at least one cable is repaired and/or unpluged/pluged:
 - . comply with paragraph 3.B.3.
