ALERT SERVICE BULLETIN

No. 05A011

SUBJECT: TIME LIMITS - MAINTENANCE CHECKS

Tail Rotor Blade Check

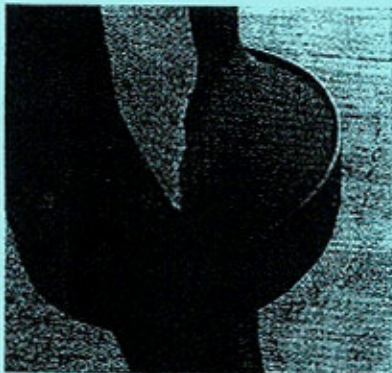
EUROCOPTER has received a report of separation and loss of a (75 mm-diameter) stainless steel ring from a tail rotor blade sleeve, in flight. After becoming distorted, the stainless steel ring slipped along the tail rotor blade prior to embedding itself in the Fanestron duct. This resulted in heavy high-frequency vibrations. Landing was nevertheless carried out normally.

Visually check that the stainless steel ring of the tail rotor blade sleeve has not moved. Any slippage is indicated by a shift of the stainless steel ring with respect to the blade root, towards the blade tip. This shift is revealed by the fact that the stainless steel ring is located outside of the profile of the flat area of the blade root (see the example shown on the photos in Appendix 1). This shift can also be detected by running your finger over the ring-to-blade root junction.

Ring slippage

b) If the stainless steel ring has moved:

- Replace the tail rotor blade,
- Contact the Blades Technical Support Department in La Courneuve, for repair, by:
Tel.: 33 (0)1.49.34.43.98
Fax: 33 (0)1.49.34.41.70

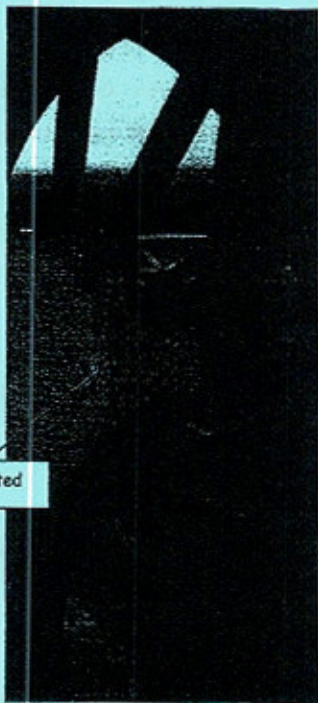
Area to be inspected
