Release Notification Date: 08/25/2023

SPM 70-33-08 REPLICATION TO IDENTIFY EVIDENCE OF FOREIGN MATERIAL AFTER BLENDING

tk70-33-08-220-000 Technical Change: Added new inspection method to evaluate the surfaces after blending.

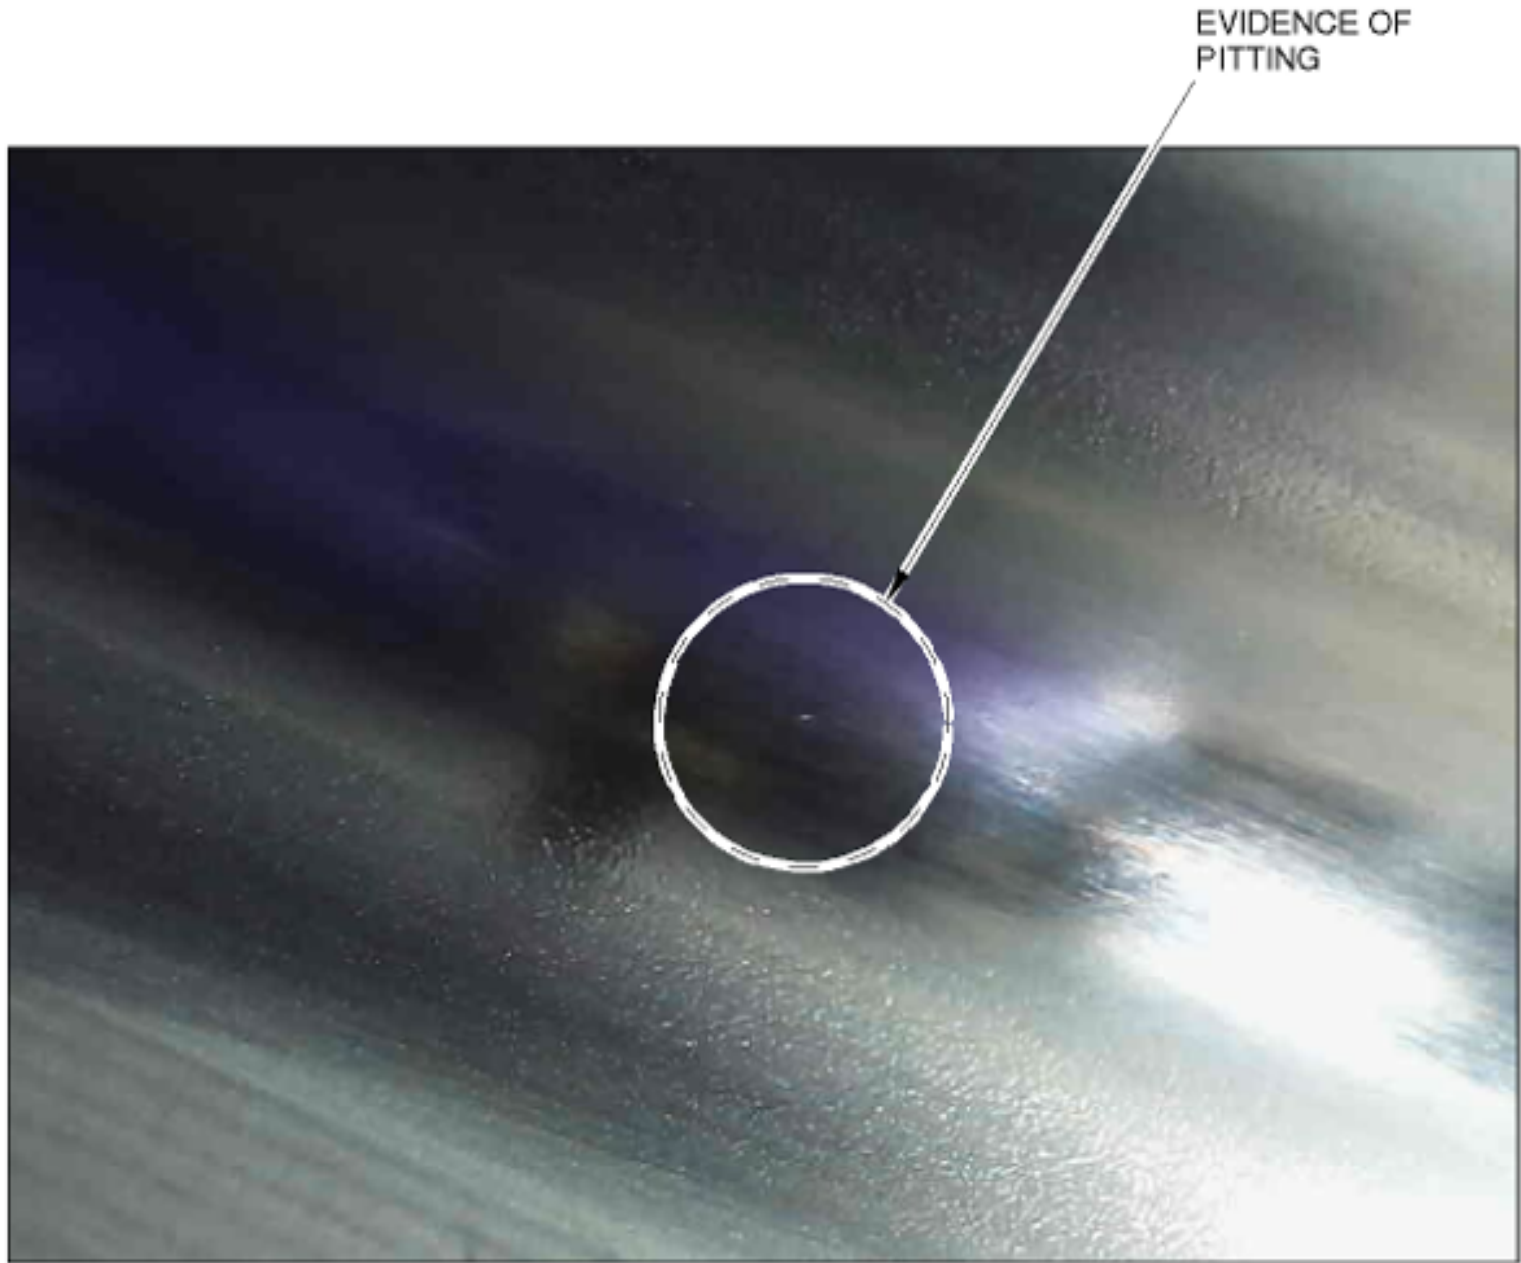
6042110-00

Figure 1 (Sheet 1) Blended Surface with Evidence of Pitting Remaining - Not Acceptable for Visual Evaluation

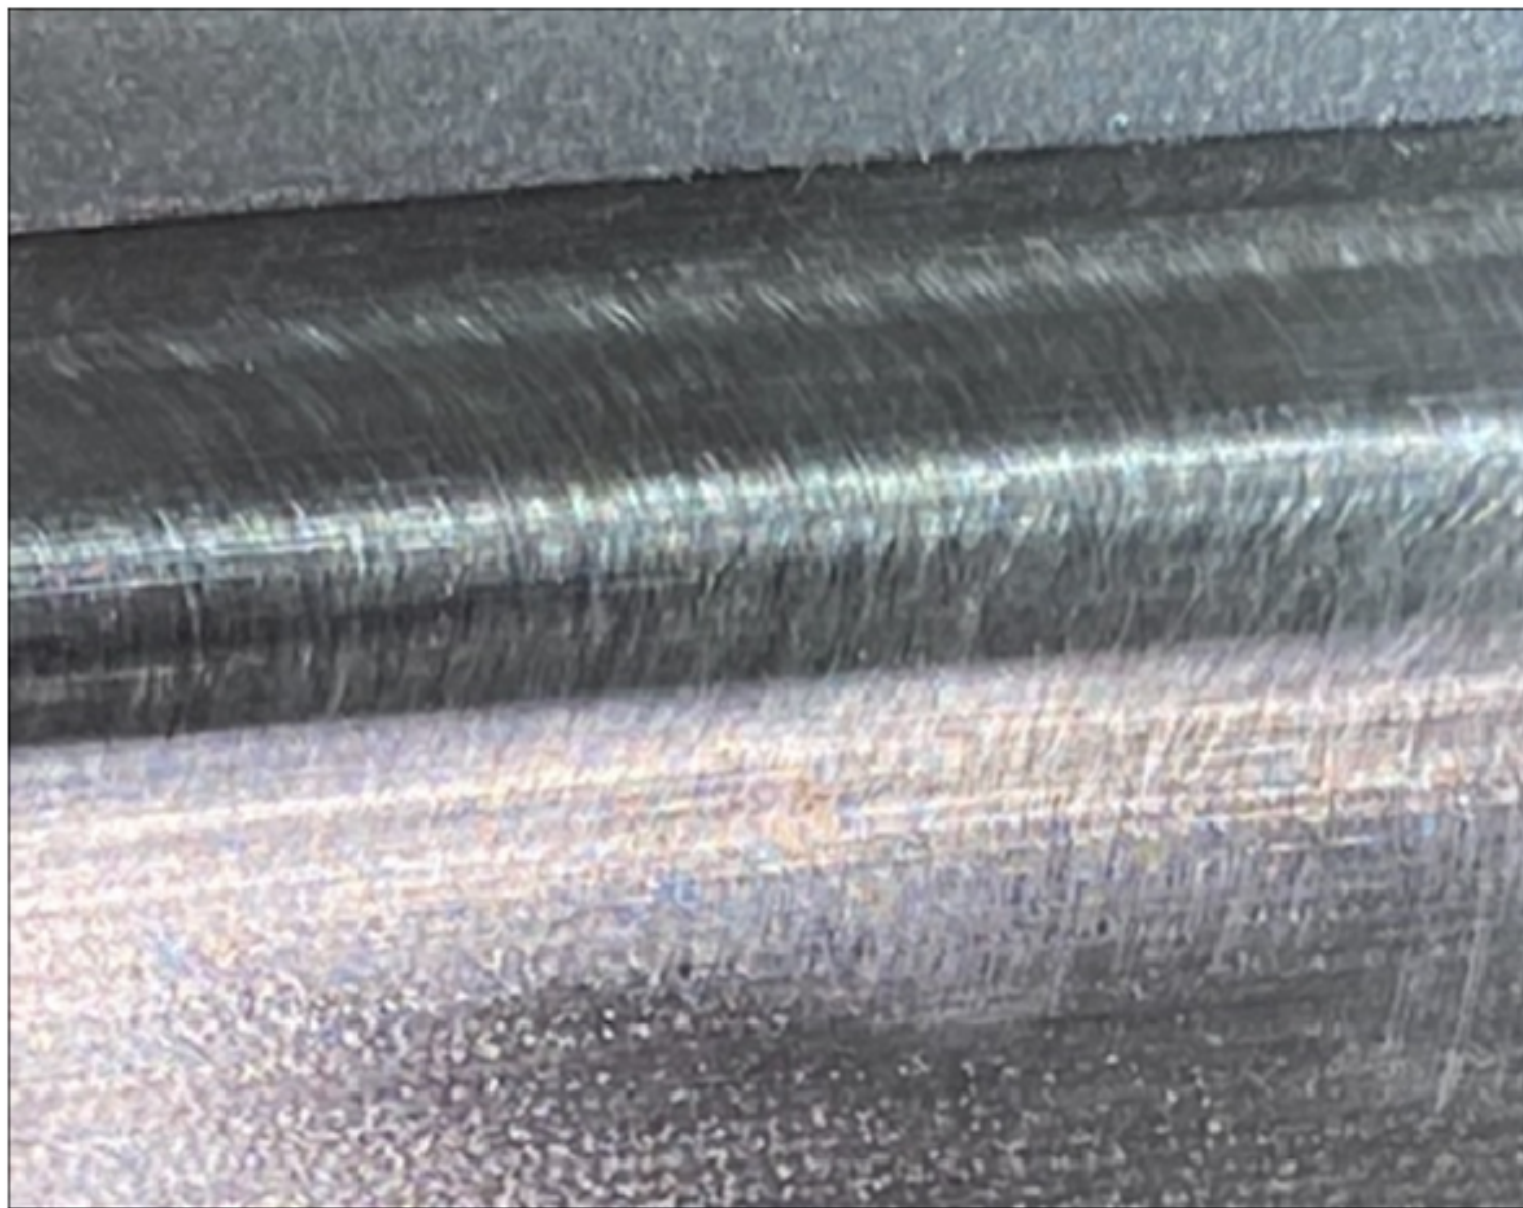
6042111-00

Figure 1 (Sheet 2) Evidence of Scratches in the Blend Zone - Not Acceptable for Visual Evaluation

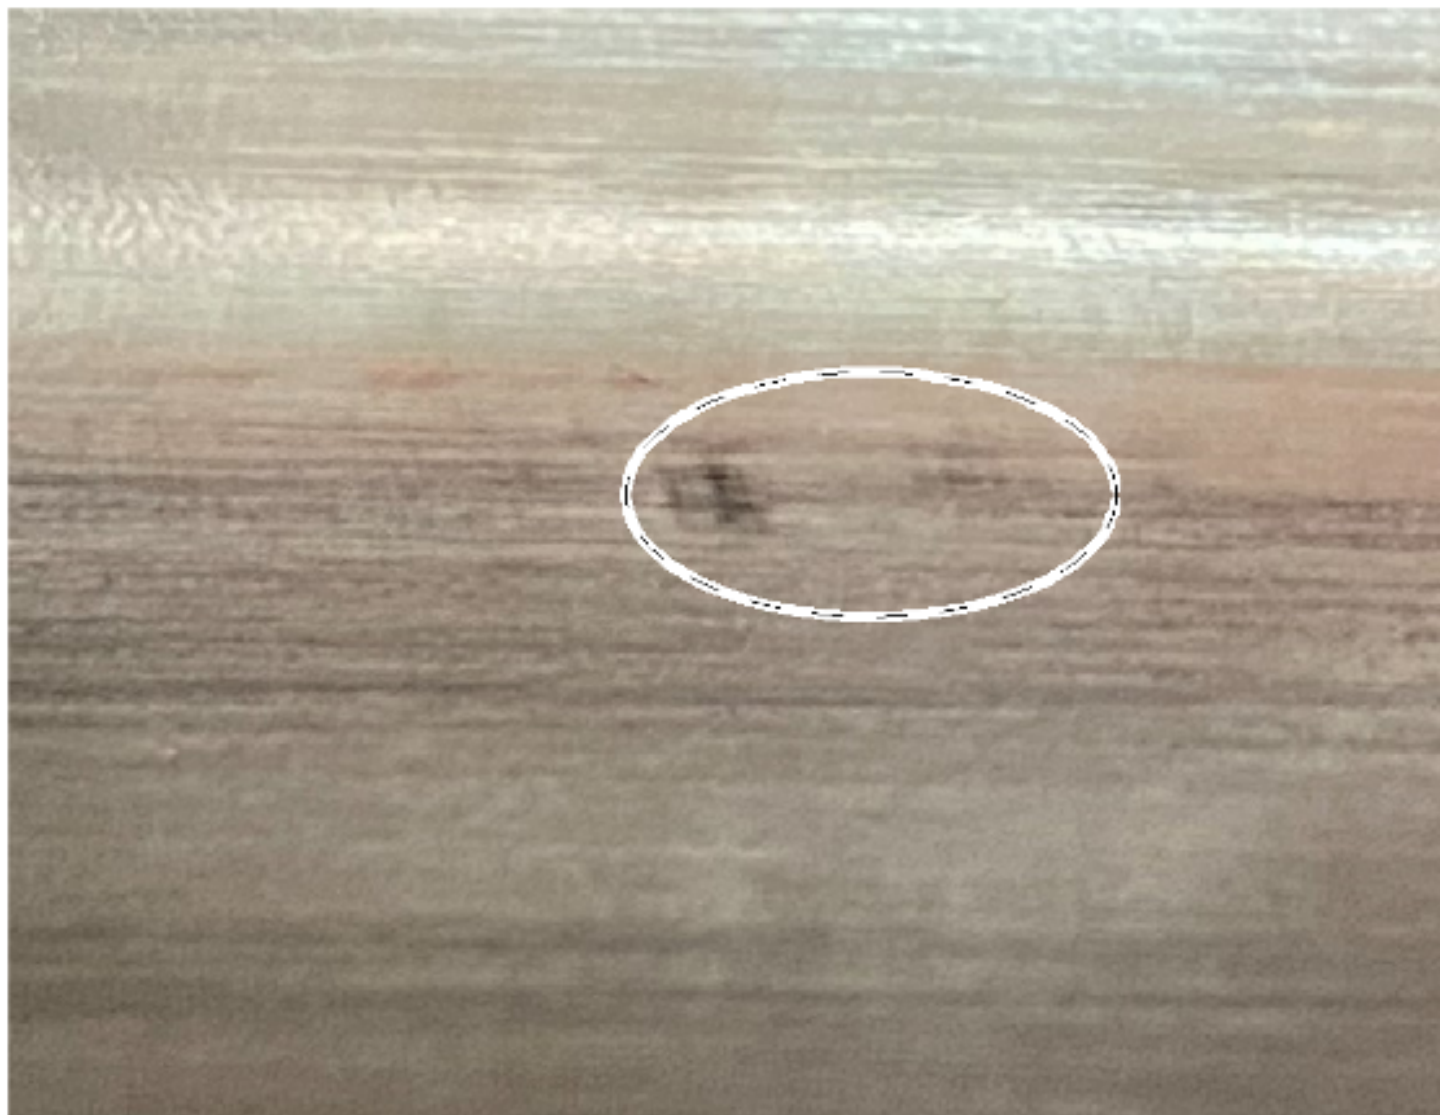
6042112-00

Figure 1 (Sheet 3) Evidence of Wheel Burning Caused During the Blending - Not
Acceptable for Visual Evaluation

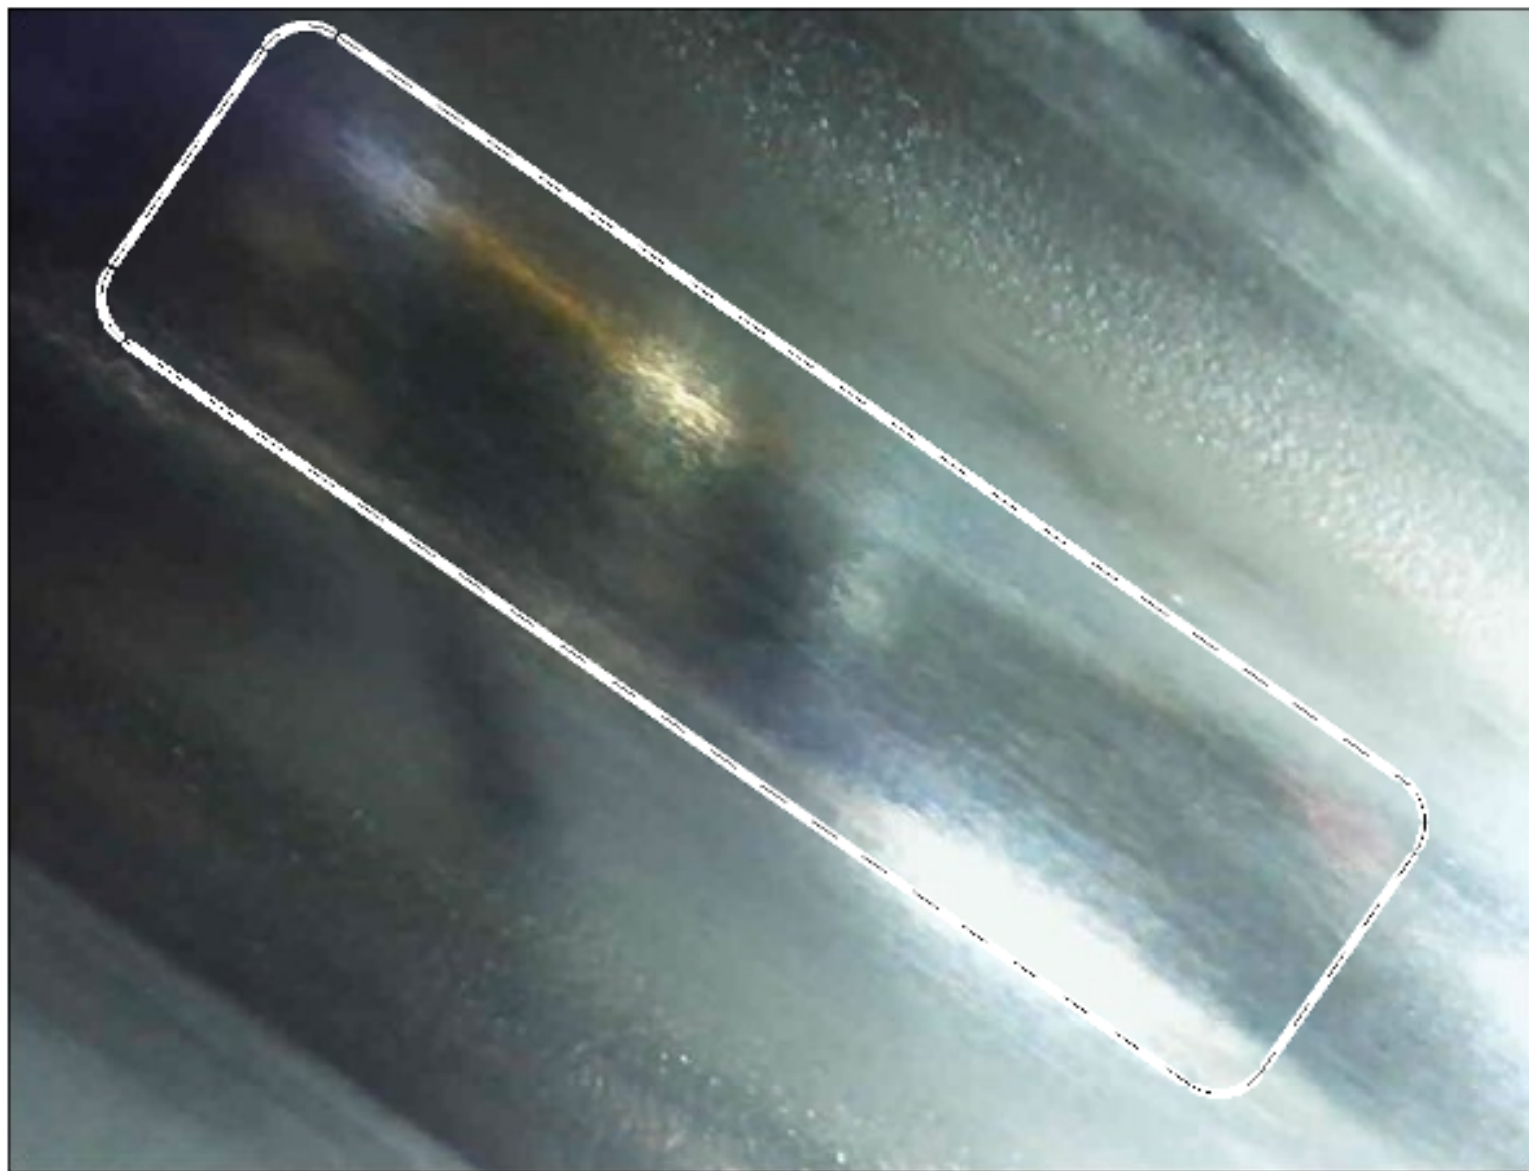
6042113-00

D. Visually inspect the blended areas using x10 magnification with white light for no evidence of remaining pitting, foreign material, discoloration, or any other surface anomalies. Refer to Figure 1 (Sheet 4).

- (1) No evidence of remaining pitting, foreign material, discoloration, or any other surface anomalies is permitted when visually inspected using x10 magnification with white light. Refer to Figure 1 (Sheet 4).
- (2) If there is no visual evidence of remaining pitting, foreign material, discoloration, or any other surface anomalies, then the blend zone is free of any foreign material.
- (3) If necessary, do rework by light polishing to improve inspection readability for better visual surface finish and texture, and re-inspect. Repeat Subtask 70-33-08-220-011, General - Method 1 - Magnified Visual Inspection (paragraph 5.B. thru paragraph 6.A.(2)).

Figure 1 (Sheet 4) Example of a Blended Surface Free of Any Pits, Scratches or Surface Anomalies - Acceptable for Visual Evaluation

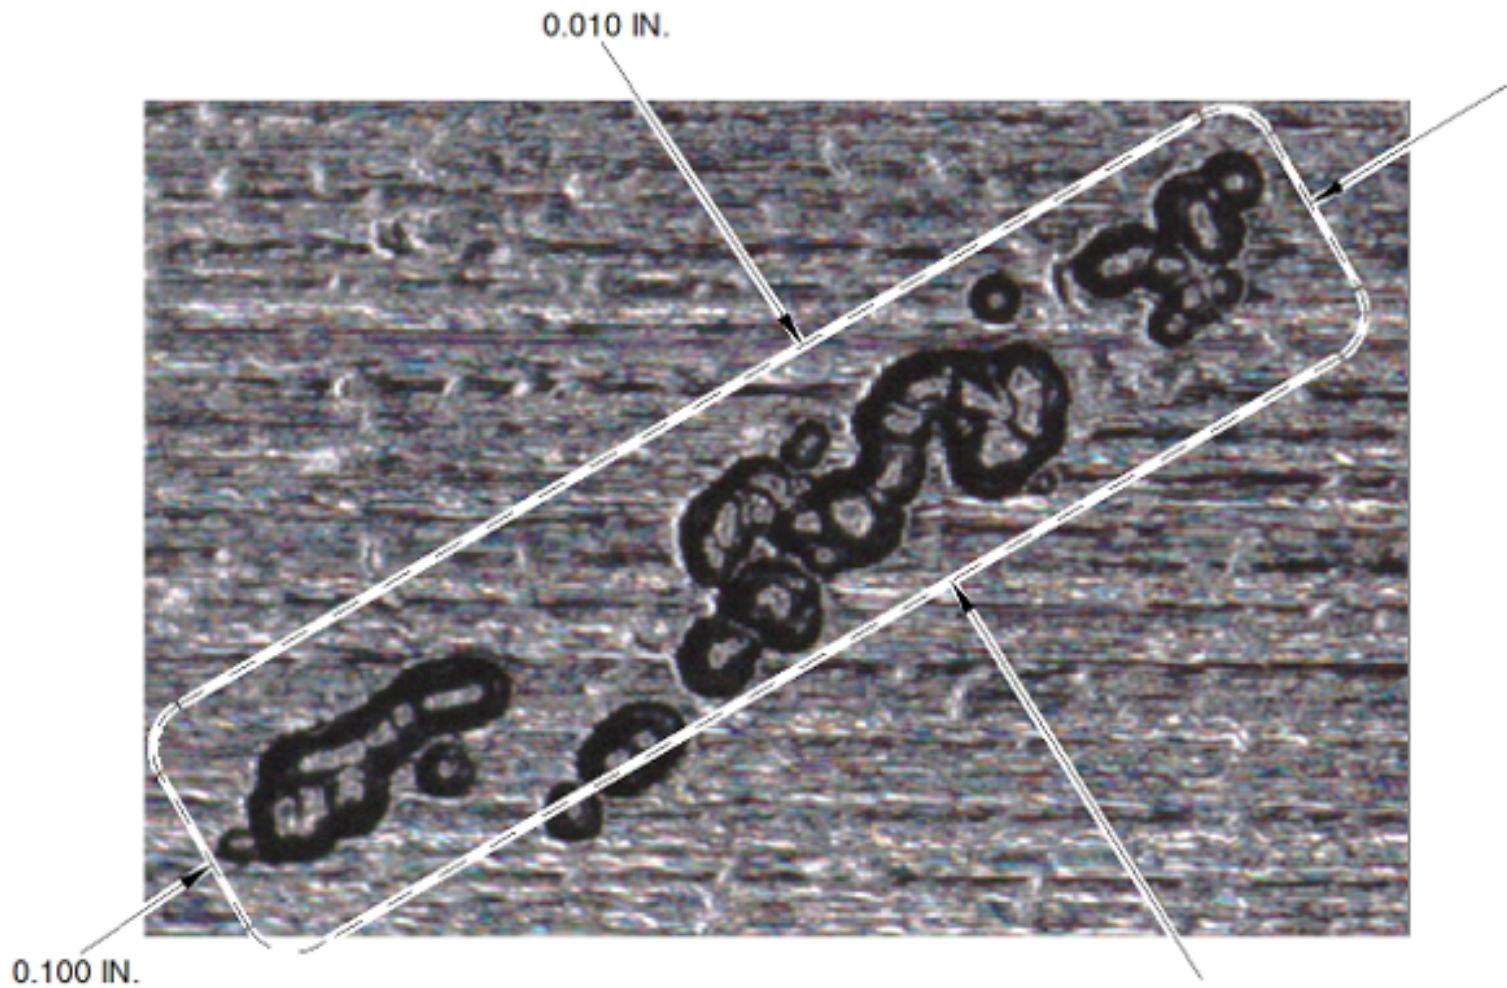
6042117-00

- A. Method 1 is only applicable to localized pitting and must be used for evaluation of foreign material only when the following criteria are satisfied:
 - (1) Pit depth prior to blend measures less than or equal to 0.002 inch (0.050 mm).
 - (2) Groups of pitting must be contained within an area less than or equal to 0.002 sq. in. (1.290 sq. mm). Refer to Figure 2.
 - (3) Spacing between groups of pits measures greater than 0.100 inch (2.54 mm).

Figure 2 Example of a "Group" Containing Coalesce and Isolated Pits Measuring 0.001 Sq. In.

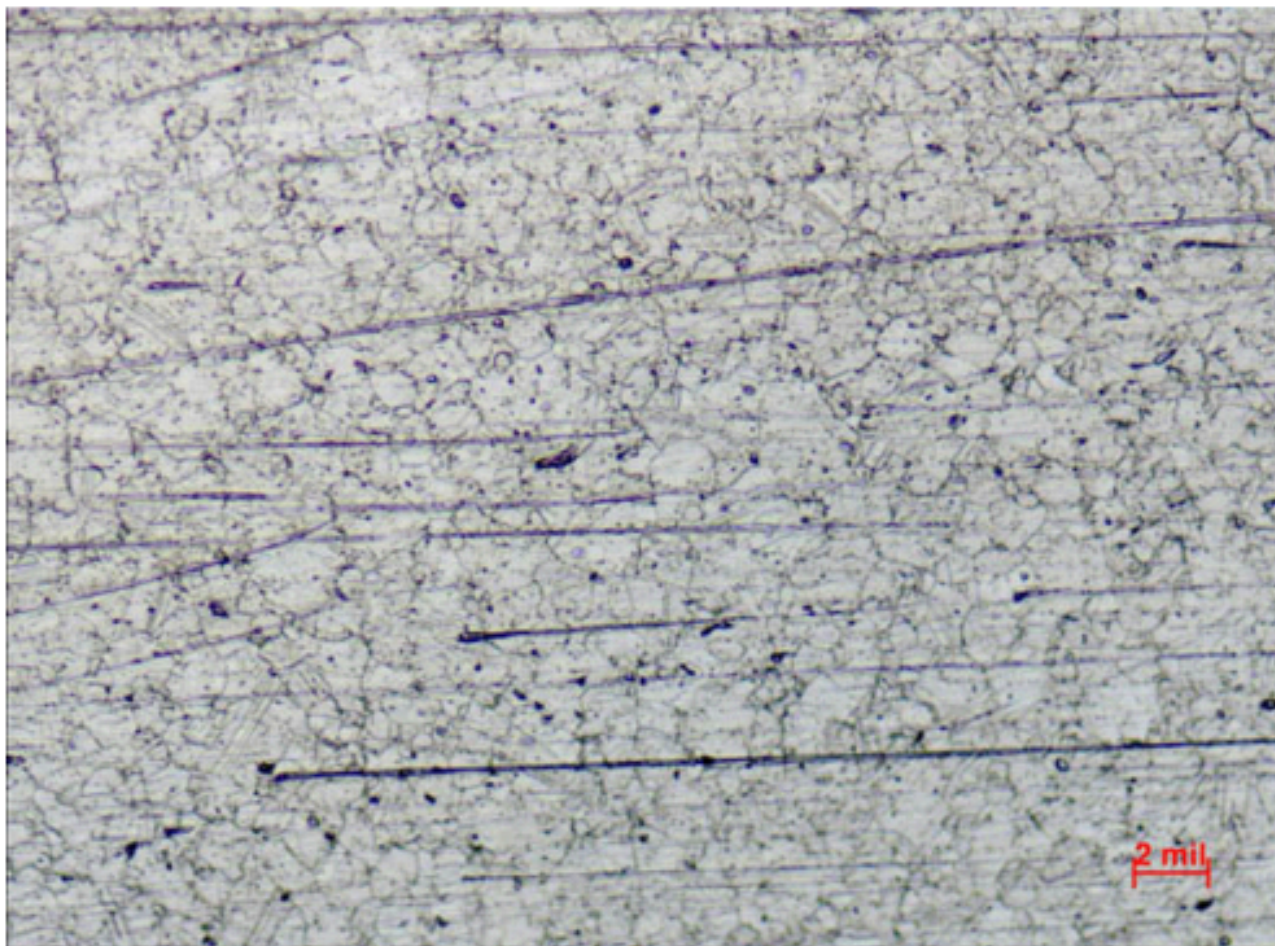
6002817-00

SCRATCHES

Figure 4 (Sheet 1) Grain Structure from Replication Rene'88DT with Scratches.

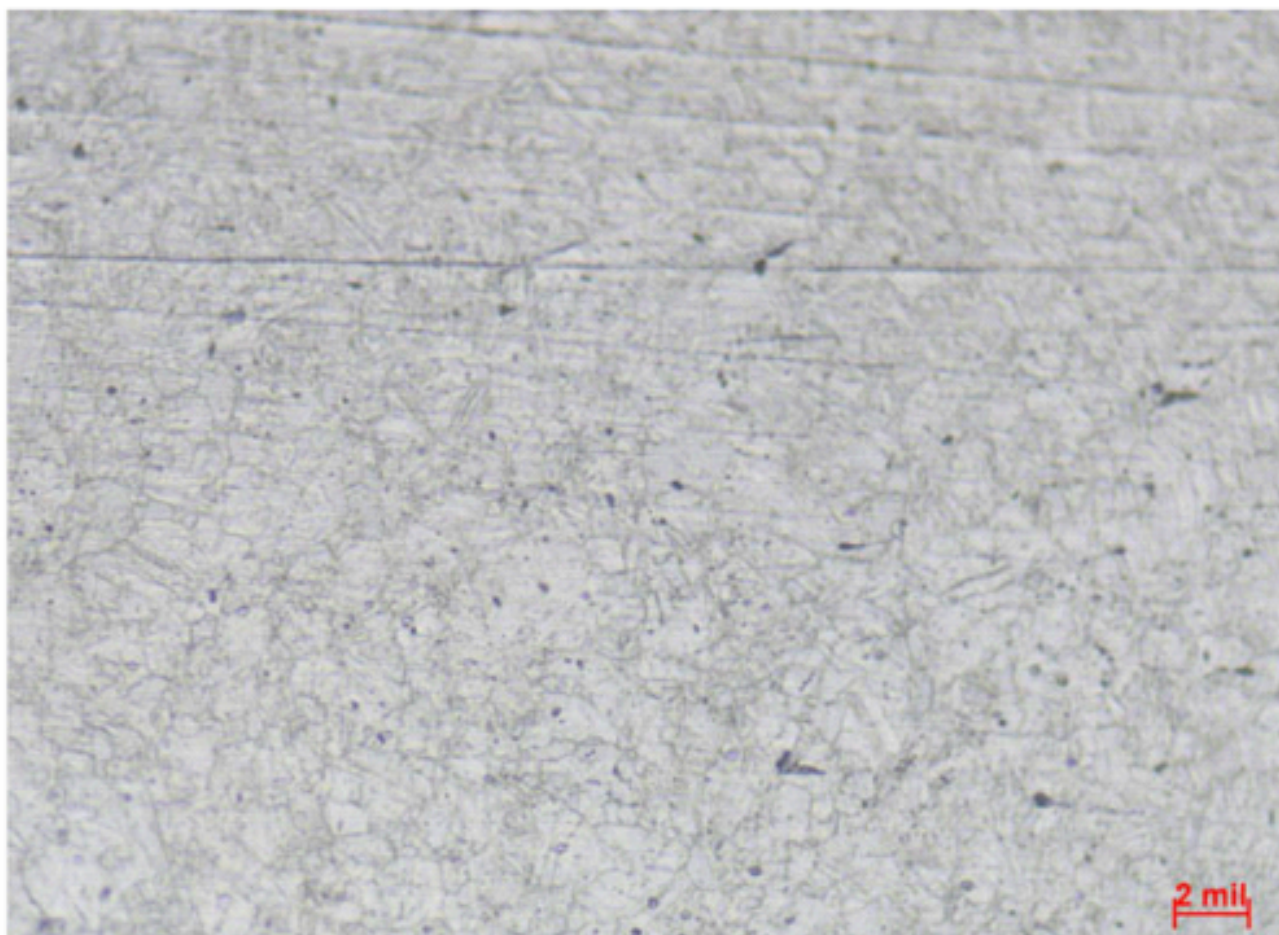
6002816-00

UNDER ETCHED

Figure 4 (Sheet 2) Grain Structure from Replication Rene'88DT Under Etched.

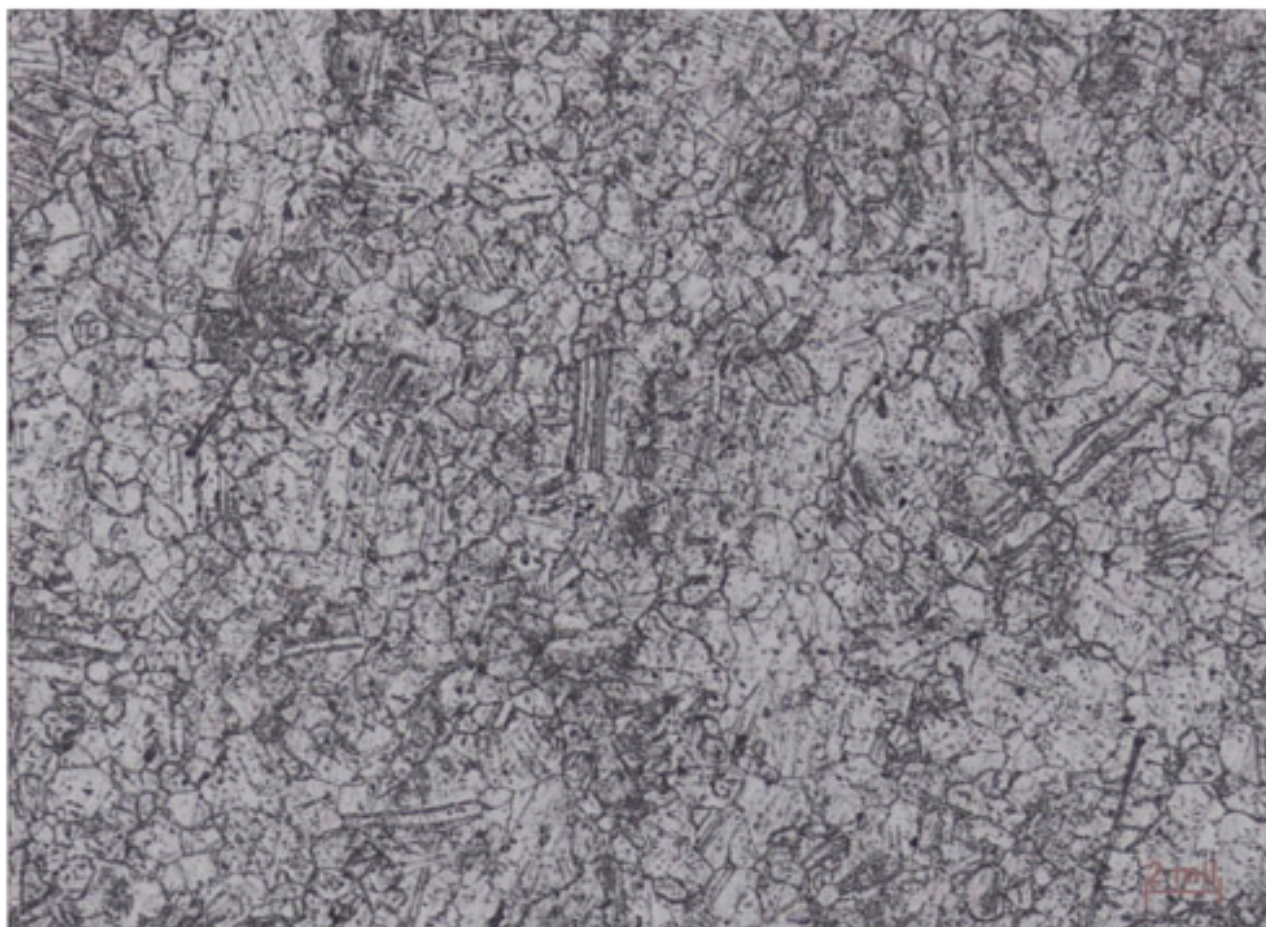
6002814-00

OVER ETCHED

Figure 4 (Sheet 3) Grain Structure from Replication Rene'88DT Over Etched.

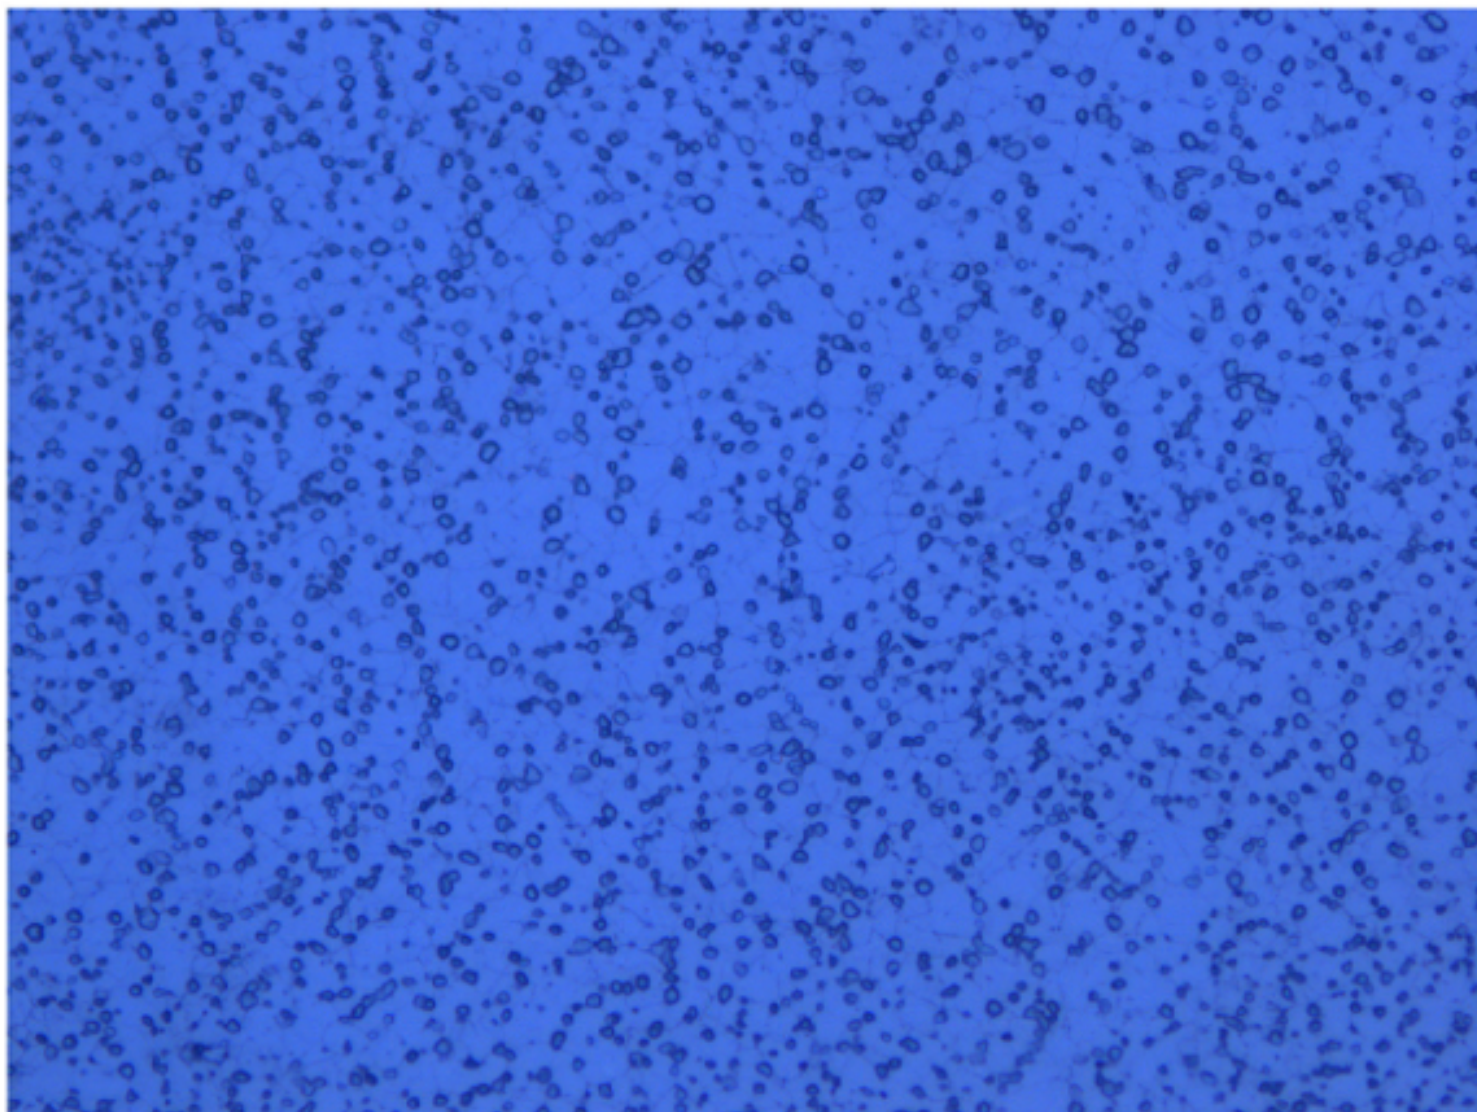
6038598-00

**UNDERETCHED
RENE 65**

Figure 4 (Sheet 4) Grain Structure from Replication Rene'65 Under Etched

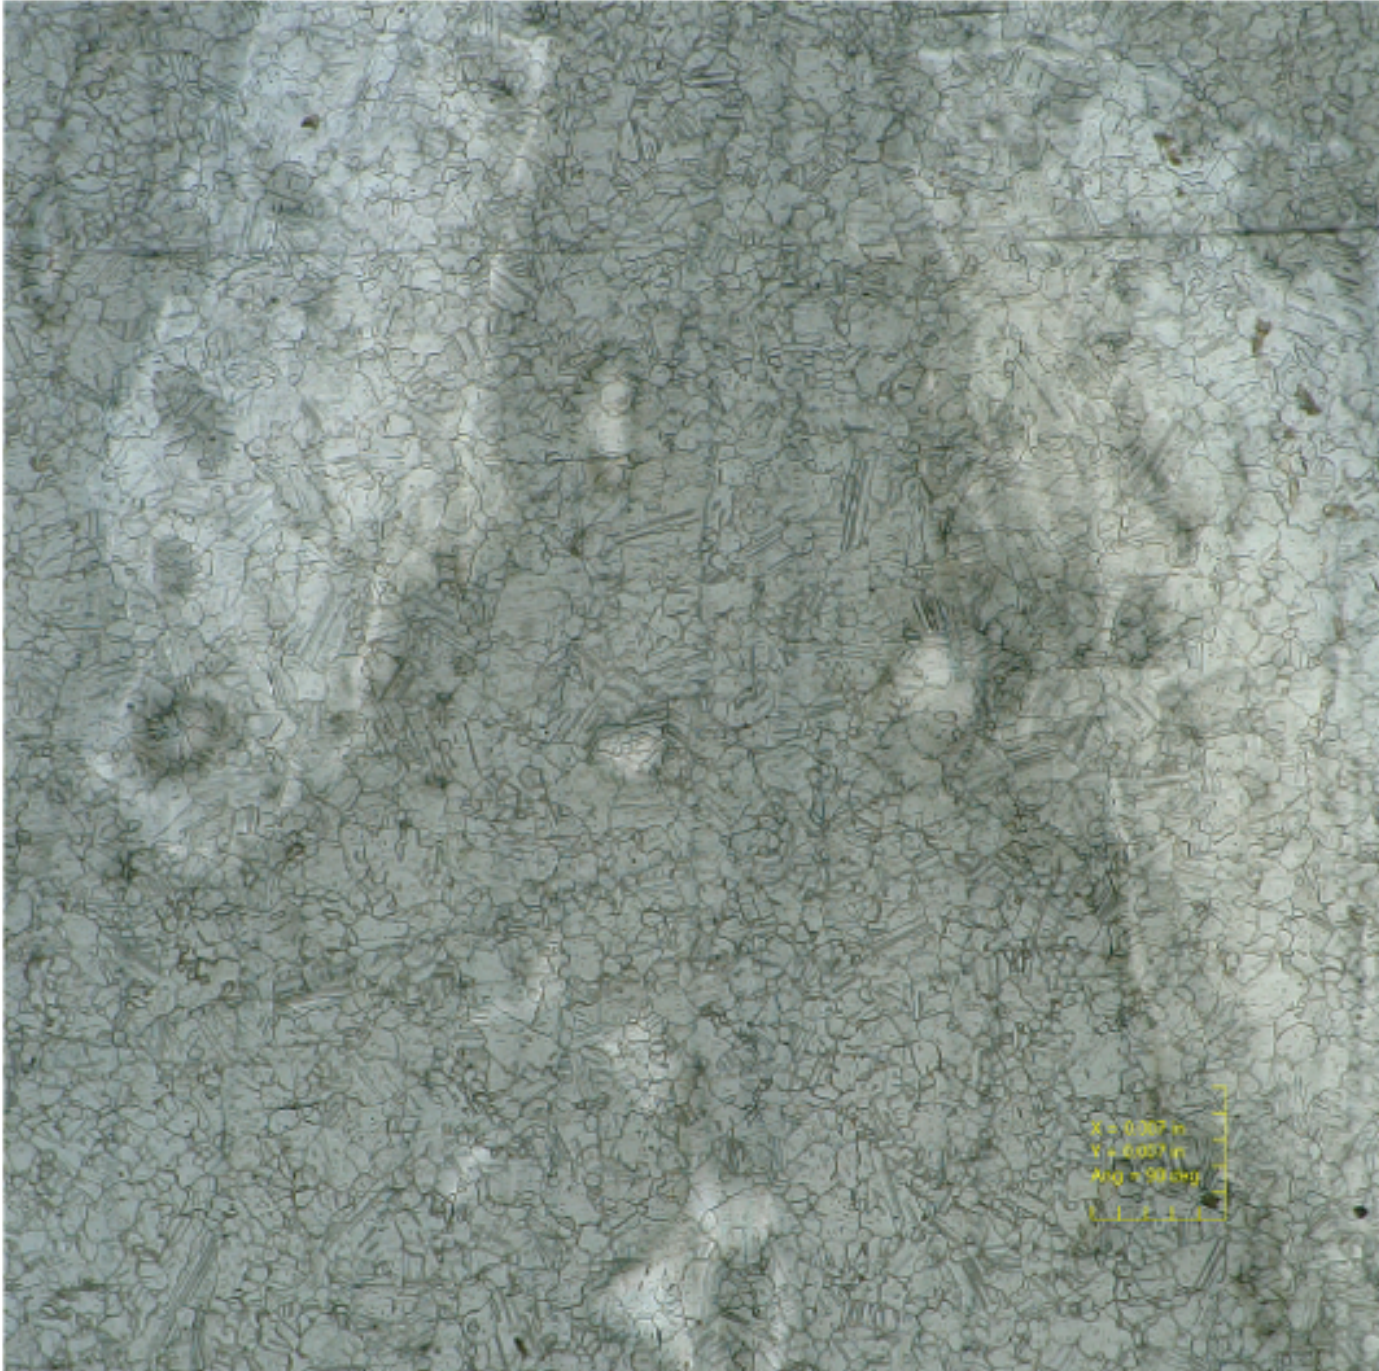
6038599-00

**BUBBLE REPLICA DEFECT
RENE 88DT
100X**

Figure 4 (Sheet 5) Replica with Region of Replica Tape that is Inadequately Adhered,
that Produces a Bubbled Area

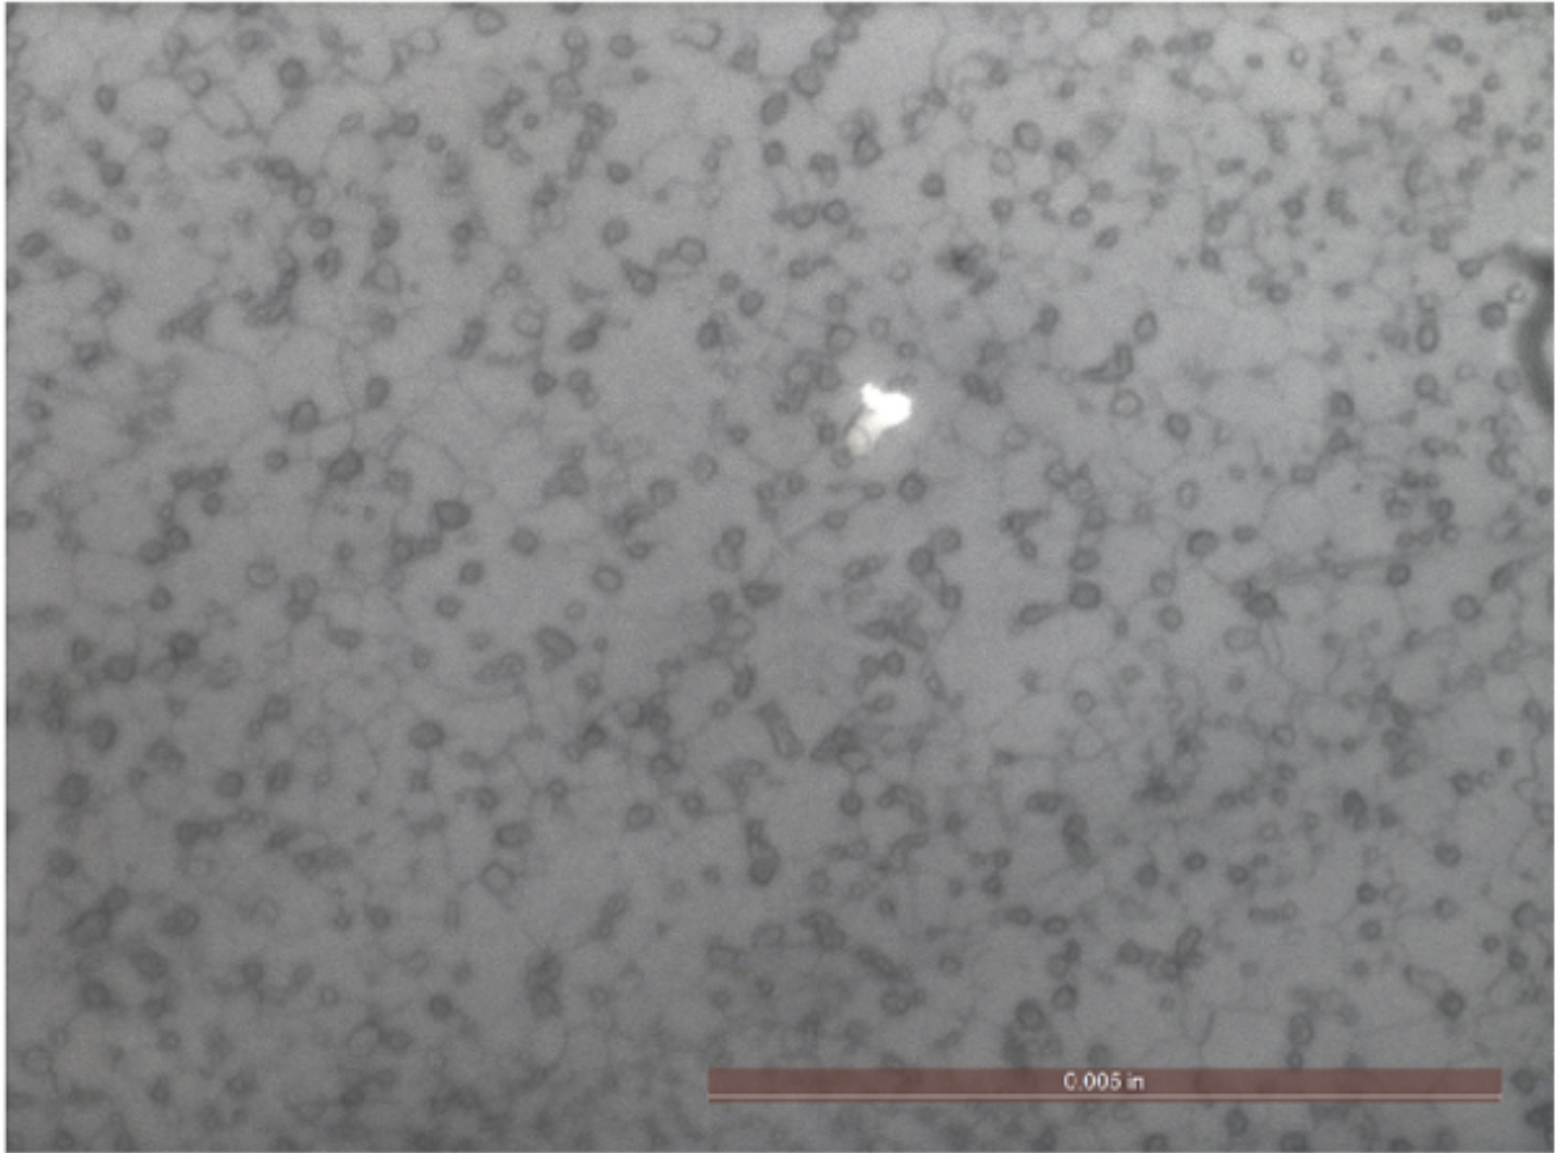
6038600-00

**BRIGHT SPOT REPLICA DEFECT FROM DEBRIS
RENE 65
500X**

Figure 4 (Sheet 6) Replica with Bright Spot due to Debris on the Surface Underneath
the Replica Tape

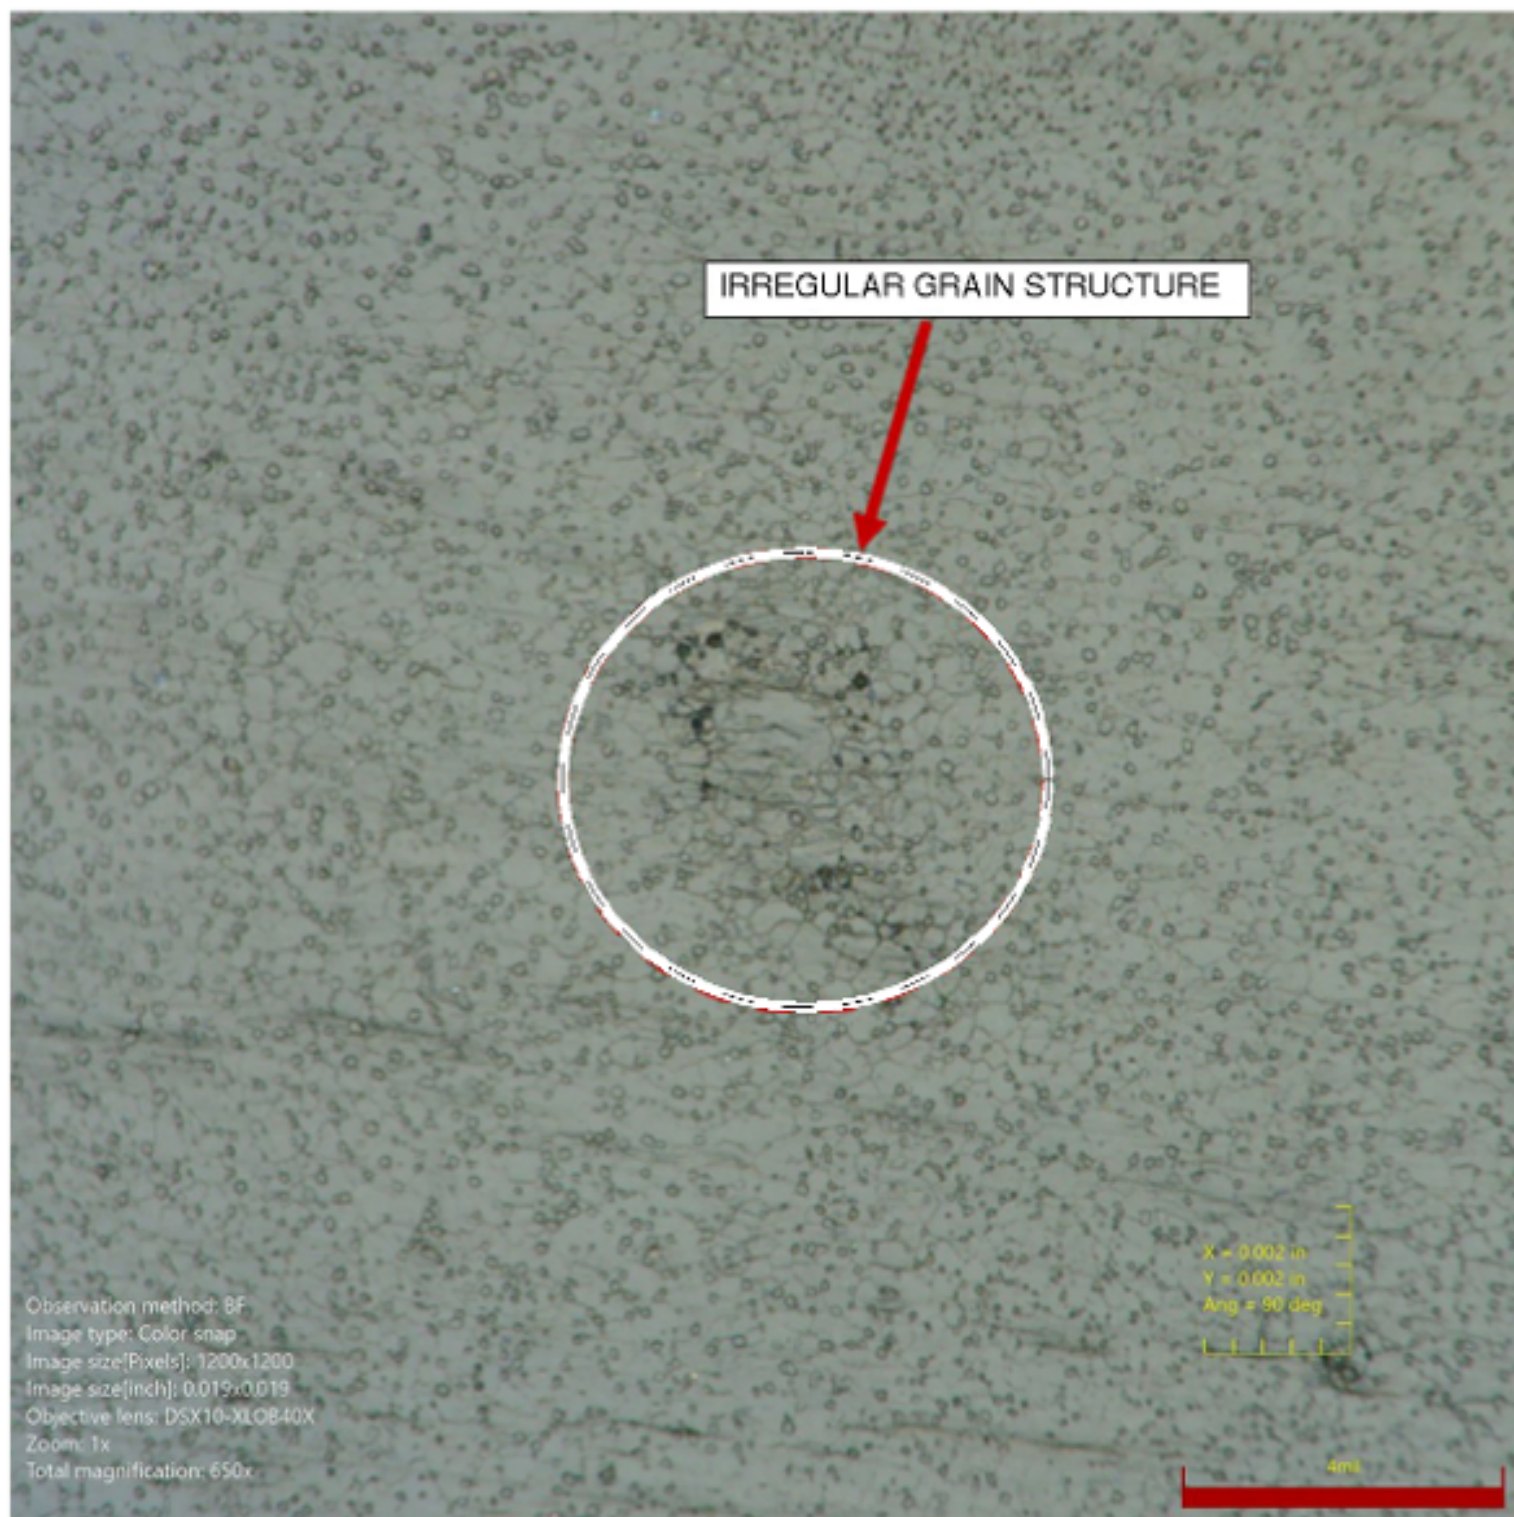
6042115-00

- (4) If there is no evidence of any foreign material present, the assessment is acceptable. Refer to Figure 5 for evidence of an irregular (unacceptable) grain structure and foreign material.

NOTE: No grain boundaries or large areas of no grain boundaries shows foreign material is present.

IRREGULAR GRAIN STRUCTURE, RENE 65, 650x

Figure 5 (Sheet 1) Unacceptable Grain Structure from Replication of Rene 65 - Evidence of an Irregular Grain Structure

NOTE: Any suspect evidence of foreign material must be sent to GE Engineering for further assessment. Please include the details that follow: part number and serial number, customer/operator, time since new, cycles since new, time since overhaul, and cycles since overhaul. This information can be submitted as a Service Request (SR) via myGEAviation.com. Alternatively, send photos of replica with a scale bar included for the magnification used, to Support at Aviation.Fleetsupport@ge.com.
