Release Notification Date: 08/25/2023

SPM 70-33-08 REPLICATION TO IDENTIFY EVIDENCE OF FOREIGN MATERIAL AFTER BLENDING

tk70-33-08-220-000 Technical Change: Added new inspection method to evaluate the surfaces after blending.

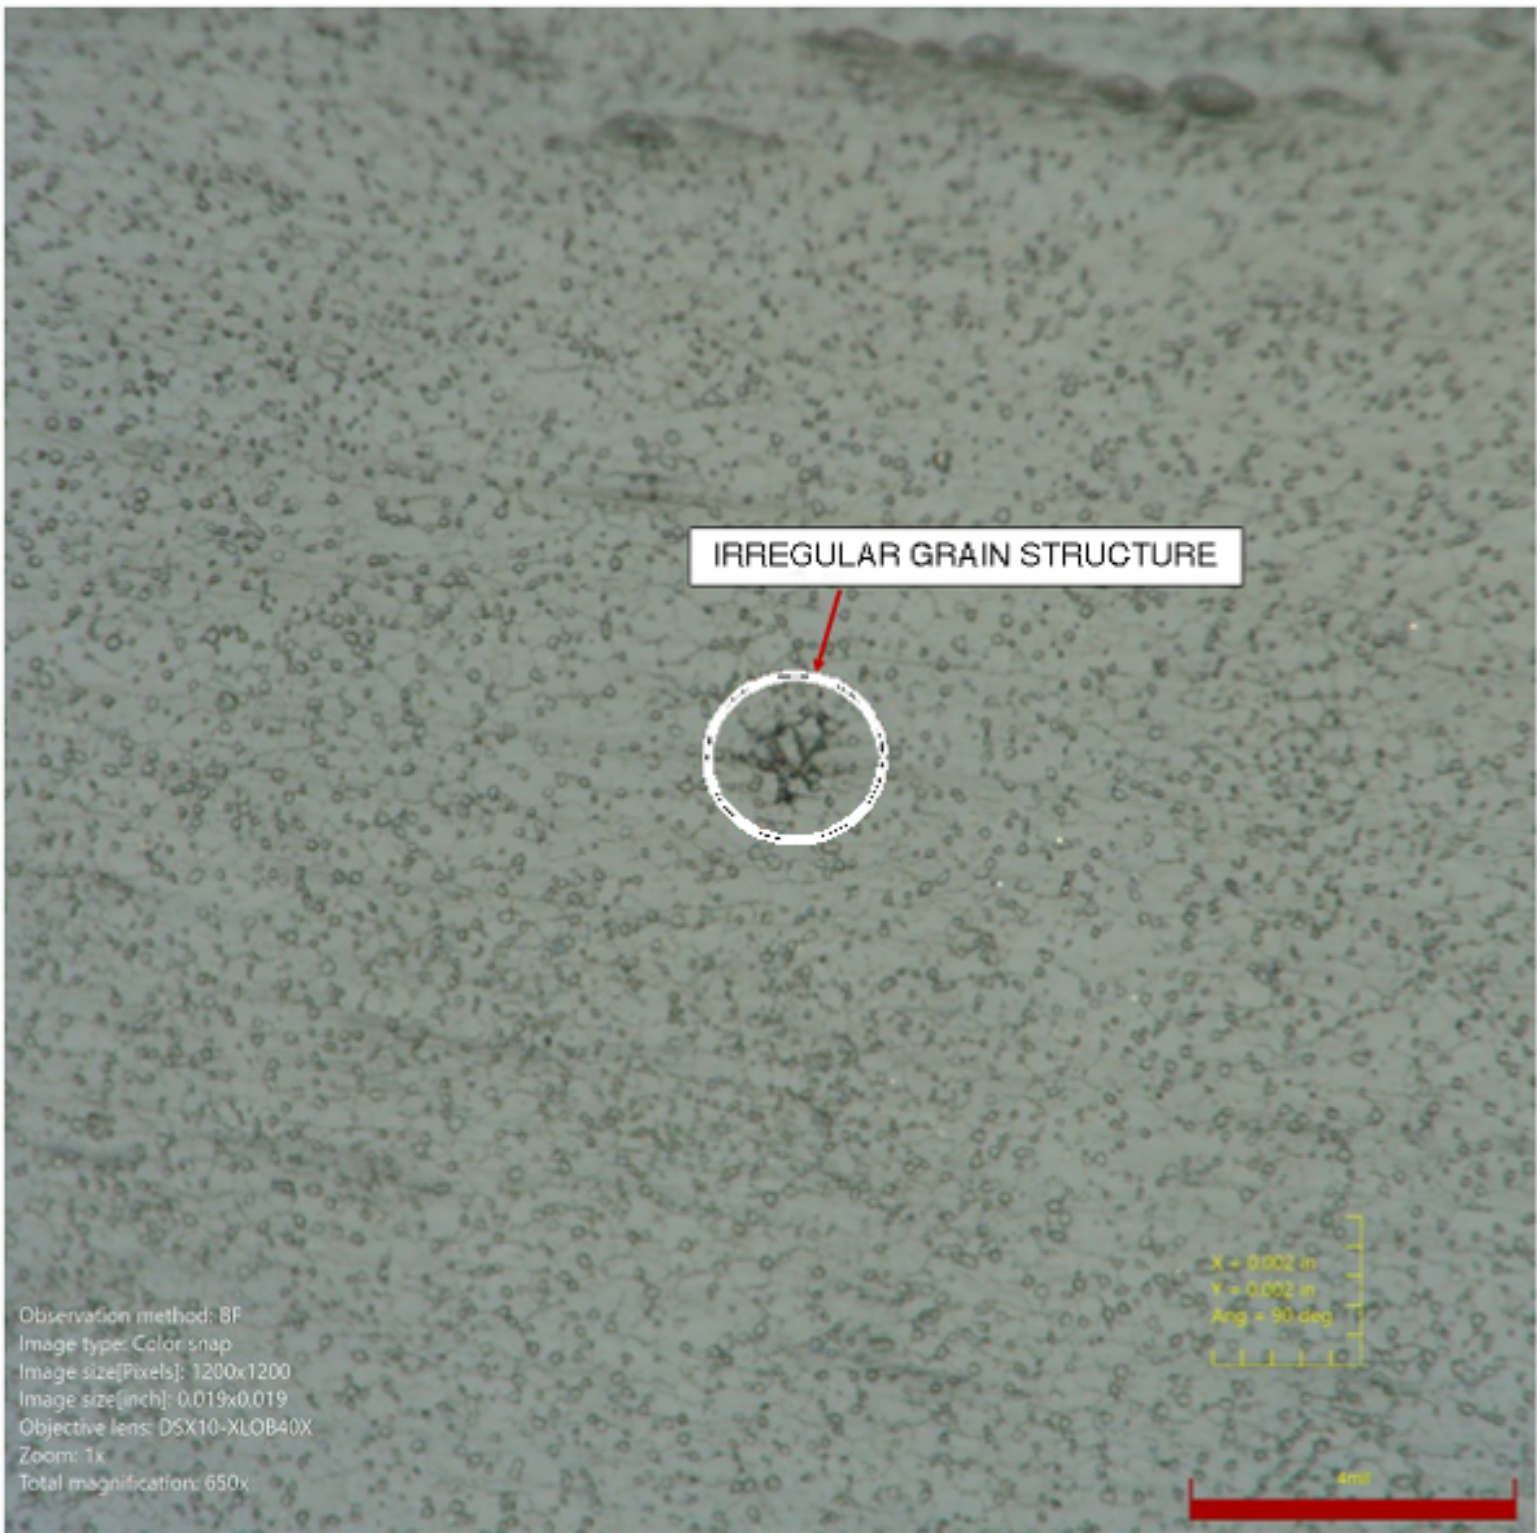
6042114-00

IRREGULAR GRAIN STRUCTURE, RENE 65, 650x

Figure 5 (Sheet 2) Unacceptable Grain Structure from Replication of Rene 65 - Evidence of an Irregular Grain Structure

NOTE: Any suspect evidence of foreign material must be sent to GE Engineering for further assessment. Please include the details that follow: part number and serial number, customer/operator, time since new, cycles since new, time since overhaul, and cycles since overhaul. This information can be submitted as a Service Request (SR) via myGEAviation.com. Alternatively, send photos of replica with a scale bar included for the magnification used, to Support at Aviation.Fleetsupport@ge.com.

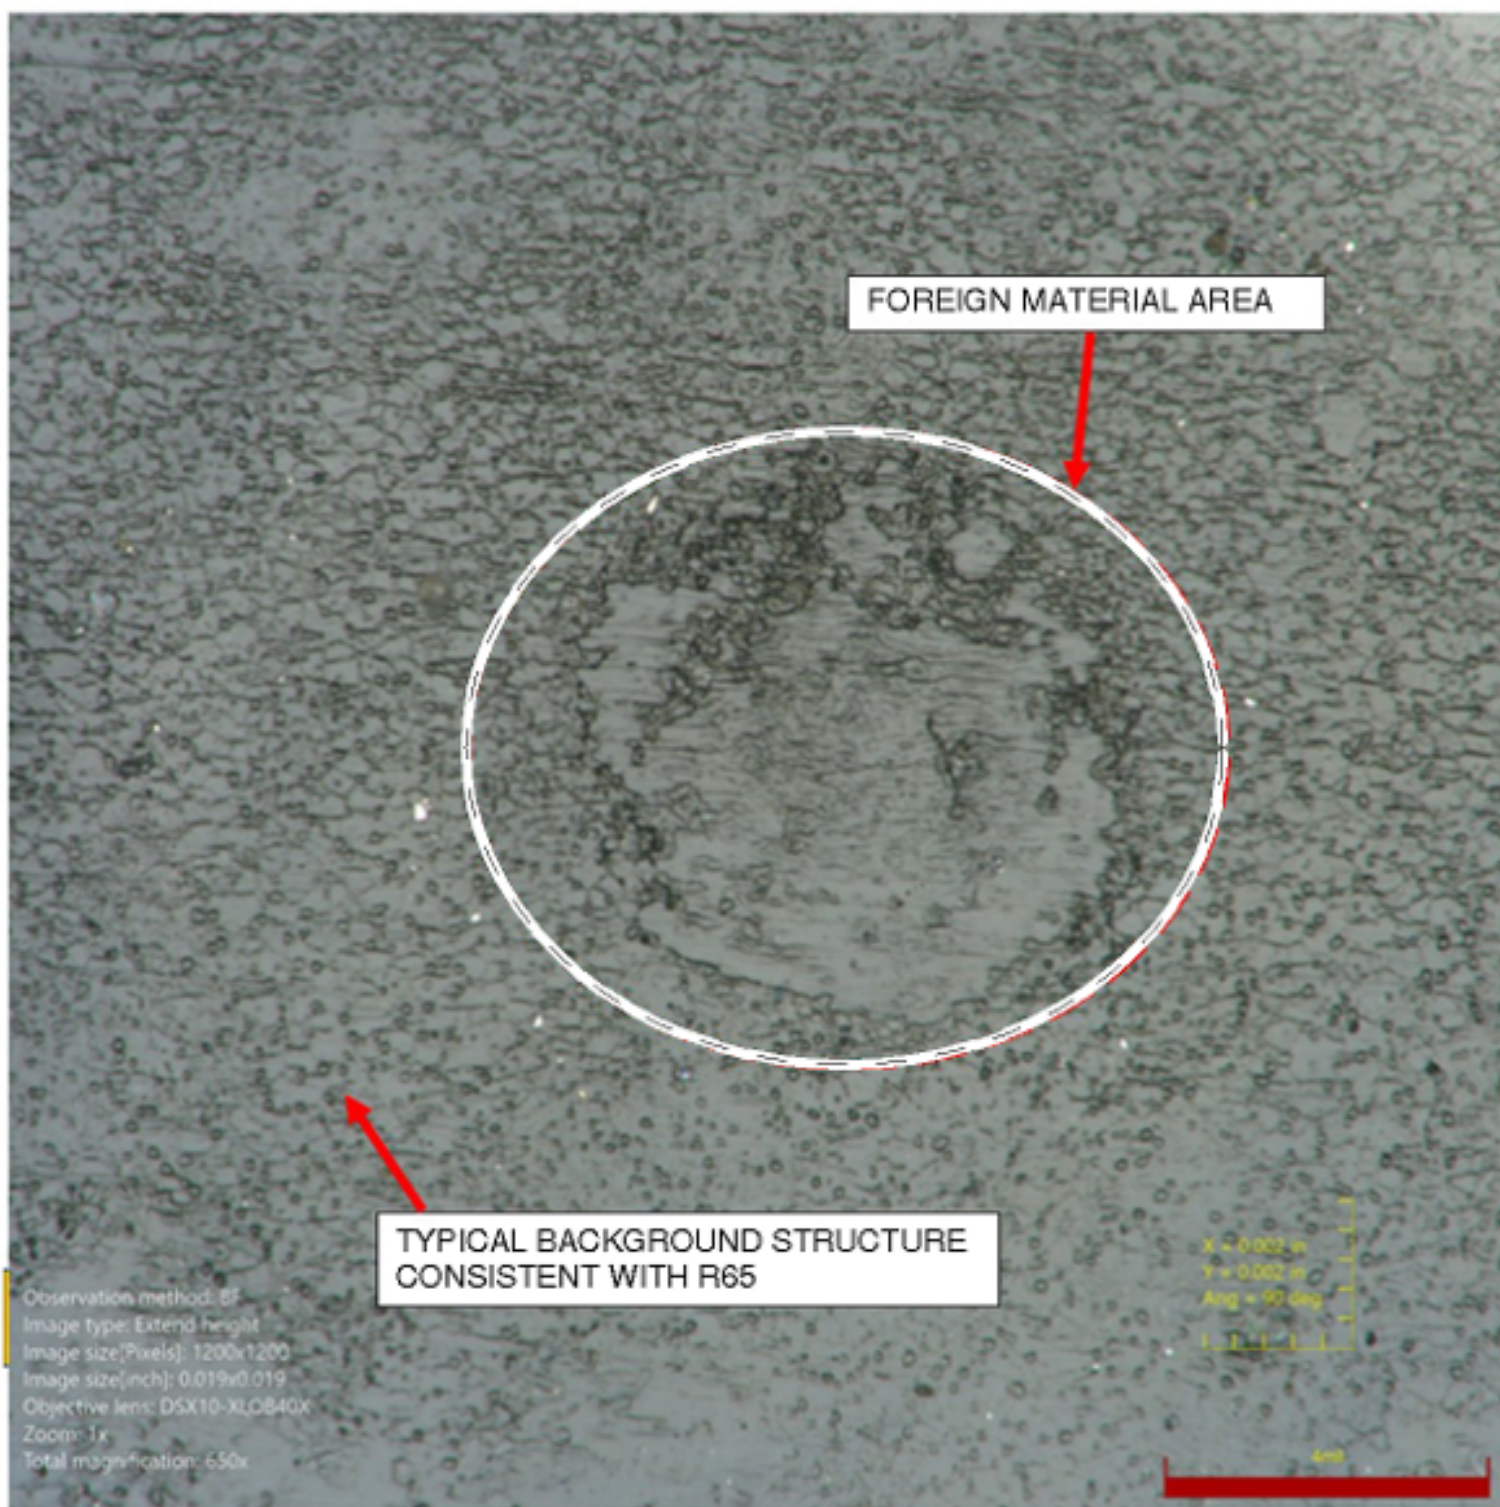
6042116-00

FOREIGN MATERIAL AREA AND TYPICAL BACKGROUND STRUCTURE, RENE 65, 650X

Figure 5 (Sheet 3) Unacceptable Grain Structure from Replication of Rene 65 - Evidence of Foreign Material With Different Grain Structure
