**M** INCREMENTAL CHANGE

### SPM 70-33-08 REPLICATION TO IDENTIFY EVIDENCE OF FOREIGN MATERIAL AFTER BLENDING

Release Notification Date: 09/25/2024

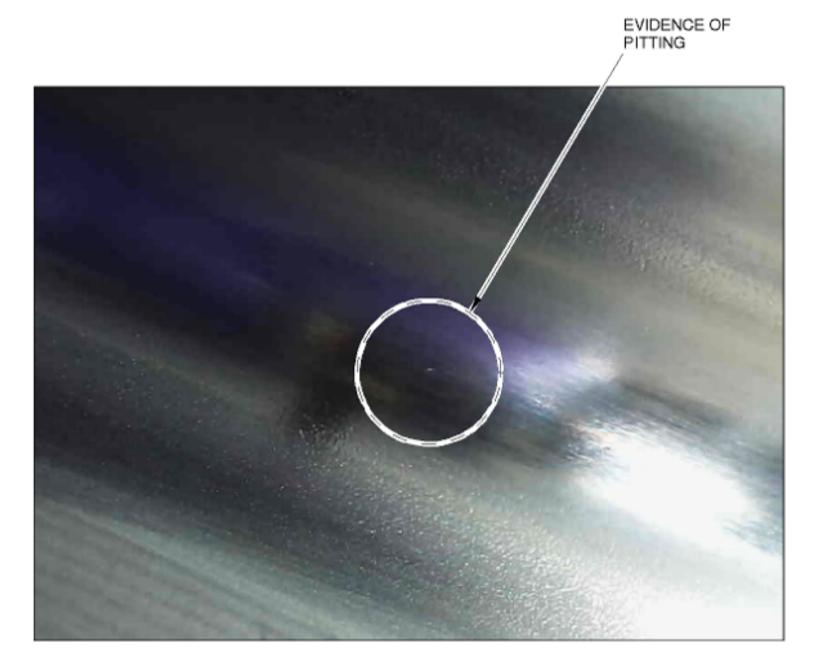
6042110-00

Figure 1 (Sheet 1) Blended Surface with Evidence of Pitting Remaining - Not Acceptable for Visual Evaluation \* \* \* FOR ALL

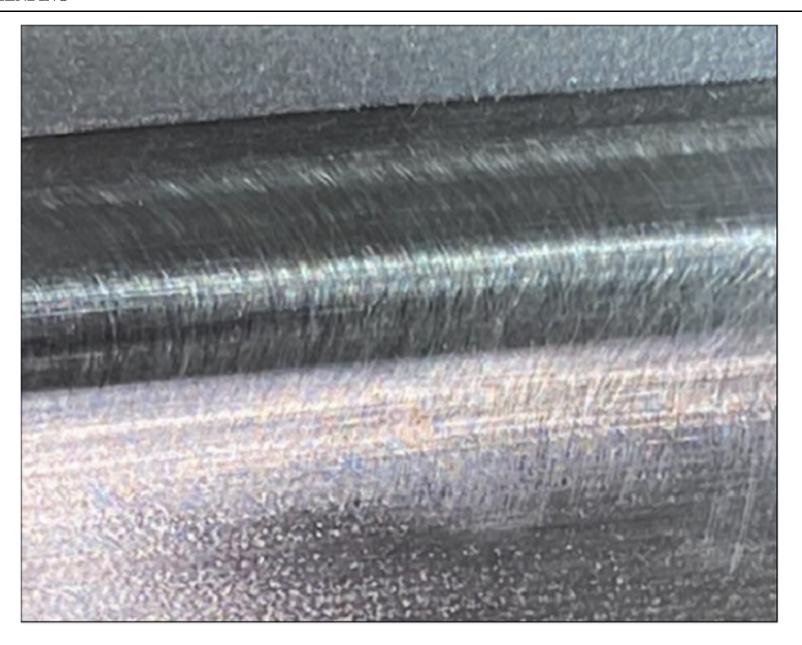
6042111-00

Figure 1 (Sheet 2) Evidence of Scratches in the Blend Zone - Not Acceptable for Visual Evaluation  $***FOR\ ALL$

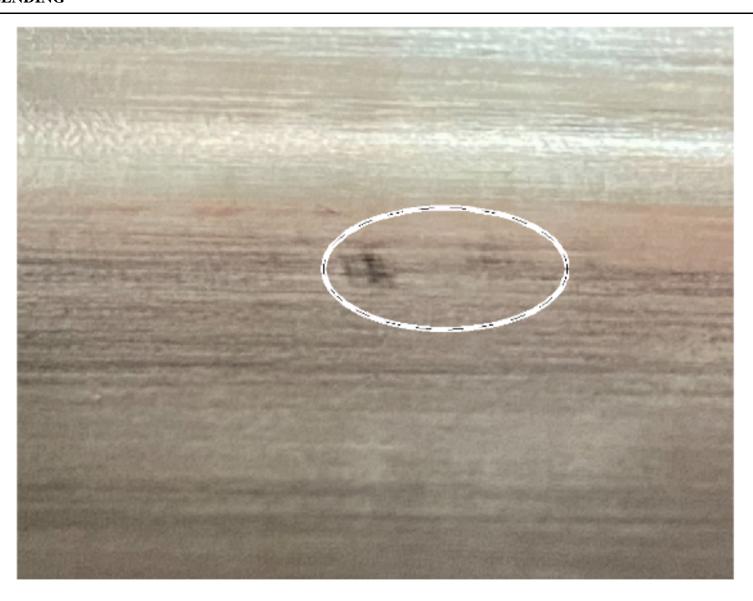
6042112-00

Figure 1 (Sheet 3) Evidence of Wheel Burning Caused During the Blending - Not Acceptable for Visual Evaluation \* \* \* FOR ALL

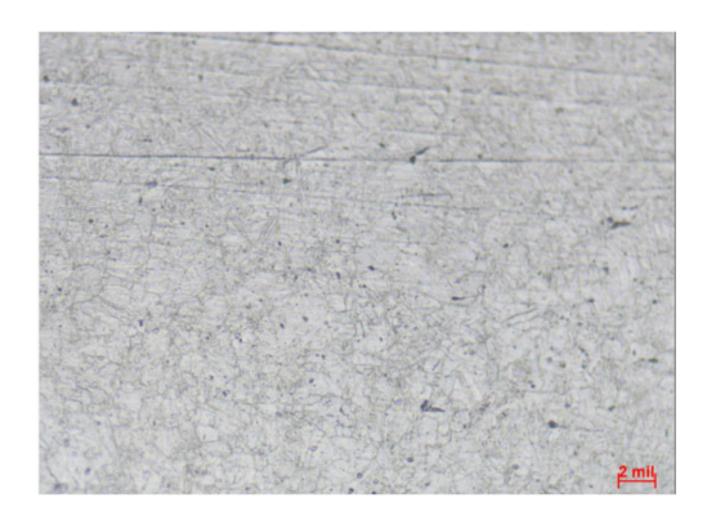
6002817-00

Figure 4 (Sheet 1) Grain Structure from Replication Rene'88DT with Scratches.

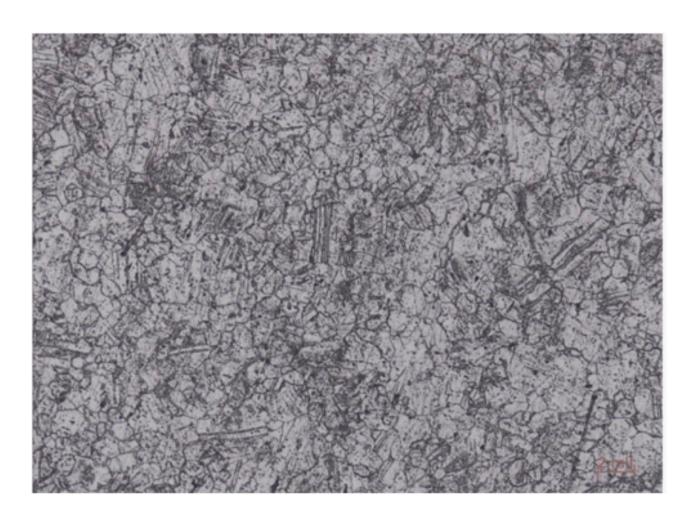
6002816-00

Figure 4 (Sheet 2) Grain Structure from Replication Rene'88DT Under Etched.

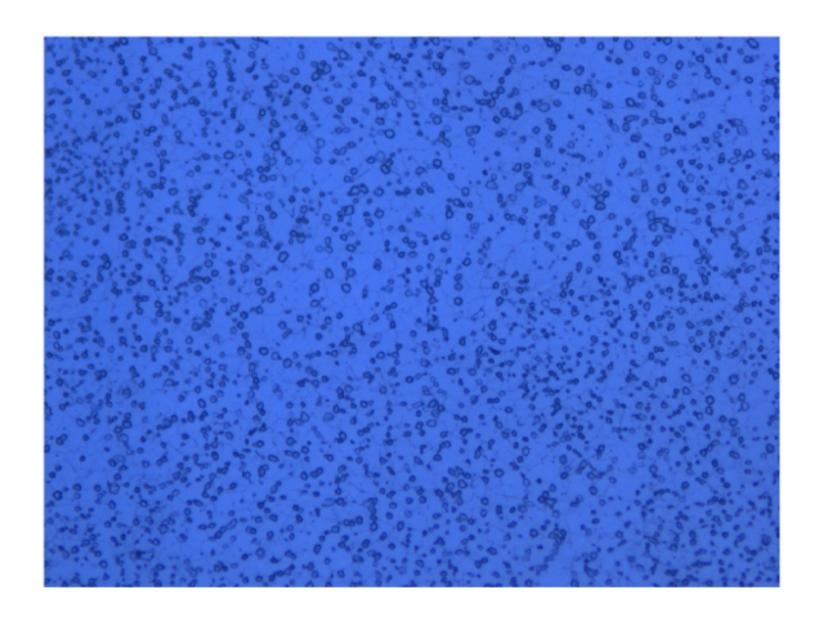
Figure 4 (Sheet 3) Grain Structure from Replication Rene'88DT Over Etched.

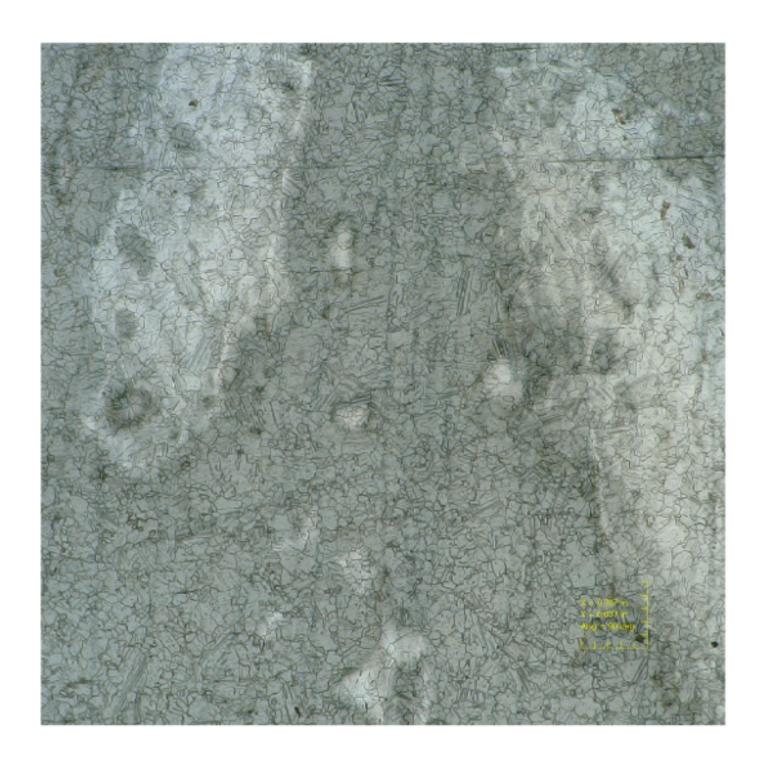
6038598-00

Figure 4 (Sheet 4) Grain Structure from Replication Rene'65 Under Etched

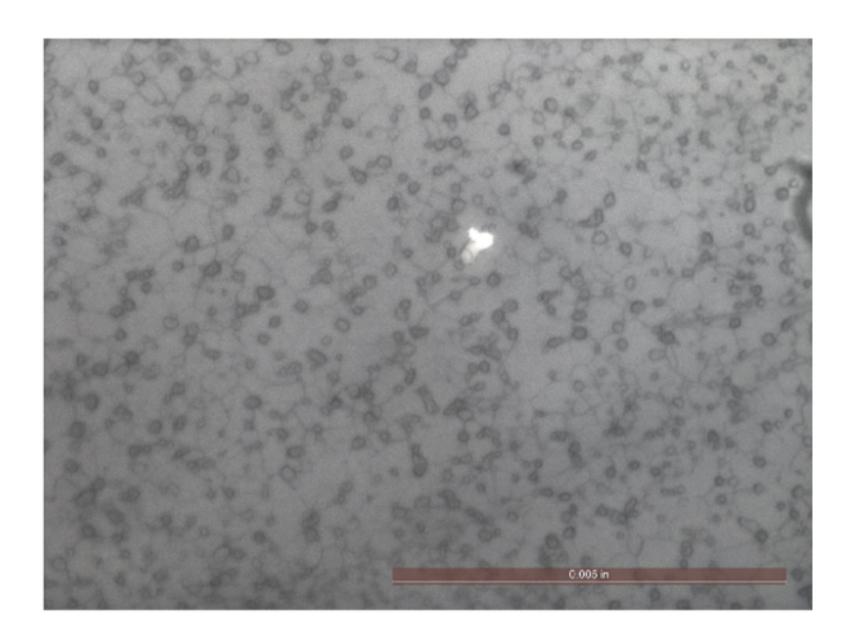
6038599-00

Figure 4 (Sheet 5) Replica with Region of Replica Tape that is Inadequately Adhered, that Produces a Bubbled Area \* \* \* FOR ALL

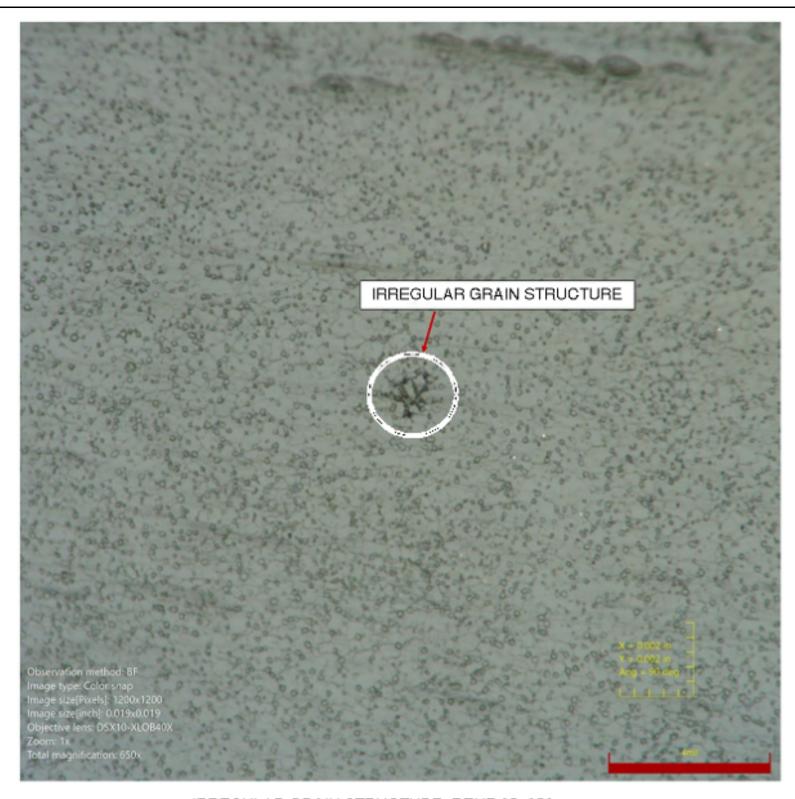
(4) If there is no evidence of any foreign material present, the assessment is acceptable. Refer to <u>Figure 5</u> for evidence of an irregular (unacceptable) grain structure and foreign material.

Figure 5 (Sheet 1) Unacceptable Grain Structure from Replication of Rene 65 - Evidence of an Irregular Grain Structure \* \* \* FOR ALL

NOTE: Any suspect evidence of foreign material must be sent to GE Engineering for further assessment. Please include the details that follow: part number and serial number, customer/operator, time since new, cycles since new, time since overhaul, and cycles since overhaul. This information can be submitted as a Service Request (SR) via myGEAviation.com. Alternatively, send photos of replica with a scale bar included for the magnification used, to Support at Aviation.Fleetsupport@ge.com.
