**CT7-2E Maintenance INCREMENTAL CHANGE  
MM 72-00-00, FAULT ISOLATION 002  
NON-FADEC FAULT ISOLATION (CT7-2E1)**

Release Notification Date: 08/08/2024

tk72-00-00-810-810      [Technical Change: Changed the chip detector inspection criteria in Figure 116, Sheet 5.](#)

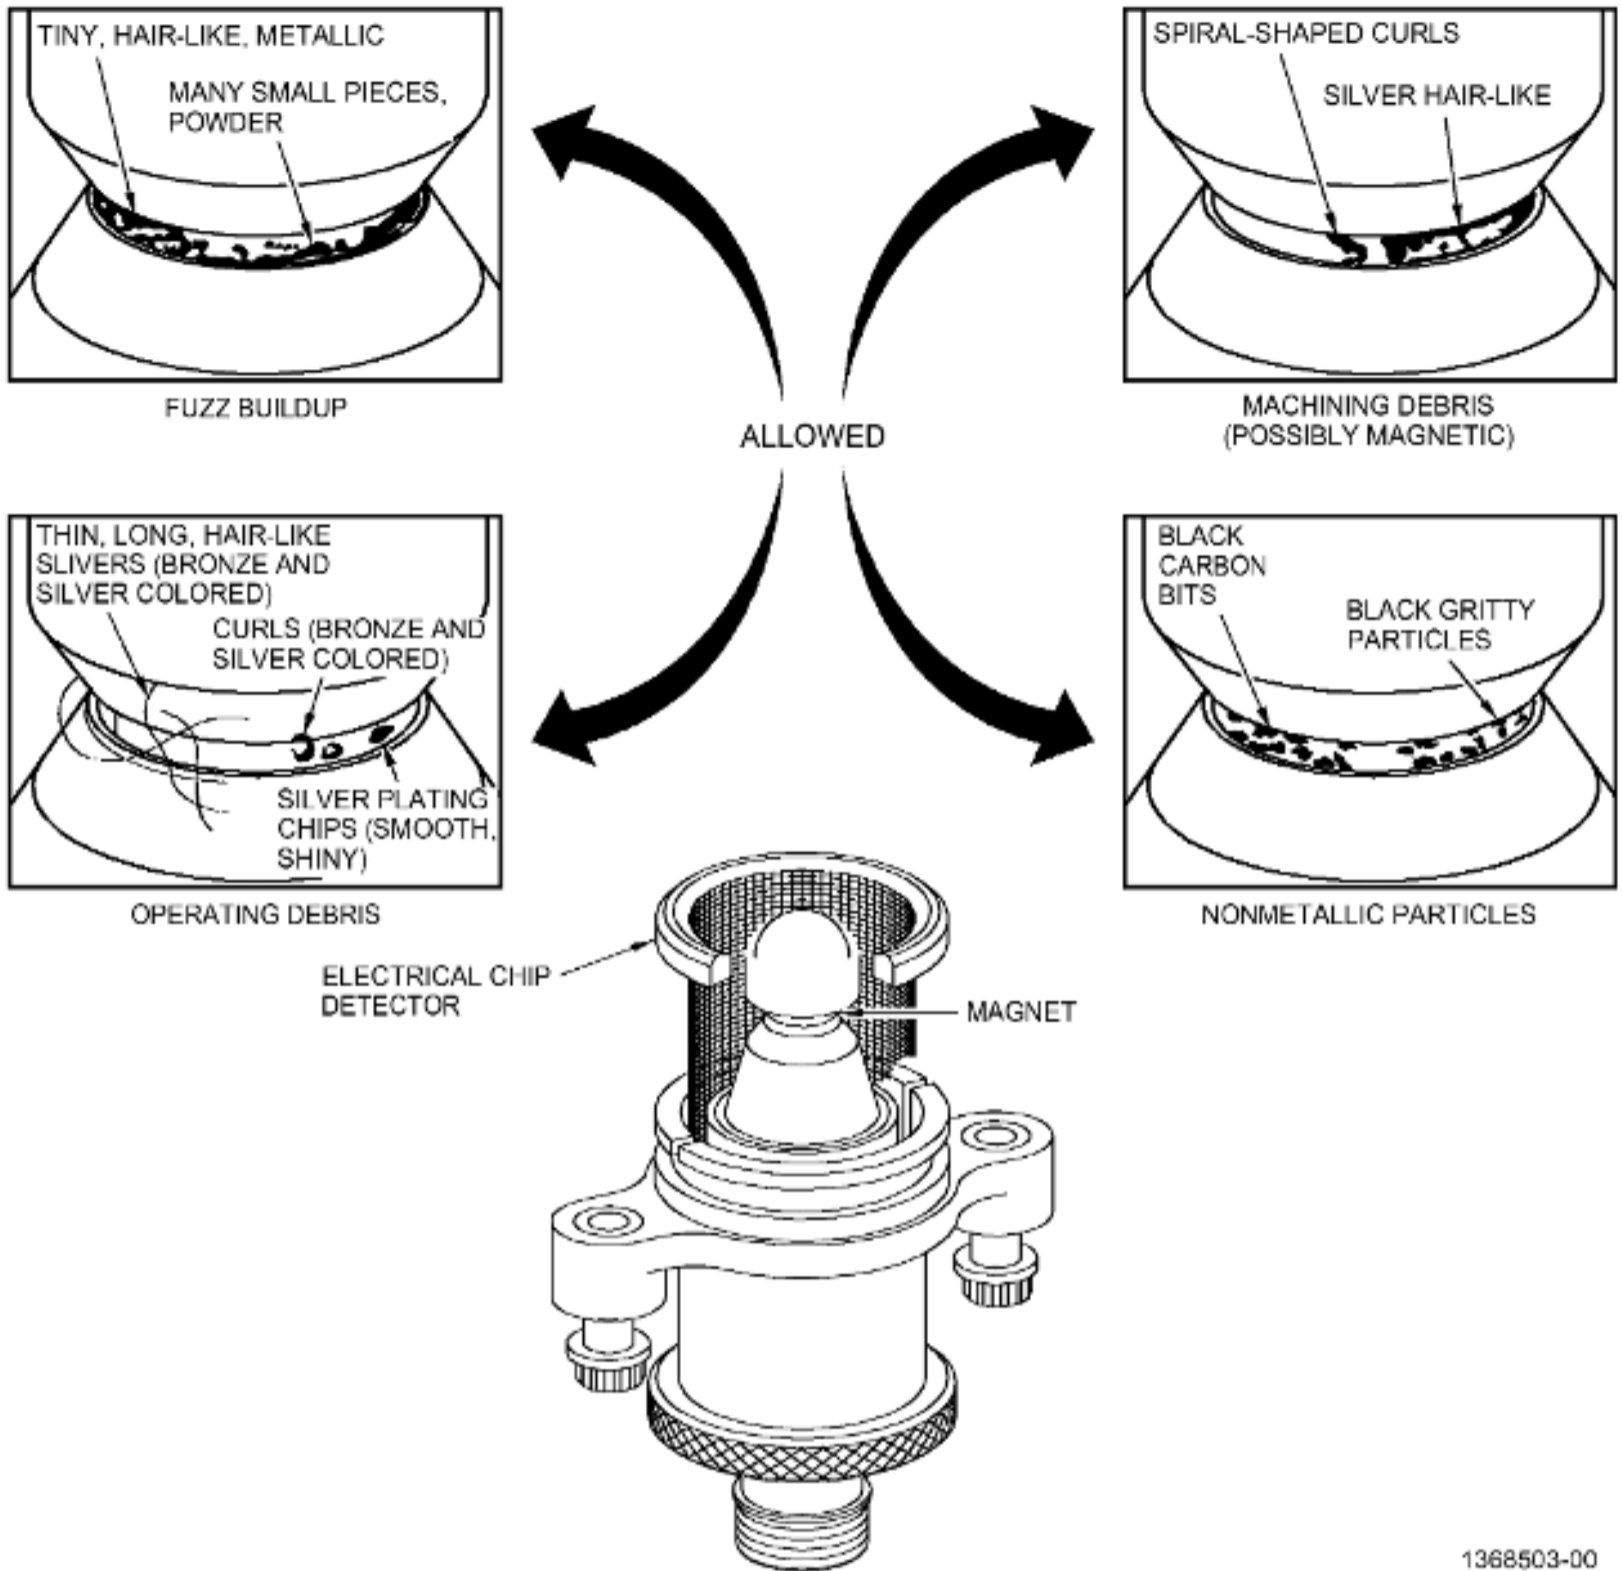
Figure 116 (Sheet 3) Electrical Chip Detector Light On During Engine Operation

**NOTE**

- All debris must be examined with a 10x magnifying glass.
- Characteristics of chips of the allowable category are as follows:
  - Machining debris. This type of material is left over from the manufacturing operations used to make the engine parts. Typical characteristics include spiral shaped curls, semi-circular curls, or section of curls. Section of curls will appear as tiny rectangular shapes. One side of the chip may be stained or blued more than the other. Usually non-magnetic, as with nickel based steels such as the INCO series, aluminum, etc. But can also be magnetic.

- Non-magnetic metal chips. Except relatively large pieces of non-magnetic material (chunks) which appear to have fractured away from larger structure as evidenced by a machined surface on one side, irregular and jagged on the other surfaces.

- Non-metals, such as preformed packing and carbon seal material.
  - Long, hair-like, bronze colored slivers, non-magnetic, typical of sump labyrinth seal material.

- Long, hair-like, slivers, magnetic, typical of driveshaft bearing locknut threads.
  - Wire shaped pieces.
  - Soft, ductile, silvery colored material, typical of silver plating. Can be deformed by hand. May have copper tint on one side.

- Fuzz-like accumulation on chip detector, particularly on a new or recently overhauled engine. Under magnification fuzz will appear as tiny slivers or a fine powder.

- Non-metallic, black, gritty particles, carbon-like in appearance, typical of coked oil.
  - Chunks of carbon seal, or chunks of hard black plastic are allowable as long as oil consumption is within limits and oil temperatures and pressures are normal.

- Machining chips or debris are typically found during the first few hours of operation on a new engine, but experience has shown that it is possible for them to be dislodged hundreds of operating hours later. Typically this is a one time occurrence, with no subsequent reights of the chip detector after being cleaned.

- Chips less than 0.010 inch (0.25 mm) are considered too small to be interpreted by visual means; however, if the chip detector repeatedly accumulates large quantities of extremely small chips, this is to be considered an unacceptable condition.

- If chip light comes on and if debris is allowed (see sheets 3 and 4), a series of 15 minute ground runs at flat pitch, 100% Nr should be made to clean engine oil system of debris.
- If no chip light comes on during a 15 minute run, continue to operate.
- If chip light comes on, and if debris is allowed but is not present in large quantities, continue making runs until a 15 minute run is made without light coming on.
- If chip detector light comes on for three runs, replace engine. If allowed chips continue to generate and if quantity of debris is increasing, replace engine.

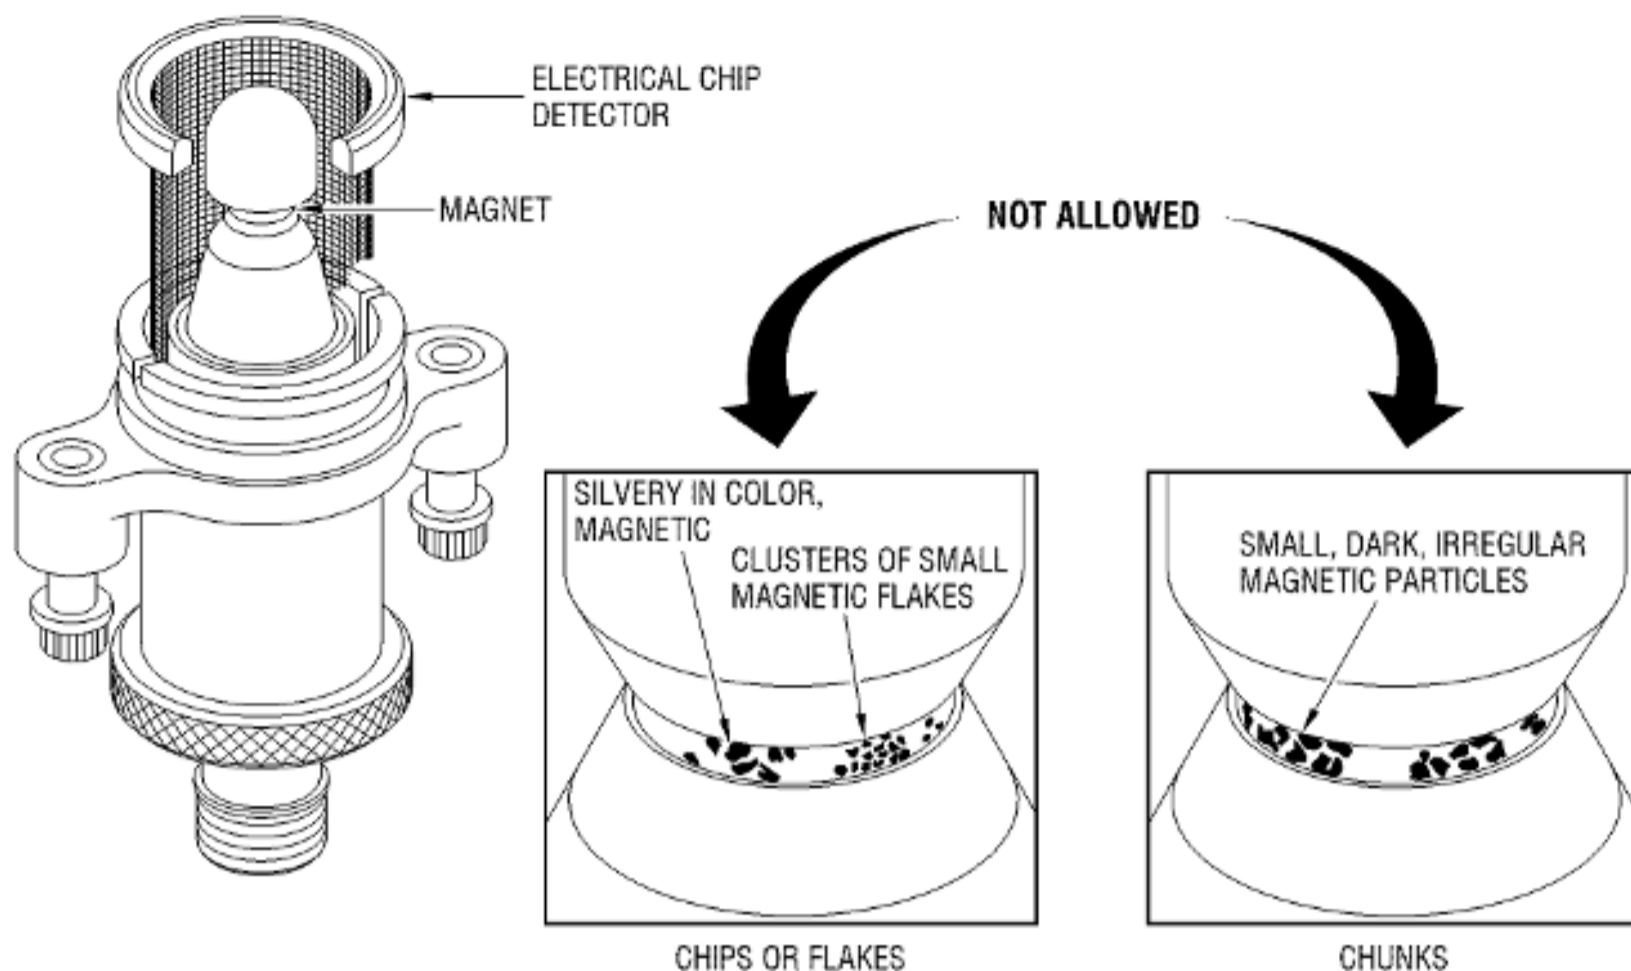
Figure 116 (Sheet 4) Electrical Chip Detector Light On During Engine Operation

**NOTE**

- All debris must be examined with a 10x magnifying glass.
- Unallowable chips are from power unit bearings, including driveshaft, power takeoff, and accessory gearbox bearings. The inner and outer races, balls, and rollers are made from M50, M50 NIL, or 52100 steel. Unallowable chips can also be from the accessory/PTO gears which are manufactured from AISI 9310. Any chip identified as unallowable debris, either visually or by laboratory analysis, is cause for immediate engine disassembly.

- Smooth and reflective (silvery) on one side, rough on the other, typical of M50 material.
  - Roughly circular or elliptical flakes, thinner around edges, typical of a spalling-type bearing distress.
