| | <b>Audit Report</b> | |
| | Report No. | IAR-2023/044 |
| | Area / Scope | GAM-145 |

| <b>A AUDIT DETAILS</b> | | |
|---|--|--|
| 1. | Audit Type / Category | Tick where applicable<br><input type="checkbox"/> Scheduled <span style="margin-left: 200px;"><input type="checkbox"/> Vendor</span><br><input type="checkbox"/> Surveillance <span style="margin-left: 150px;"><input type="checkbox"/> Product</span><br><input checked="" type="checkbox"/> Variation to approval<br><br>Specify: PGU Kuching – Line & Base Maintenance for Textron 208 Caravan |

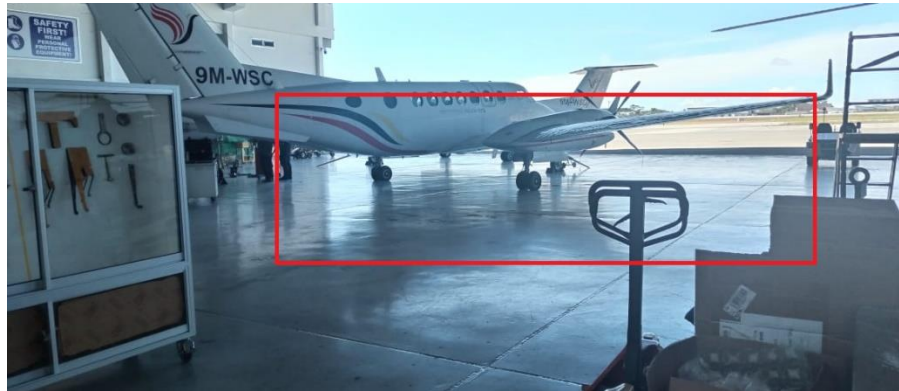
Visit to the hangar conducted for verification of the maintenance location. The proposed location is adequate with cleanliness of the area was well maintained, and housekeeping of the hangar was found satisfactory. Grounding points is available near the proposed maintenance location in the hangar. (Refer Appendix 1,2,3)

Appendix 1 – Proposed location for the Textron 208 Caravan Maintenance inside Hornbill Skyways hangar – back view

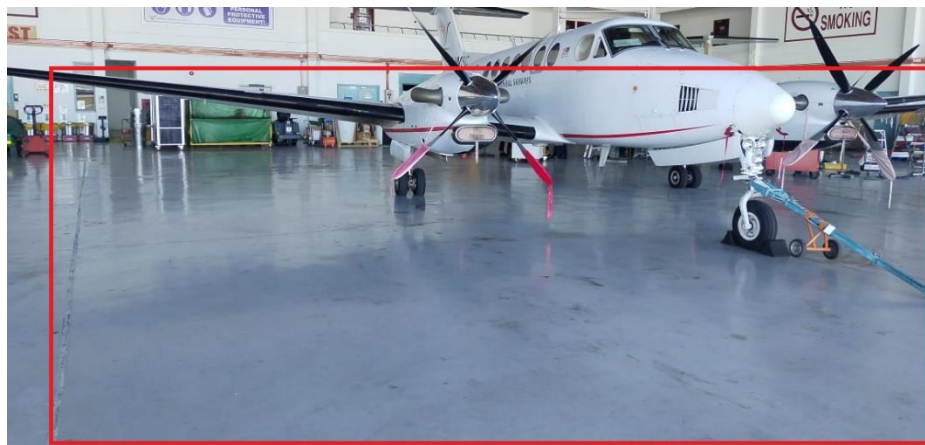
Appendix 2 – Proposed location for the Textron 208 Caravan Maintenance inside Hornbill Skyways hangar – front view

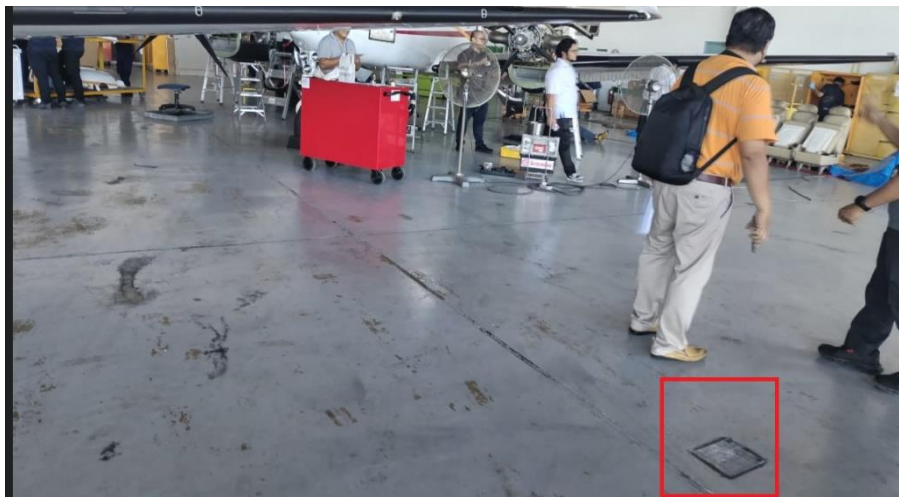
Appendix 3 – Grounding Points nearby the proposed maintenance location inside hangar

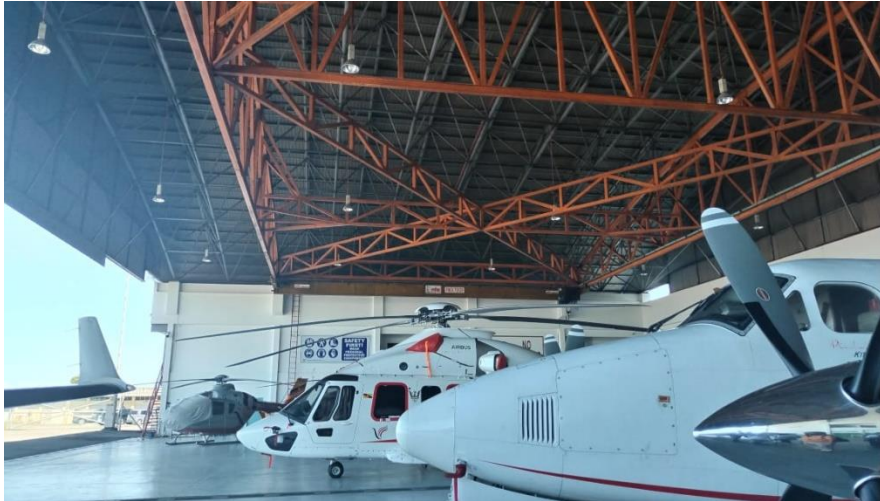
The hangar's lighting was deemed to be suitable for maintenance purposes. The lighting is featured as part of the hangar's amenities. (Refer Appendix 4)

Appendix 4 – Sufficient Lighting and Overhead Crane are available inside the hangar

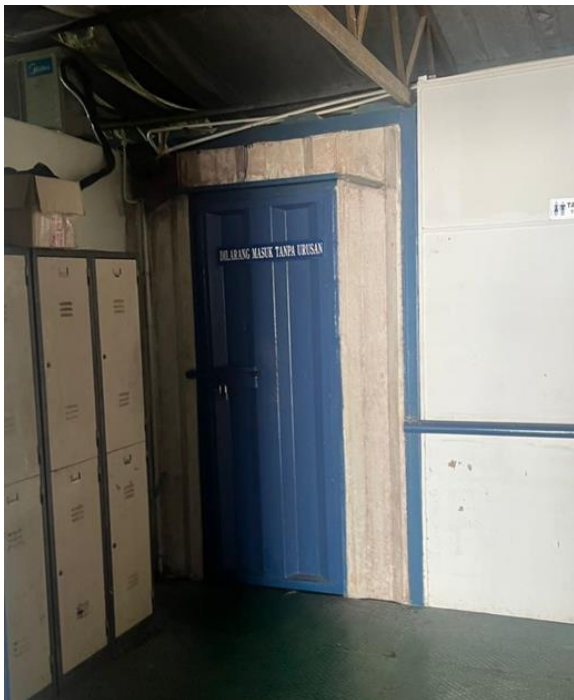
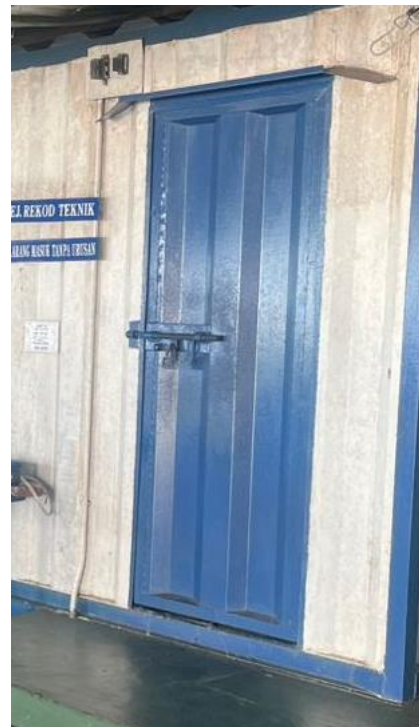
2 x container was used to accommodate all the above station. (Refer Appendix 5)

Housekeeping is required on inside the maintenance support office and surrounding area of the maintenance support office (**Observation 1**).

Appendix 5 – Entry door to PGU Maintenance Support Cabin

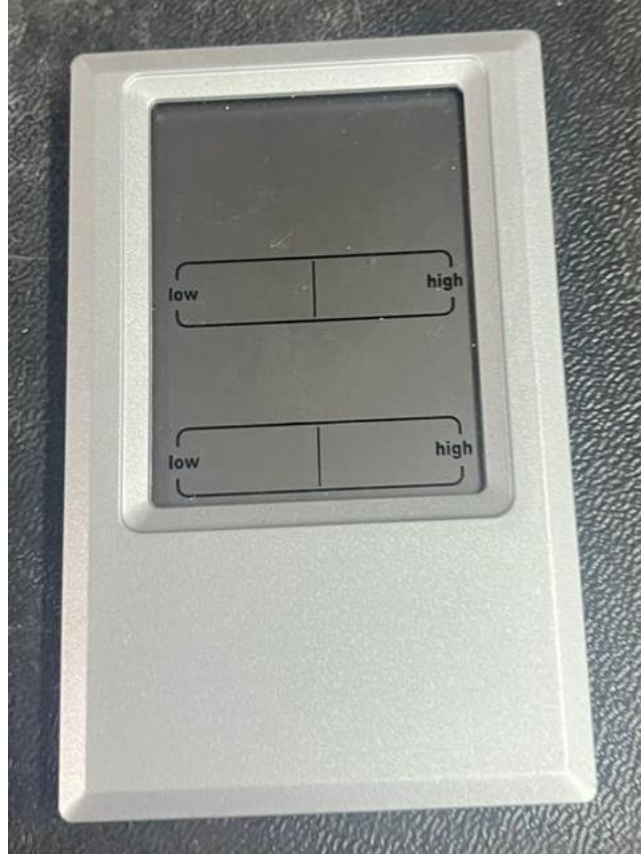
During the audit, it was observed that the Temperature & Humidity control process was not implemented as per EPMPGU. Hygro Thermometer were found not working during the audit, hence the control of temperature & humidity was not available **(NCR 06)** (Refer Appendix 6)

Appendix 6 – Unserviceable hygro thermometer
