Temporary Maintenance Instruction TMI 139-566

Tail rotor head installation - Lag damper spherical bearings - Detailed inspection.

All AW139 Helicopters

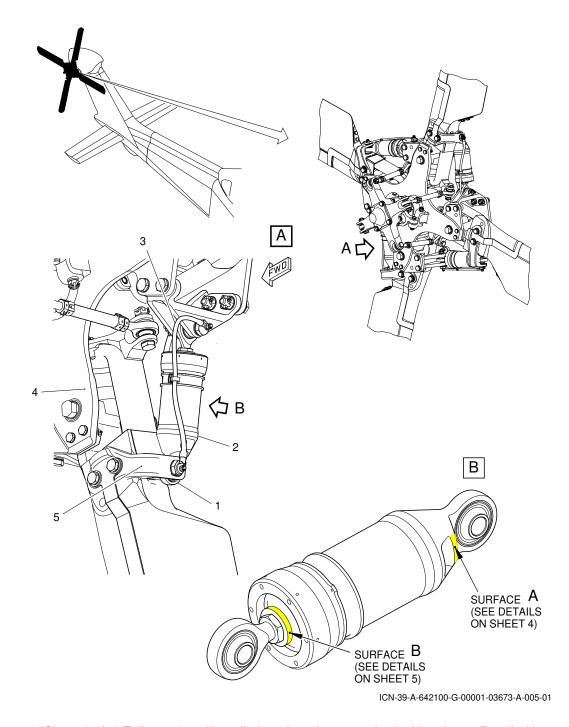
Figure 1 (Sheet 1 of 5) Tail rotor head installation - Lag damper spherical bearings - Detailed inspection on installed lag damper

- 1 Detailed inspection on installed lag damper.
- 1.1 Put the Platform, right (GG-02-00) adjacent to the right side of the fuselage.
- 1.2 Turn the tail rotor (4, Figure 1). Put the blade with the lag damper (2) that you must examine in the six o'clock position.
- 1.3 Examine the spherical bearing in the housing (1) for fretting, corrosion, loss of liner parts, displacement or rotation in its housing.
- 1.3.1 If you find the given damages to the spherical bearing:
- 1.3.1.1 Remove the lag damper (2). Refer to 39-A-64-21-02-00A-520A-A.

1.5.4	Put the plunger of the dial gauge extension against the Surface A of the lag damper (2). Refer to Detail B of Figure 1.
1.5.5	Measure and record the axial play of the spherical bearing. The maximum permitted axial play is 0.1mm (0.004in).

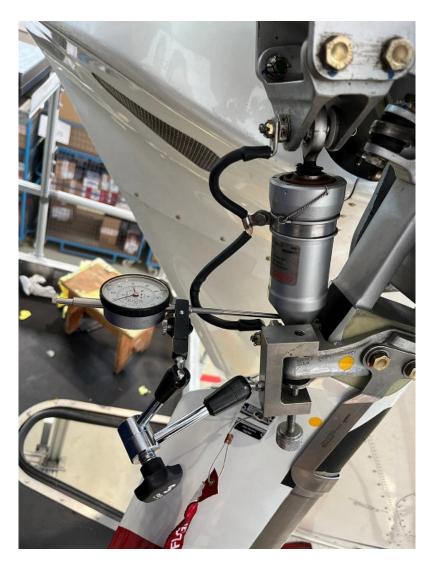
Figure 1 (Sheet 2 of 5) Tail rotor head installation - Lag damper spherical bearings - Detailed inspection on installed lag damper

HOW TO INSTALL THE DIAL GAUGE SUPPORT (T/R DAMPER BLADE SIDE) CORRECTLY TO DO MEASUREMENT ON THE SURFACE $\,A\,$

1.5.1	Install the Support assy, dial gauge (T/R damper blade side) (GF-54-07) on the blade damper attachment (5).
1.5.2	Connect the Support arm, dial gauge (GF-54-10) to the Support assy, dial gauge (T/R damper blade side) (GF-54-07) .

1.5.3	Lock the Dial gauge (GF-54-08) with the Extension, dial gauge (GF-54-09) on the end of the Support arm, dial gauge (GF-54-10) .
	Note Make sure that you put the plunger of the dial gauge extension in the center of the surface A (lag damper body end) and perpendicular to that surface as much as possible. To get an aid to put the plunger correctly in position, refer to the adjacent bolt axle to put the plunger as much as possible parallel to that axle.

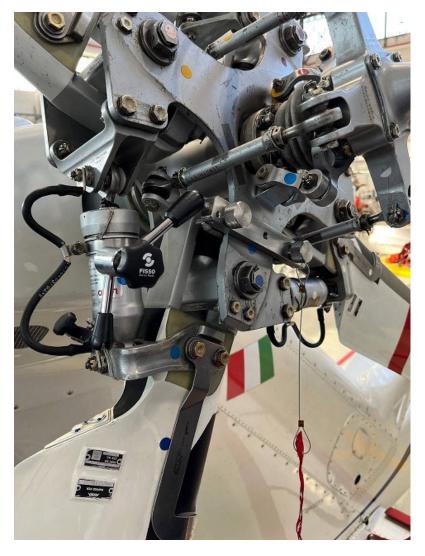
Figure 1 (Sheet 3 of 5) Tail rotor head installation - Lag damper spherical bearings - Detailed inspection on installed lag damper

HOW TO INSTALL THE DIAL GAUGE SUPPORT (T/R DAMPER HUB SIDE) CORRECTLY TO DO MEASUREMENT ON THE SURFACE $\,B\,$

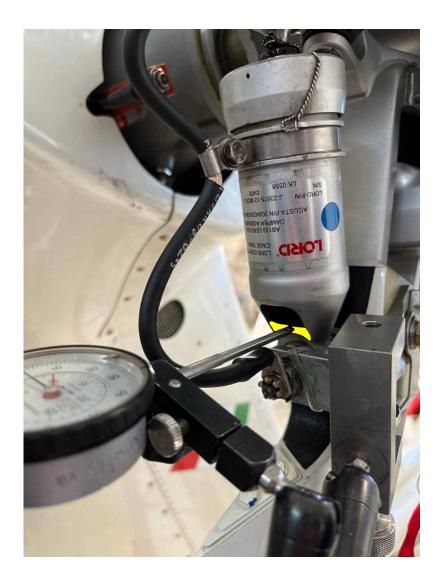
Figure 1 (Sheet 4 of 5) Tail rotor head installation - Lag damper spherical bearings - Detailed inspection on installed lag damper

CORRECT POSITION OF THE PLUNGER ON THE SURFACE $\,A\,$

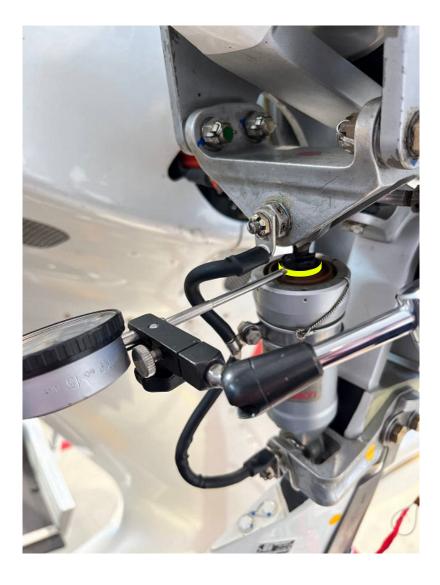
Figure 1 (Sheet 5 of 5) Tail rotor head installation - Lag damper spherical bearings - Detailed inspection on installed lag damper

CORRECT POSITION OF THE PLUNGER ON THE SURFACE \boldsymbol{B}

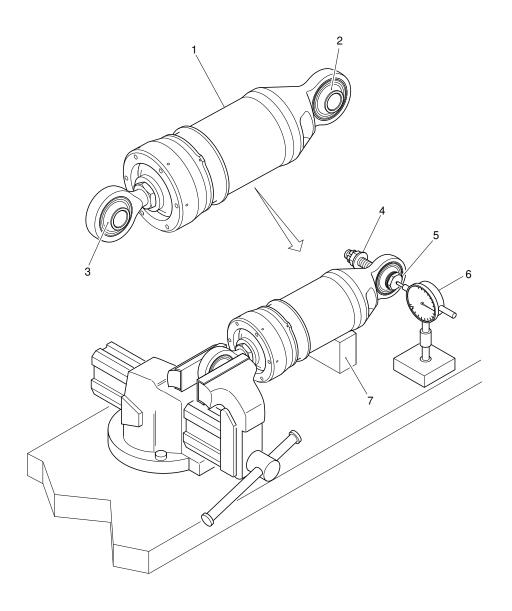
Figure 2 Tail rotor head installation - Lag damper spherical bearings - Detailed inspection on removed lag damper

3.4.1	Get an hexagon head bolt with a head flat surface and a maximum diameter of the threaded portion of 11 mm (0.4 in). Get also the related nut. Use the hexagon head bolt and the nut to do the subsequent step 3.4.2.

3.4.2	Put the hexagon head bolt (5) into the hole of the spherical bearing (2). Lock the bolt (5) in its position with the nut (4). Tighten the nut (4) with your hands.

3.4.3	Lock the spherical bearing (3) in a vice with protective padded jaws.
3.4.4	Put the V-block (ZZ-00-00) (7) below the body of the lag damper (1).
	Note Make sure that you put the plunger of the dial gauge (6) in the center of the bolt head surface and perpendicular to that surface as much as possible.

3.4.5	Put the plunger of the Dial gauge (ZZ-00-00) (6) against the head of the bolt (5).
3.4.6	Measure and record the axial play of the spherical bearing (2). The maximum permitted axial play is 0.1 mm (0.004 in).

3.4.8.2	Continue with step 3.6.
3.5	Do a check of the axial play of the spherical bearing (3) of the lag damper (1). Obey the instructions that follow:
3.5.1	Put the hexagon head bolt (5) into the hole of the spherical bearing (3). Lock the bolt (5) in its position with the nut (4). Tighten the nut (4) with your hands.

3.5.2	Lock the spherical bearing (2) in a vice with protective padded jaws.
3.5.3	Put the V-block (ZZ-00-00) (7) below the body of the lag damper (1).
	Note Make sure that you put the plunger of the dial gauge (6) in the center of the bolt head surface and perpendicular to that surface as much as possible.

3.5.4	Put the plunger of the Dial gauge (ZZ-00-00) (6) against the head of the bolt (5) in the spherical bearing (3).
3.5.5	Measure and record the axial play of the spherical bearing (3). The maximum permitted axial play is 0.1 mm (0.004 in).
3.5.6	If the axial play is in the specified limit:
3.5.6.1	Remove the nut (4) and the hexagon head bolt (5) from the spherical bearing (3).
3.5.6.2	Remove the lag damper (1) from the vice and the V-block.
3.5.6.3	Continue with step 3.6.
3.5.7	If the axial play is more than the specified limit:
3.5.7.1	Replace the rod end with the damaged spherical bearing (3). Refer to 39-A-64-21-02-01A-921A-B.
3.5.7.2	Continue with step 3.6.
3.6	Install the lag damper on the tail rotor (if necessary, use a new lag damper). Refer to 39-A-64-21-02-00A-720A-A.
4	Do step 1.2 thru step 3.6 for the other three lag dampers.
