SAFETY INFORMATION NOTICE

SUBJECT: EQUIPMENT AND FURNISHINGS

Schroth safety belt buckle jammed

No. 4047-S-25

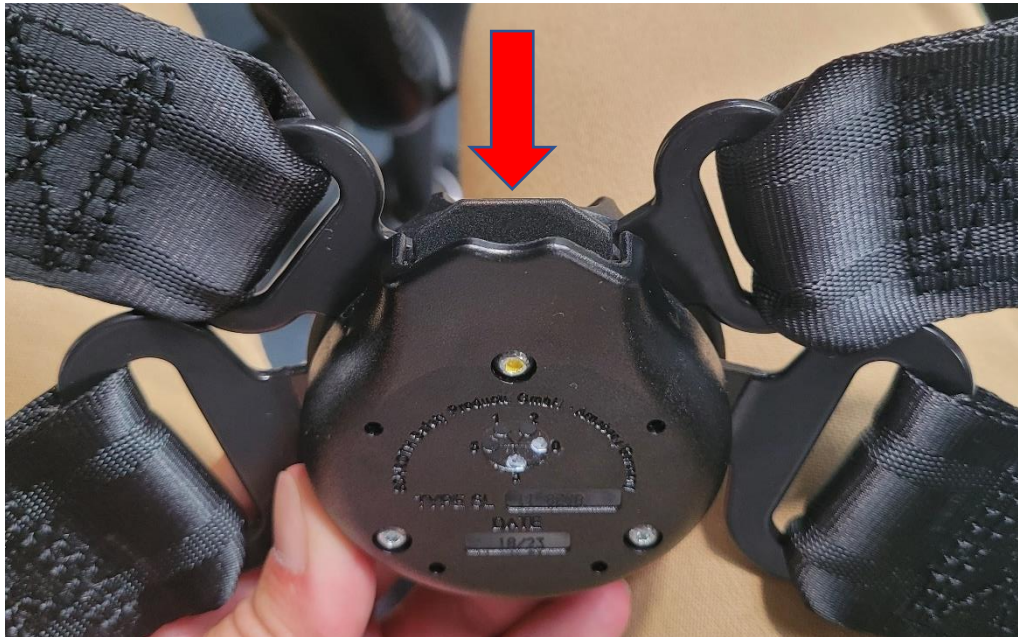
The top finger tab (PHOTO 1) located at the top of the buckle allows the shoulder strap connectors to be released (PHOTO 3) when it is pushed forward (PHOTO 2).

PHOTO 1 - Location of the finger tab

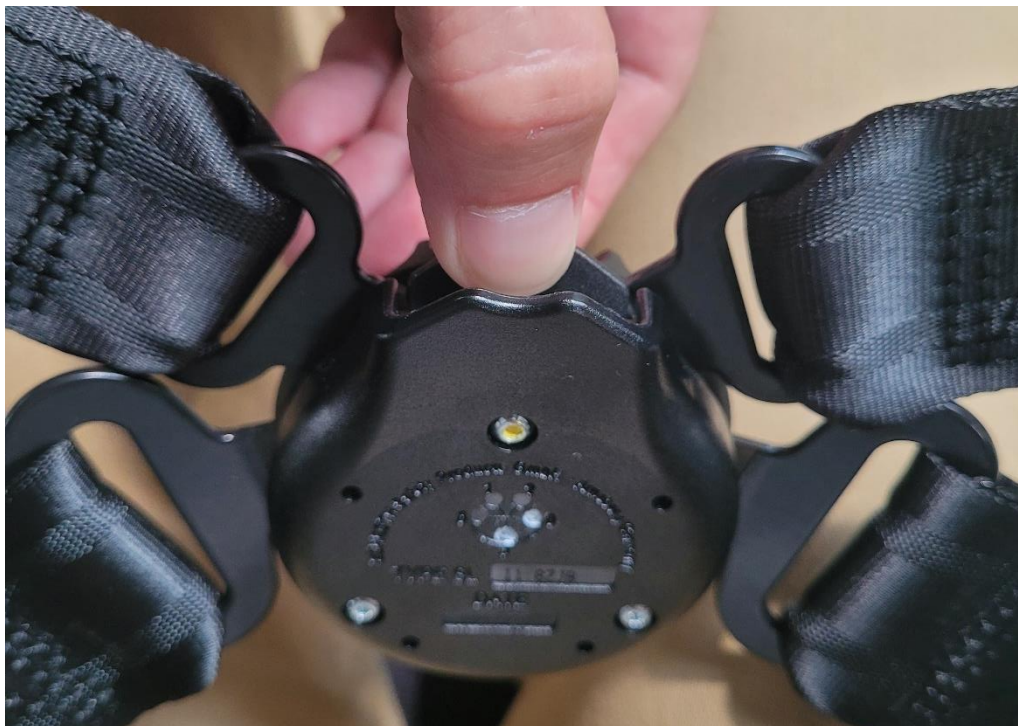
PHOTO 2 - Action of pressing the finger tab forward

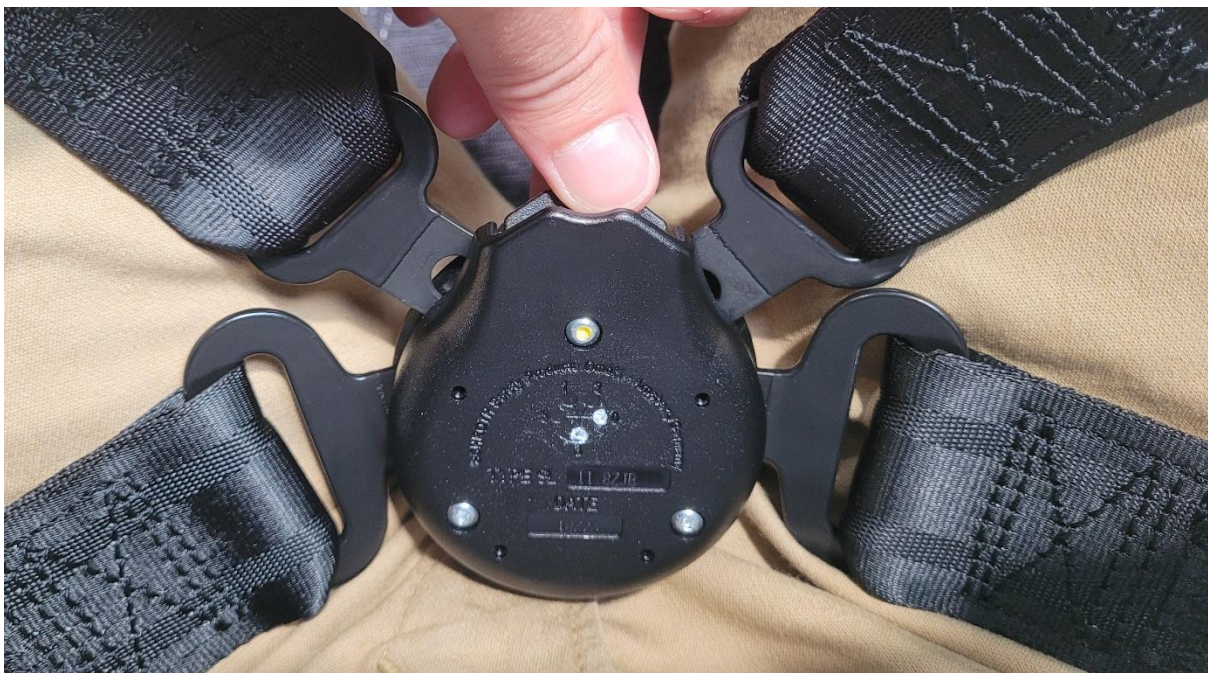
PHOTO 3 - The harness connectors are released

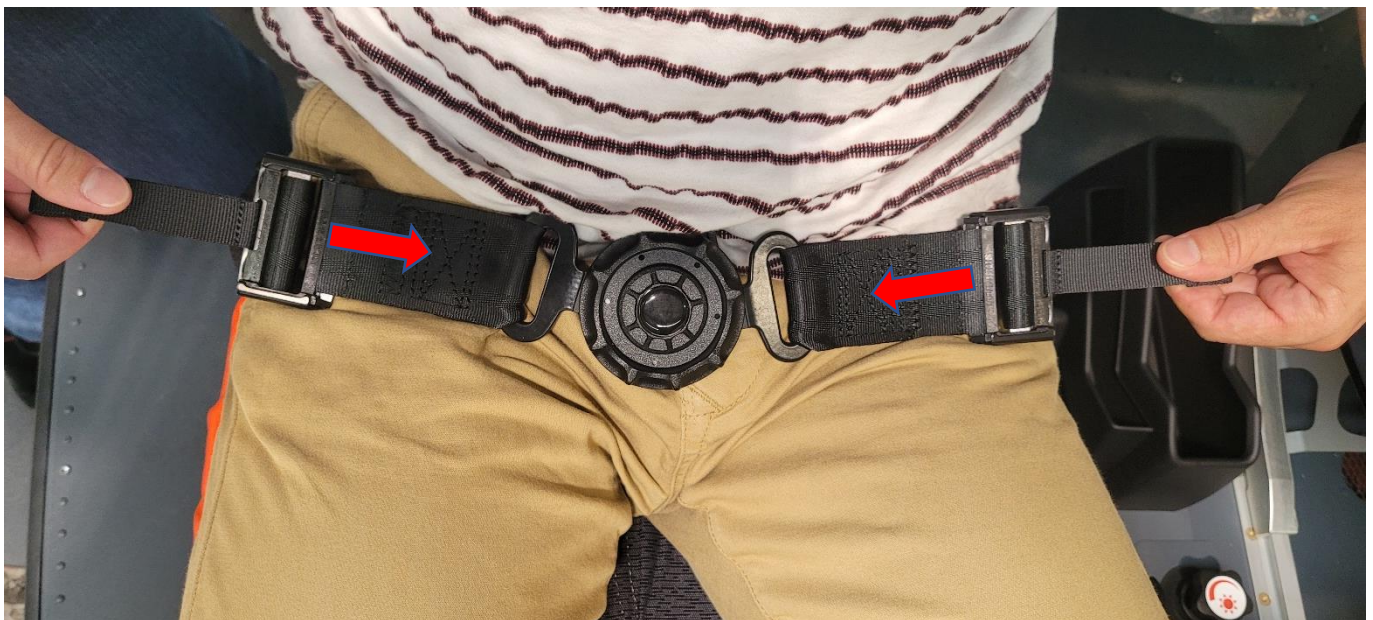
In order to be able to free yourself from the other two lap straps, you will need to pull towards the buckle on the strap adjustment tabs (PHOTO 4) to obtain a maximum strap length, which will allow you to free yourself by letting the straps fall to the ground (PHOTO 5).

PHOTO 4 - Action of pulling the adjustment tabs of the lap straps towards the buckle

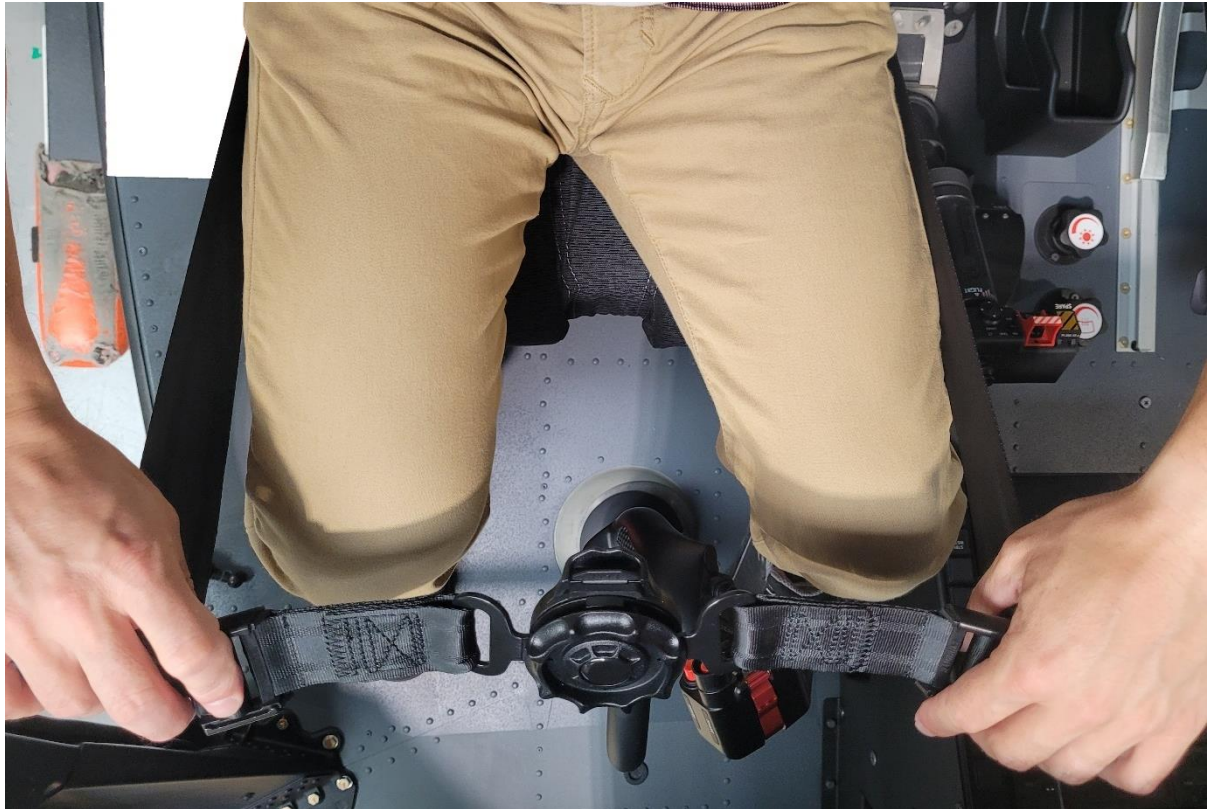
PHOTO 5 - The lap straps are long enough to be passed over the knees, meaning the legs can be released once the straps are placed on the floor of the aircraft. The seat occupant can easily evacuate the aircraft if necessary.

The tests above have been satisfactorily performed at Airbus Helicopters. Consequently, should the aircraft need to be evacuated, each operator must provide the correct information to passengers and crew members during Safety Briefings before boarding.
