No. EC155-25A160

ALERT SERVICE BULLETIN

EQUIPMENT AND FURNISHINGS - Main Rotor Flight Controls
Check of the shear-button safety-cap on the collective pitch handle

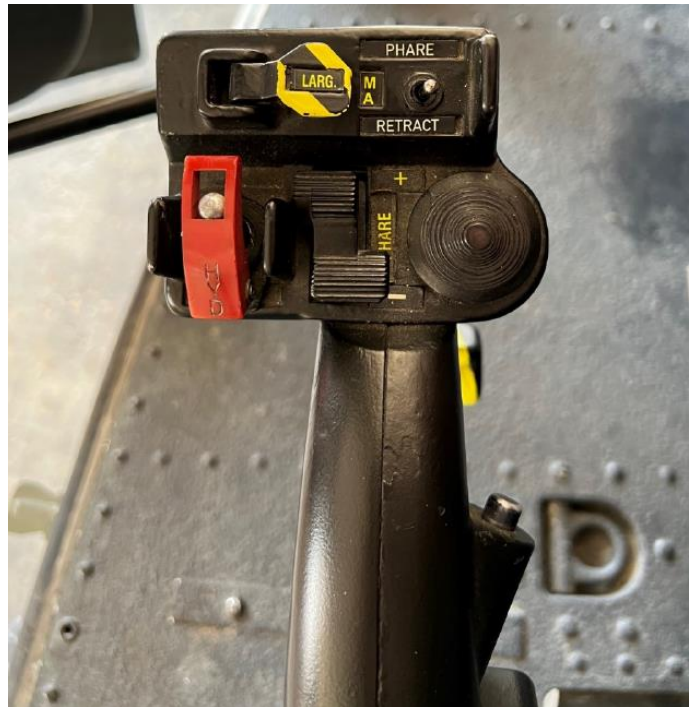
Figure 1 - Collective pitch handle

Helicopters EC155 versions B and B1 equipped with a hoist (removable and/or fixed parts) and that have collective pitch handle MP/N 704A41-1101-32 on pilot and co-pilot collective sticks (Figure 1).

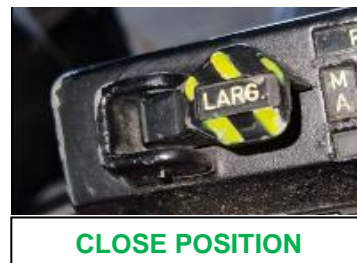
Figure 2 - Correct positions

- If the safety-cap does not stay in a middle position between the open position and the closed position (Figure 2) during each step:
 - . The spring of the safety-cap on the collective pitch handle operates correctly.
 - . Do the steps in paragraph [3.B.4](#).

- If the safety-cap does not stay in middle position between open and close position ([Figure 2](#)) during each step:
 - . The spring of the safety-cap on the collective pitch handle operates correctly.
 - . The collective sticks with collective pitch handle or the collective pitch handle can be installed.
- If the safety-cap stay in middle position between open and close position or if the safety-cap is not fully closed in closed position ([Figure 3](#)) minimum one time:
 - . The spring of the safety-cap on the collective pitch handle does not operate correctly.
 - . Replace the spring of the safety-cap before installation, refer to paragraph [3.B.3.](#)

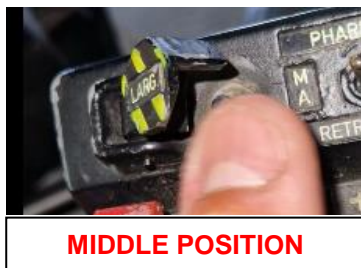
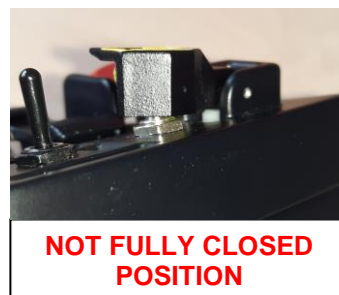
Figure 3 - Incorrect positions

During the technical investigations, it has been identified that the effect of ageing of the shear-button safety-cap may lead to an improper functioning of the shear-button protection. The shear-button safety-cap is fitted with a spring which is supposed to maintain the safety-cap in a frank and effective position either closed or fully open. The correct mechanical effect of the spring is to prevent the safety-cap from staying in middle position.

- If the safety-cap stays in middle position between the open position and the closed position (Figure 3) or the safety-cap is not fully closed in closed position (Figure 3) minimum one time:
 - . The spring of the safety-cap on the collective pitch handle does not operate correctly.
 - . Replace the spring of the safety-cap within 150 flight hours following application of paragraph 3.B.2. Refer to paragraph [3.B.3](#).
 - .. Until you replace the spring of the safety-cap:
 - It is forbidden to use the hoist by night.
 - Locally make a label.
 - Attach it to the instrument panel, refer to [Appendix 4.B](#).

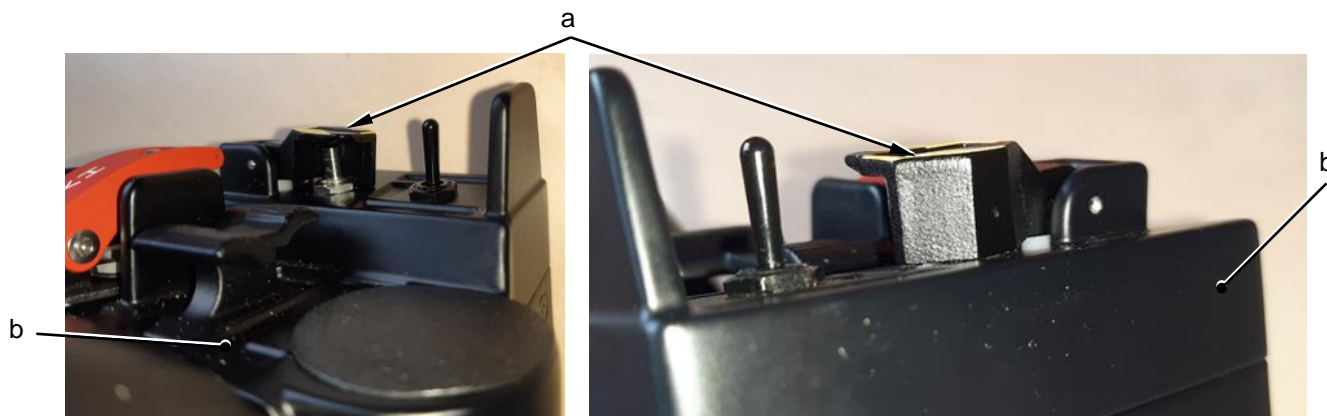
Figure 4 - Fully close position of the safety-cap

The safety-cap has a bi-stable behavior. It can only be in the fully open or fully closed position.

- Make sure that the safety-cap (a) on the collective pitch handle (b) is in the fully closed position, refer to Figure 4.

- Fully open the safety-cap (a).
- Make sure that it stays in the open position.
- Close the safety-cap (a).
- Make sure that the safety-cap (a) is fully closed ([Figure 4](#))
- Do all these steps three times minimum.

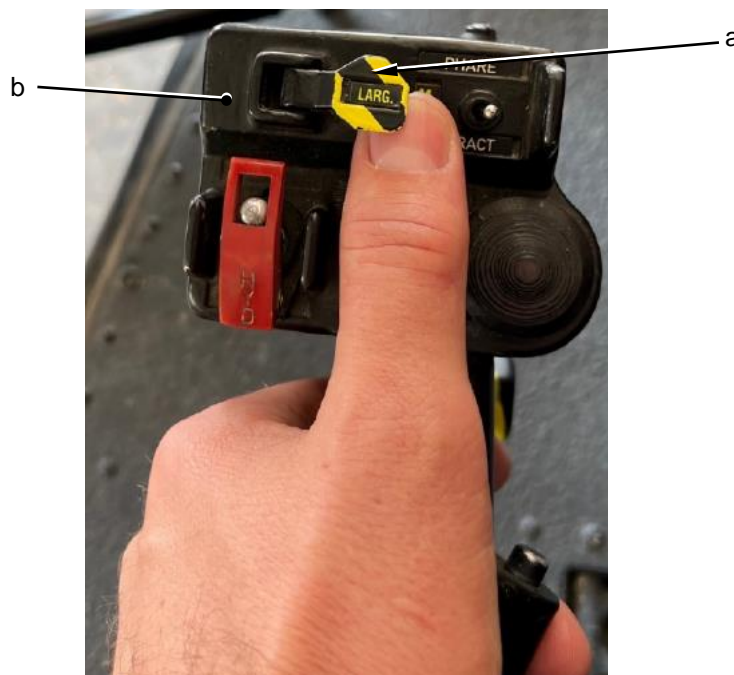
Figure 5 - Position of the thumb

- Put the thumb below the safety-cap (a) of the collective pitch handle (b), refer to Figure 5.

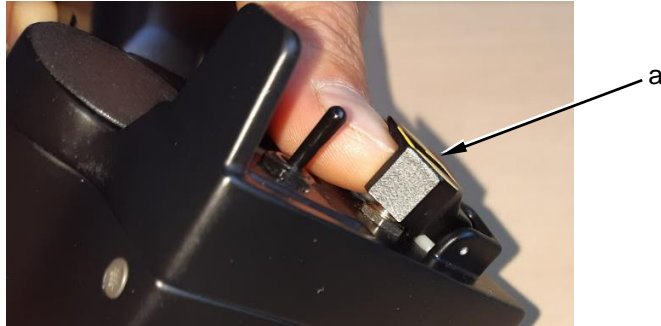
Figure 6 - Step1

- Do the steps that follow to do the check of the safety-cap (a):
 - . Put the thumb below the safety-cap (a).
 - . Lift the safety-cap (a) with your thumb, refer to Figure 6.
 - . Remove the thumb.
 - . Make sure that the safety-cap (a) go back to the fully closed position or move to the fully open position.
 - . If necessary close the safety-cap (a).

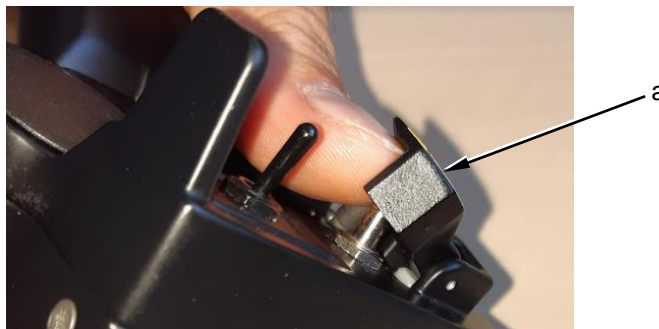
Figure 7 - Step2

- . Put the thumb below the safety-cap (a).
- . Lift the safety-cap (a) with your thumb, refer to Figure 7.
- . Remove the thumb.
- . Make sure that the safety-cap (a) goes back to the fully closed position or moves to the fully open position.
- . If necessary close the safety-cap (a).

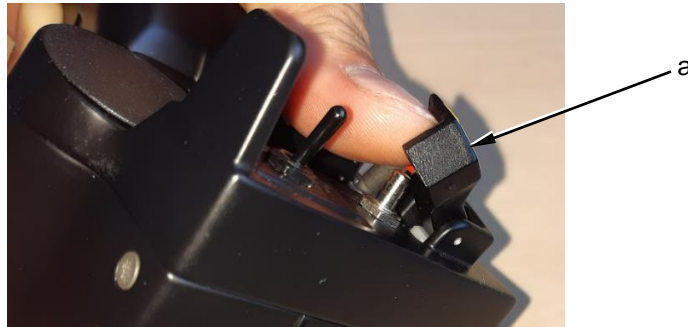
Figure 8 - Step3

- . Put the thumb below the safety-cap (a).
- . Lift the safety-cap (a) with your thumb, refer to Figure 8.
- . Remove the thumb.
- . Make sure that the safety-cap (a) goes back to the fully closed position or moves to the fully open position.
- . If necessary close the safety-cap (a).
