# DISCREPANCY REPORT

AIRCRAFT TYPE A109E REG. NO. M-BOB DR. NO. 1940, BOB

BT 109EP-128 REV C DTD 26.5.2015: INSP OF GLEASON CROWN  
P/N 101-0403-07-103 (PART 1) - REFER E1 109.0009/BOB.

TITLE: INSPECTION OF GLEASON CROWN P/N 109-0403-07-103 - PART I

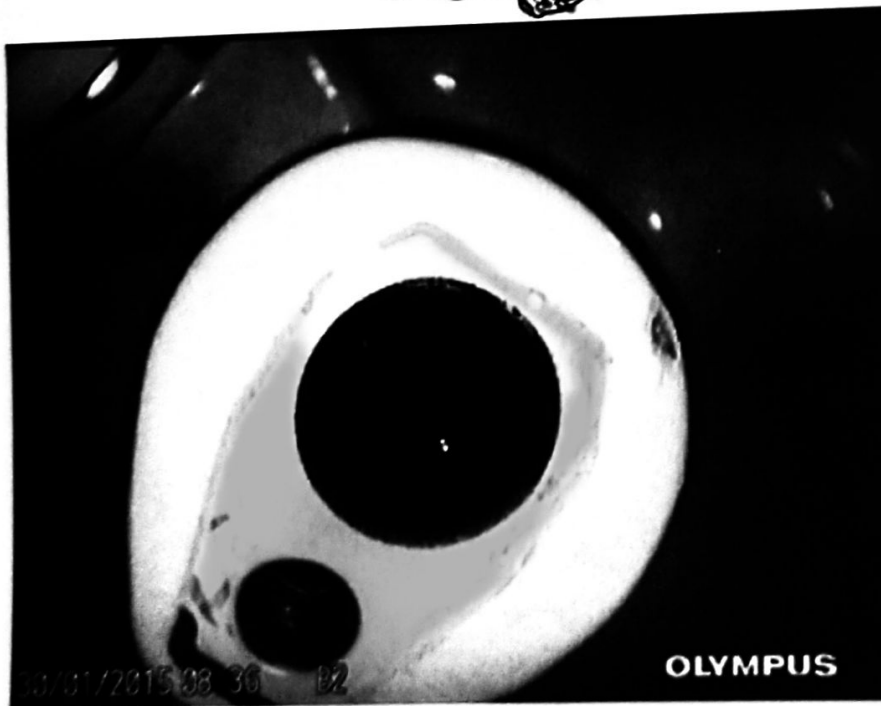
**FIGURE 2**

4. Inspect the Gleason Crown as follows:  4.1. Insert an endoscope in the oil jet P/N DPN09Q-63005 hole (See Figure 2). 4.2. Once inside the transmission, turn right with a reference to Figure 3. 4.3. Insert the boroscope inside the hole shown in the Figure 4. 4.4. Verify if the Gleason Crown is Welded or Bolted with a reference to Figure 5.  <u>'WELDED GLEASON CROWN'</u>	Sgt.	A/C 465 ASB	QAP 949 ASB Muel	}

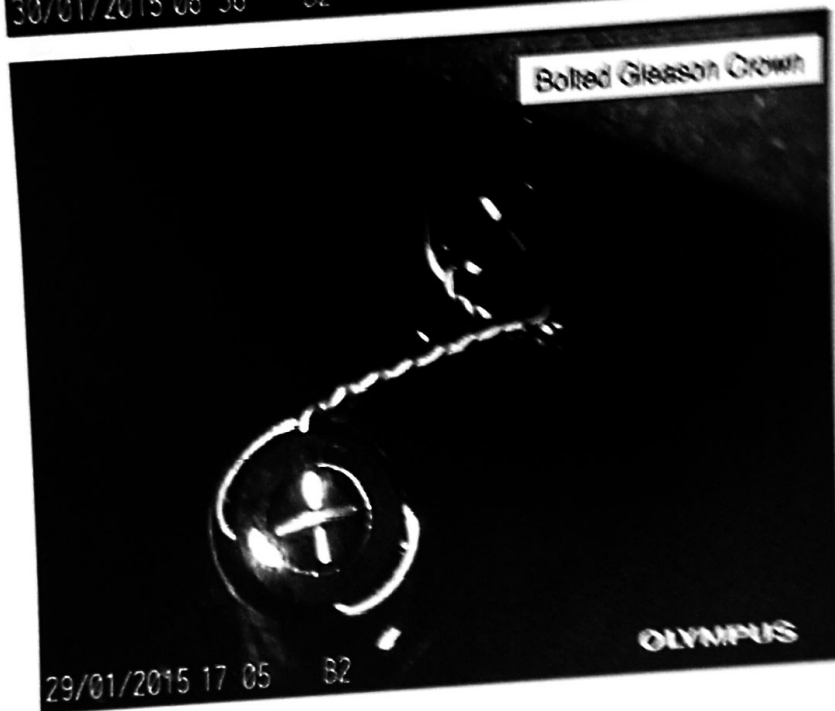
**FIGURE 5**

BT 109EP-128 REV. C DTD 26.5.2015 -  
INSP OF GLEASON CROWN (OUT AND  
COMPLETED AND FOUND SATISFACTORY  
(WELDED TYPE OF GLEASON CROWN AND  
NIL CRACK FOUND)

3.3. If it's not possible to determine the Gleason Crown P/N, perform the inspection described in the Annex 2.				
3.3.1. If the Gleason Crown is Welded (ref. Figure 5 of Annex 2) go to step 4.	SAT.	A/C 465 ASB	QAP 949 ASB M	}

3.3.2. If the Gleason Crown is Bolted (ref. Figure 5 of Annex 2), perform the Part II <sup>A</sup> of this Bollettino Tecnico, in accordance with the scheduling defined in the paragraph "Compliance".	SAT.	A/C 465 ASB	QAP 949 ASB M
