Multi-Engine Turboprop Communiqué

Communiqué ME-TP-0029
January 2022

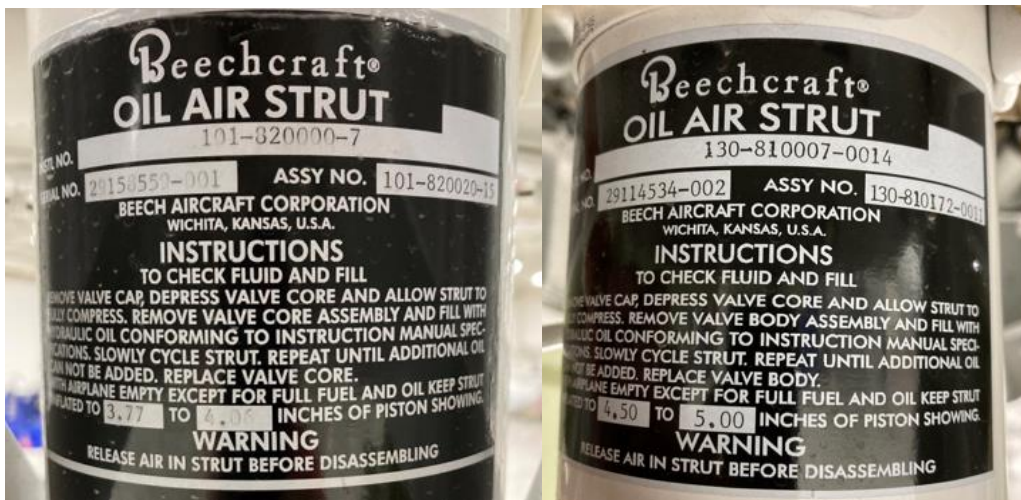
NLG placard example

MLG placard example

The landing gear are serviced during installation and any time that there is an in-service leak or anomaly causing a collapsed strut. The service instructions are found within Chapter 12 of the appropriate Maintenance Manual. All landing gear have an identification placard on the back of the gear brace. For example, the B300/B300C MLG placard is part number 101-810085-1, or later and the NLG is P/N 101-820027-1, or later. These placards have nomenclature on them that shows they are inflated to XXX to XXX inches of piston showing.

These placards are not intended for preflight inspection limits, they are to be used only by the maintainer servicing the gear.

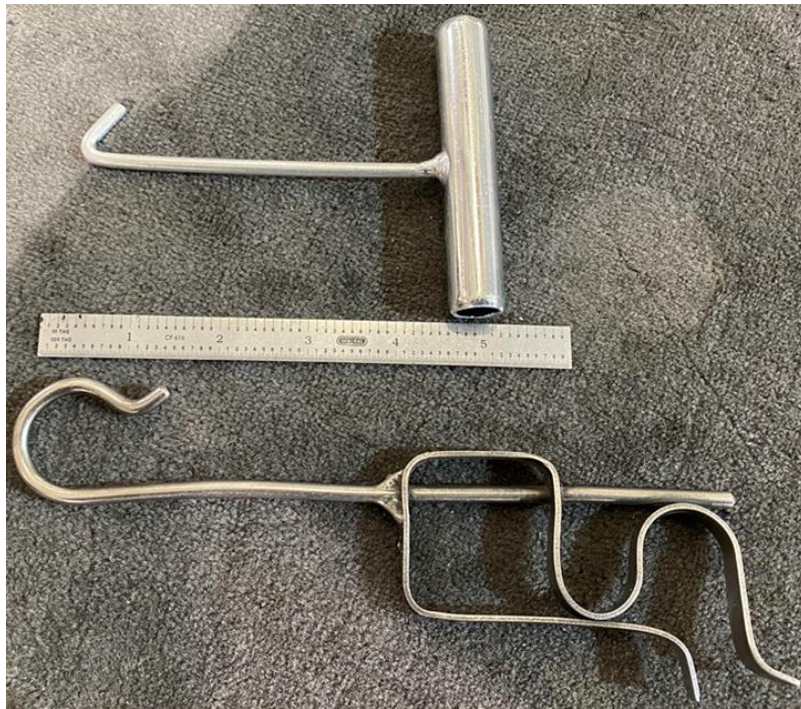
The cabin doorstep retract mechanism uses a very strong spring in the system, which is very difficult to install. A question has been asked what is used in the assembly line to install this spring. The picture below shows two tools that are used in the assembly line. These tools are shop aids and do not have a part number, nor are they available to purchase. The picture can be used as a guide for you to come up with your own. The first tool shown is commercially available, intended for trampoline spring installations.

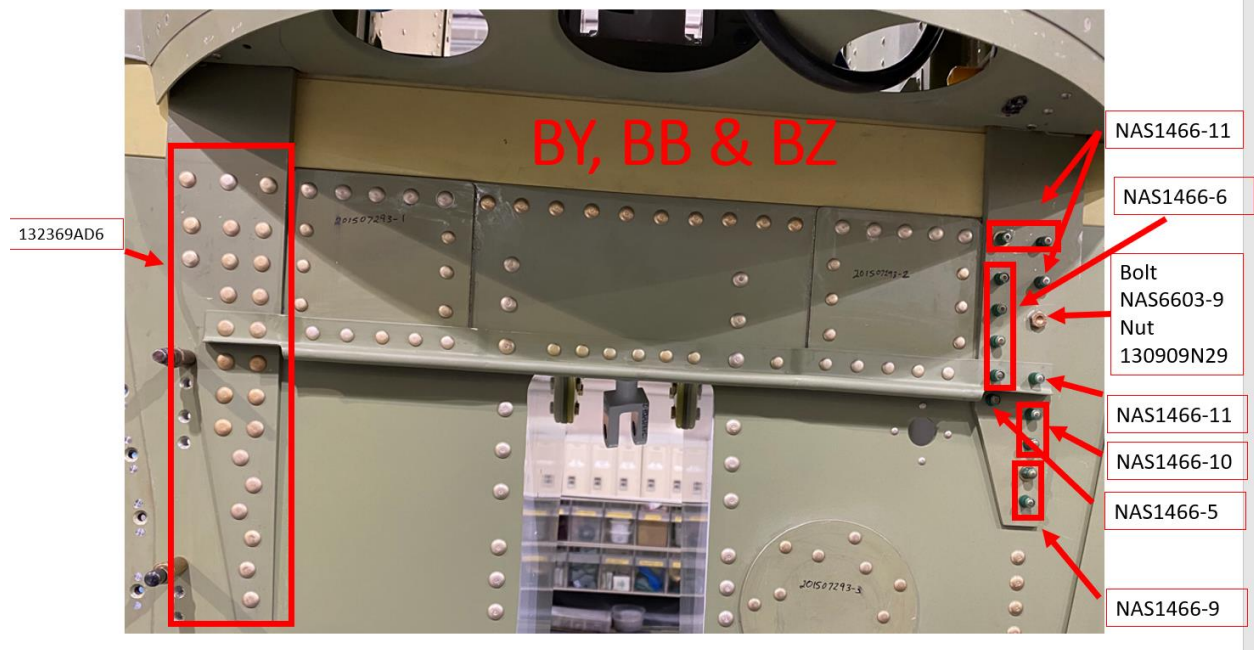
The nacelle splice plates are installed on the airplane using various fasteners that should be noted by the mechanic when they are removed, so that replacement part numbers match the type design of the airplane as shown below. For the King Air models not listed in the effectivity above, refer to the King Air Structural and Inspection Repair Manual. The use of other fasteners not called out will have to be approved by Textron Aviation Engineering via the Structures Team prior to use.

* length to be determined during installation
