## Main Rotor swashplate duplex bearing installation inspection

## Annex A

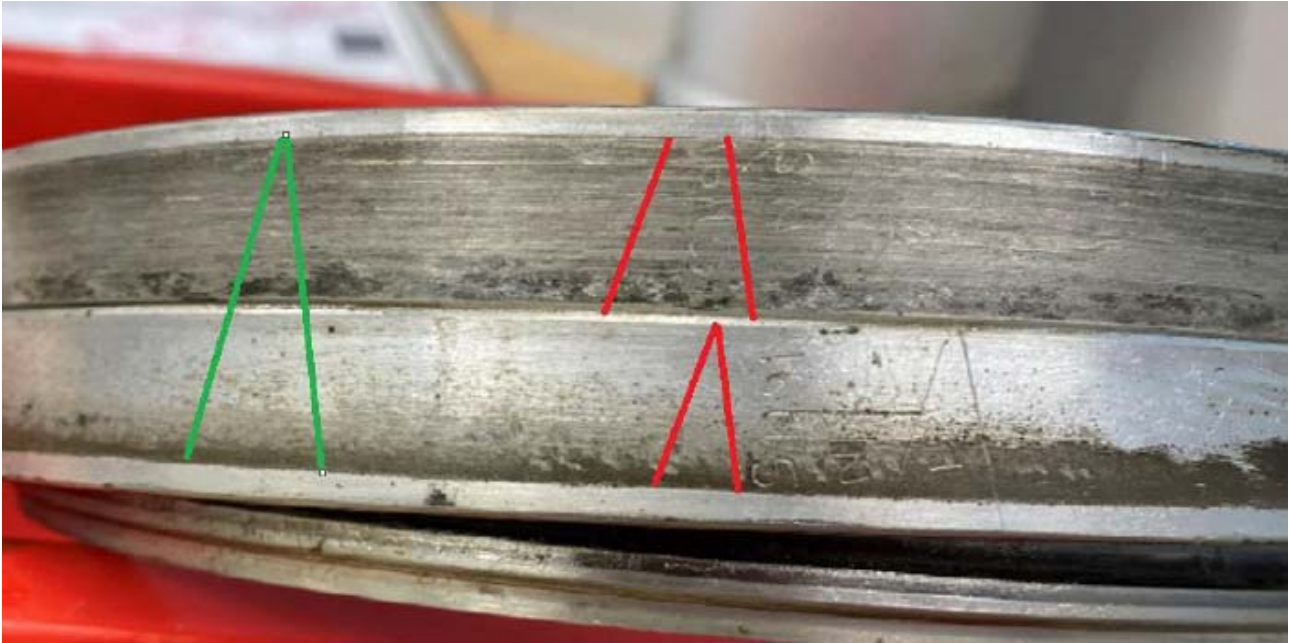
The design data for the swashplate duplex bearing P/N 109-0110-35-3 shows a “V” etched into the upper and lower races to facilitate the correct alignment of the two halves of the bearing.

- Red lines illustrate incorrect duplex bearing alignment.
- Green lines illustrate correct alignment per design.
