## **TECHNICAL BULLETIN**

**429-21-65**

**MODEL AFFECTED:** 429

**SUBJECT:** MISSING DECALS ON FIREWALL 429-069-101-187, INSPECTION AND INSTALLATION OF

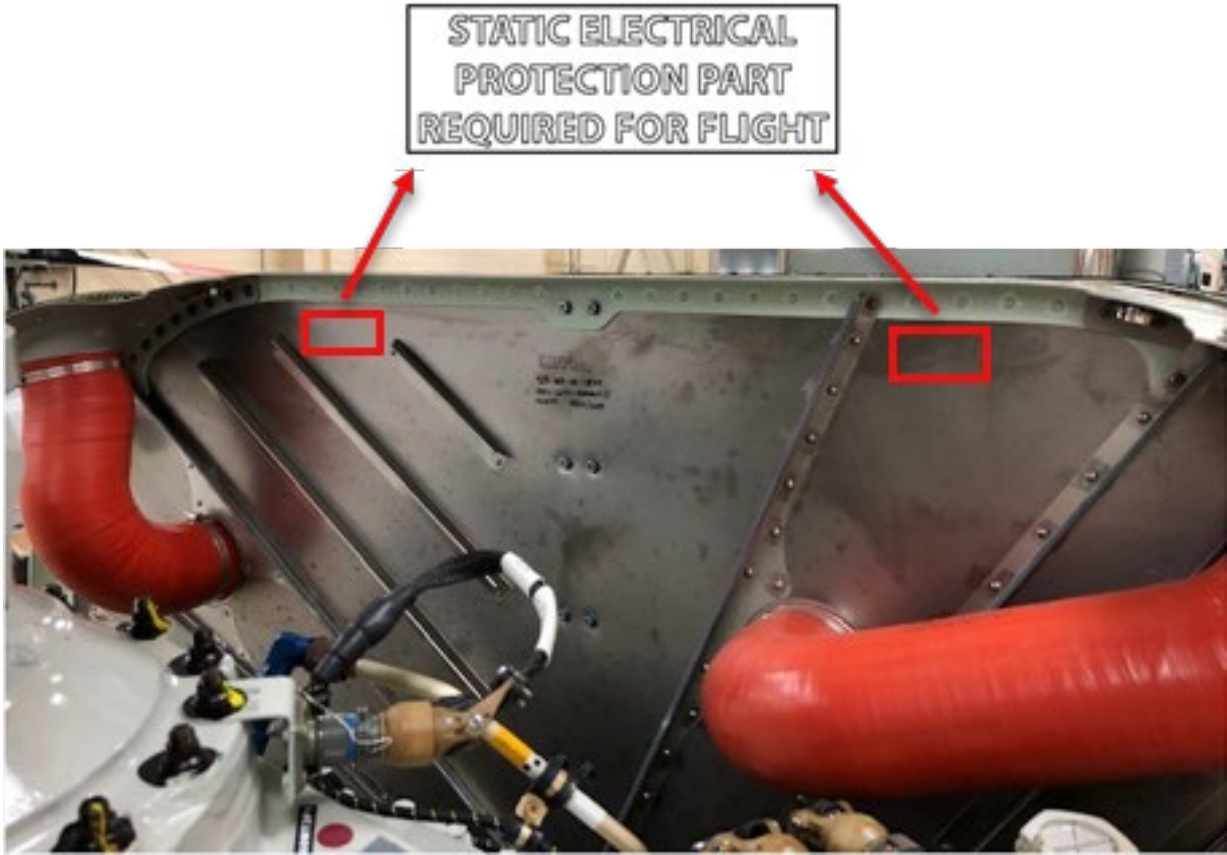
**Figure 1 –Missing Decal on Forward Firewall**

Bell recently discovered that two decals 31-055-19DMHP may have been inadvertently omitted from the forward firewall 429-069-101-187 during manufacturing. This Technical Bulletin (TB) provides procedures to inspect for the required decals and install if missing. The purpose of these decals is to remind operators that access panels 429-061-201-101 and -103 are static electrical protection parts and are required for flight. The approved engineering configuration requires these decals to be installed on the adjacent structure of the access panels, which is the subject firewall.

1. Prepare the helicopter for maintenance.
2. Remove the transmission cowl assembly 600EL and 600ER. (DMC-429-A-53-00-00-46A-520A-A)
3. Check for the presence of two decals 31-055-19DMHP on the forward firewall 429-069-101-187 per figure 1. If the decals are present, go to step 5.

Locations of the decals are shown in figure 1. They need to be clearly visible after installation. The receiving surface must be free of dirt, grease, wax and other contaminants.

4. Install two decals onto the forward firewall 429-069-101-187. (DMC-429-A-11-00-00-00A-067A-A)
5. Reinstall the transmission cowl assembly 600EL and 600ER. (DMC-429-A-53-00-00-46A-520A-A)
6. Make an entry in the helicopter logbook and historical service records indicating compliance with this Technical Bulletin.
