SAFETY INFORMATION NOTICE

SUBJECT: ELECTRICAL POWER

Information about Fuses and Fuse Holders potentially containing Asbestos Material

No. 3700-S-24

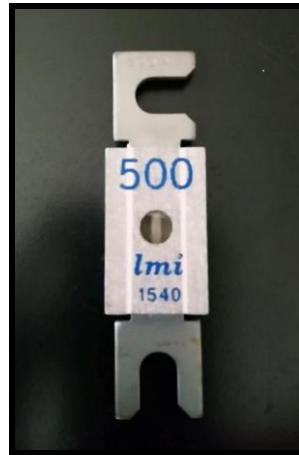
Fig. 1 - Example of a 58550-500A fuse

Airbus Helicopters has been informed by one of its Customer that at least one fuse ref. 58550-XXXX (refer to figure 1) fitted on an airplane is containing Asbestos material. This family of fuses ranging from 40 to 600 amps is mainly used to protect devices or systems with high level of electrical power consumption. These fuses can also be identified in Airbus Helicopters technical documentation through alternative references (where XXX is indicating the fuse amp rating):

Airbus Helicopters performed laboratory analysis on fuses ref. 58550-XXXX and confirms that some of these fuses (ref. 58550-XXXX) contain Asbestos material.

Nevertheless fuse Supplier confirmed that fuses produced after January 01st, 1997 do not contain Asbestos. Therefore, by reading the fuse production batch date code marked on the fuse body it is possible to determine whether the fuse is impacted or not. There are two different types of marking available to identify the production batch:

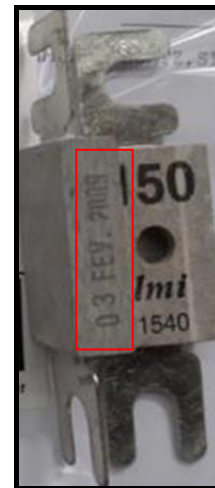
Fig. 2b - Side Date Code (03 FEB. 2009)

- On fuse face using following marking standard: YY-WW (year-week - refer to Fig. 2a)
- On fuse side using following marking standard: DD MMM YYYY (day-month-year - refer to Fig. 2b).

However, production batch markings (date code) has been introduced recently thus limiting the capacity of identification. In case, the fuse body would not show any date code marking, the fuse shall be considered as potentially containing Asbestos.

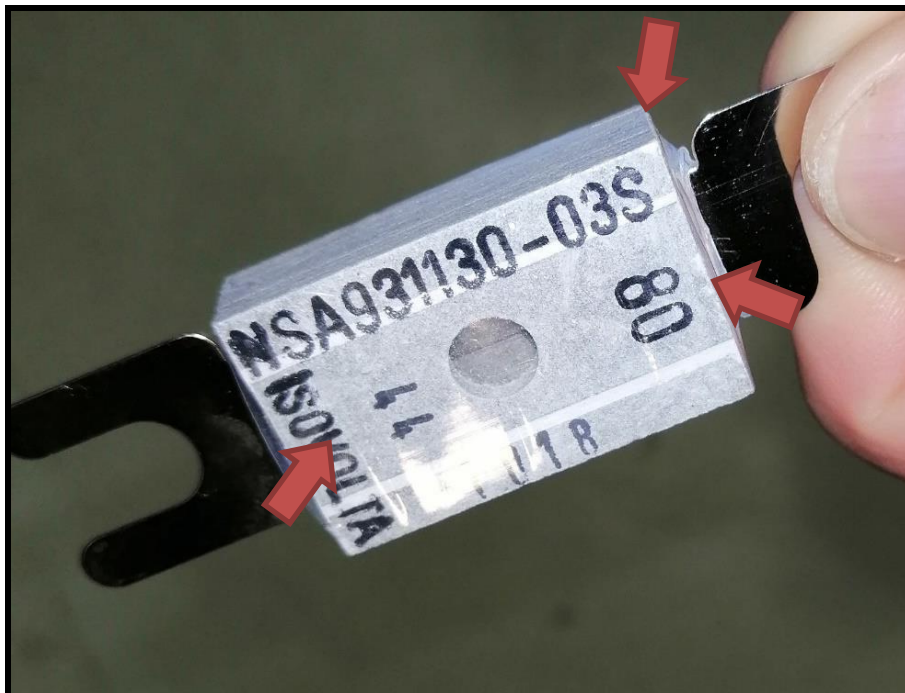
Fig. 3 - Example of a ECS0856-03S fuse (arrows showing the protection sleeve)

For information, some helicopters have been fitted with an alternative fuse reference (ref. ECS0856-XXS - refer to Figure 3). This alternative reference (ECS0856-XXS) does not contain Asbestos material and can be easily identified as the fuse main body is wrapped into a transparent thermos retractable sleeve (see Figure 3 below). The previous generation of fuses (58550-XXXX) do not integrate this thermo retractable sleeve feature.

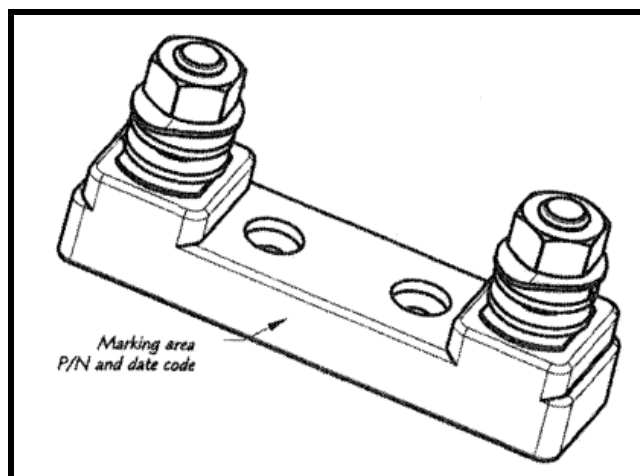
Fig. 4 - Fuse Holder ECS0858-XXX marking location

Then, with respect to the fuse holders, some helicopters may have been fitted with an alternative reference (ref: ECS0858-XXX). This alternative fuse holder does not contain Asbestos material and can be identified by looking directly at the fuse holder base plate, as a specific marking recalling the fuse holder reference (starting with ECS0858) and the manufacturing batch number is provided.

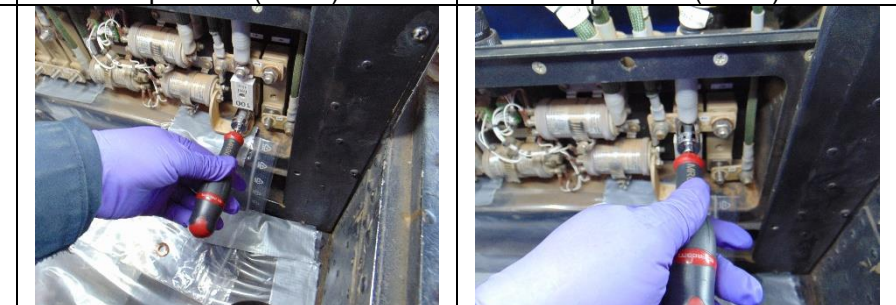
<p>Example of fuses implantation (H225)</p>	<p>Surfaces protection before operation (skin 1)</p>	<p>Surfaces protection before operation (skin 2)</p>

- Carry out the needed dismantling operations to access the fuses according to AMM procedures
- Protect the intervention area using a double skin polyane or similar covering

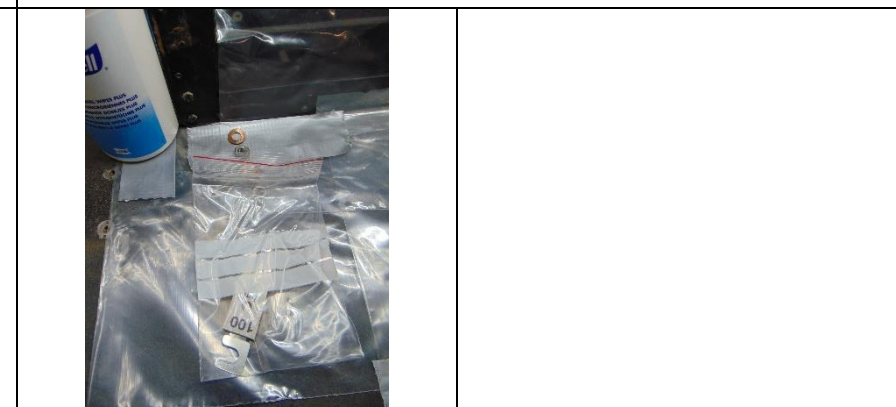
<p>Illustration of tools and individual protections to be used</p>	<p>Fuse disassembly</p>

<p>Used fuse conditioning after disassembly</p>

- Remove the fuses before any other operation (including intervention area cleaning)
- Recover the fuses by an appropriate means and discard them using an adapted depollution channel according to national Environmental regulations

- The operators, must wear in addition to the standard site required personal protection equipment:
 - . Single use FFP3 mask (half disposable FFP3 mask)

- . Single-use gloves made of nitrile or similar material.
