INCREMENTAL CHANGE Release Notification Date: 01/16/2023

SPM 70-33-08 REPLICATION TO IDENTIFY EVIDENCE OF FOREIGN MATERIAL AFTER BLENDING

TASK 70-33-08-220-000

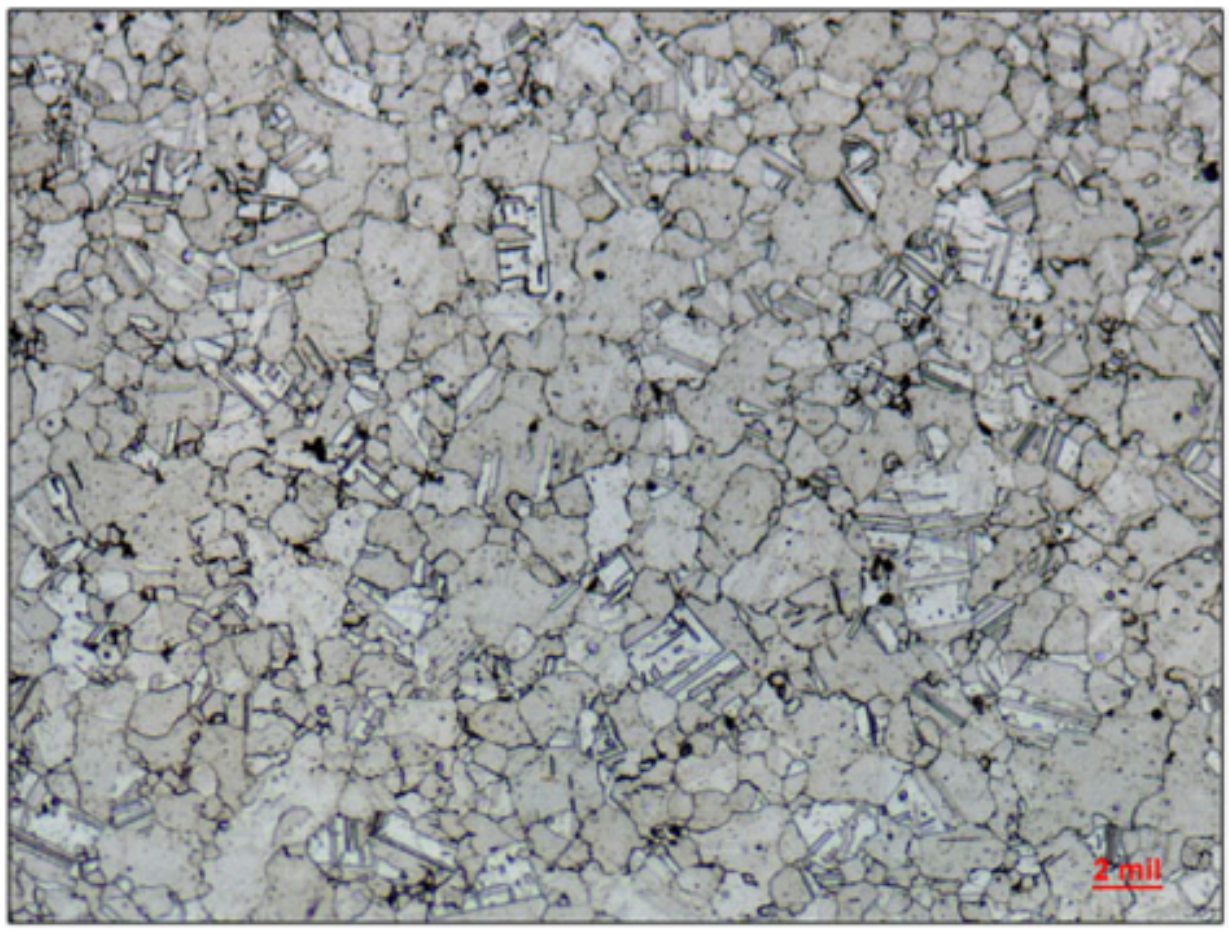
Figure 1 (Sheet 1) Normal Grain Structure from Replication.

NORMAL RENE´88DT
100X MAGNIFICATION

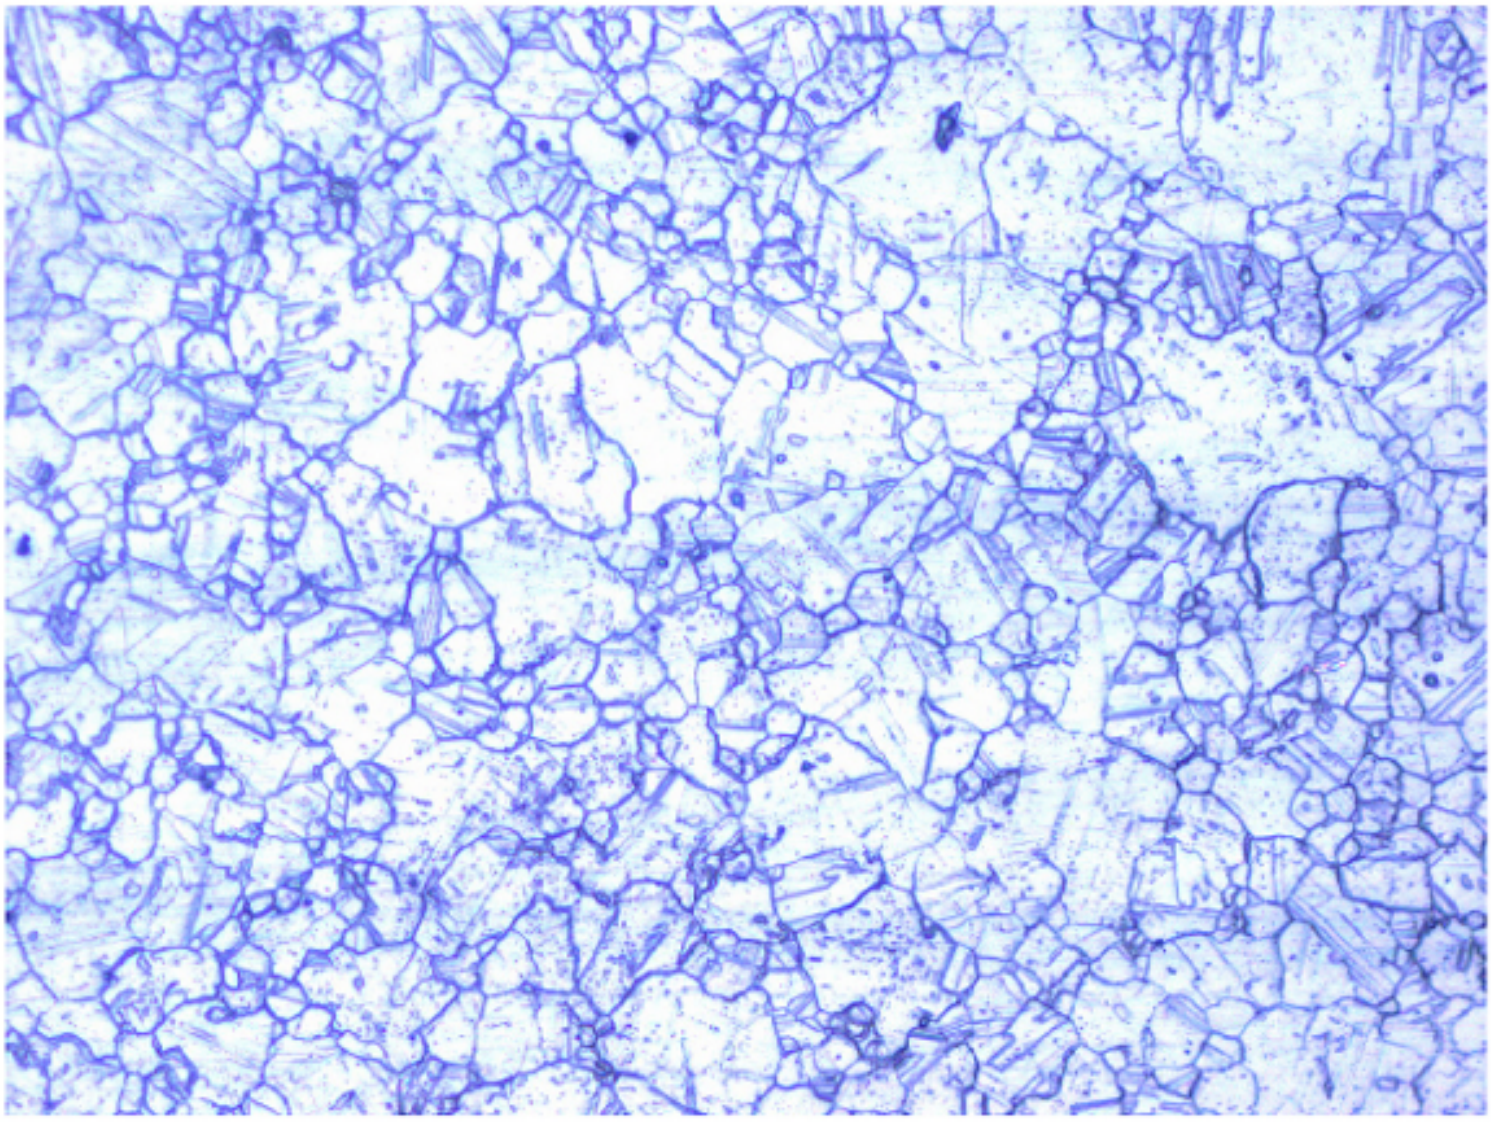
Figure 1 (Sheet 2) Normal Grain Structure from Replication

NORMAL RENE 88DT
200X

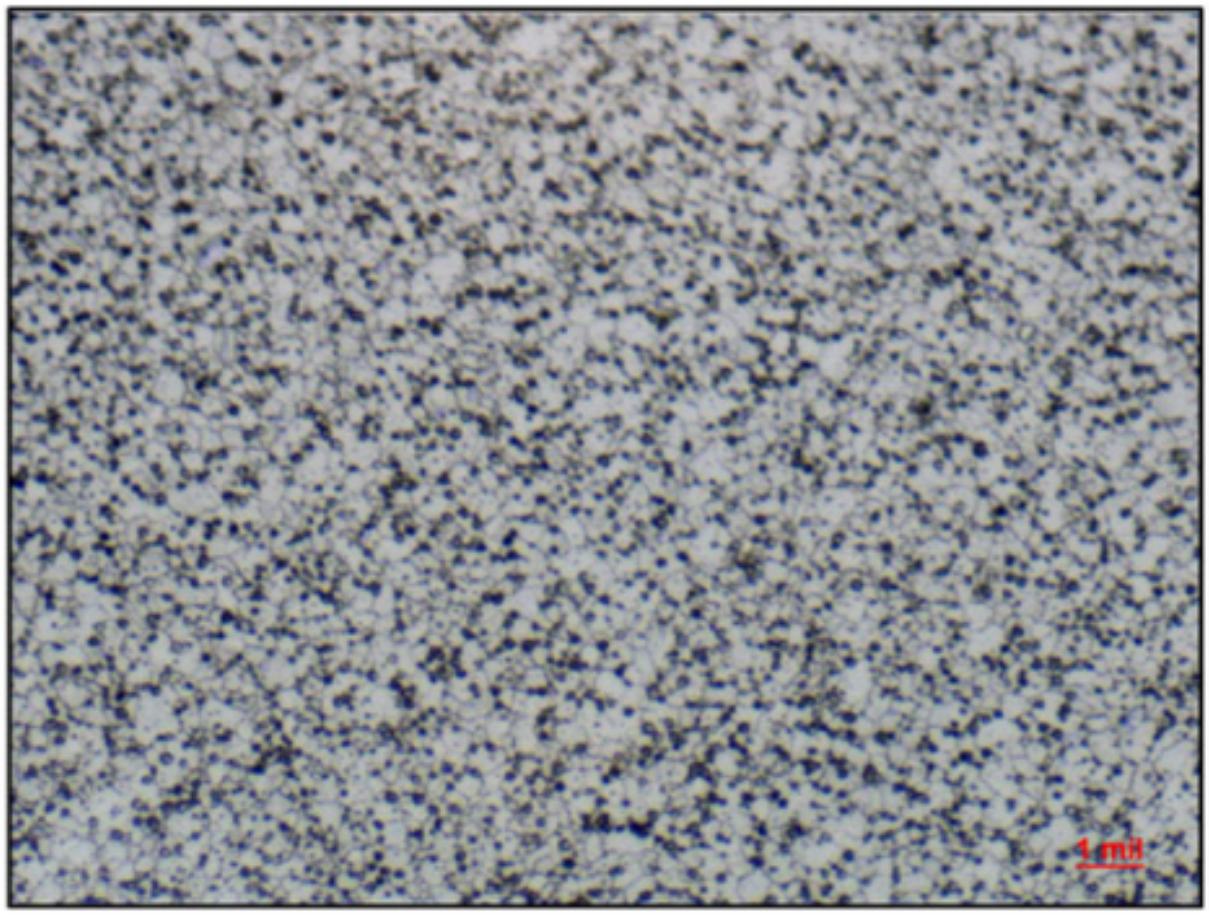
Figure 1 (Sheet 4) Normal Grain Structure from Replication

NORMAL RENE´65
200X MAGNIFICATION

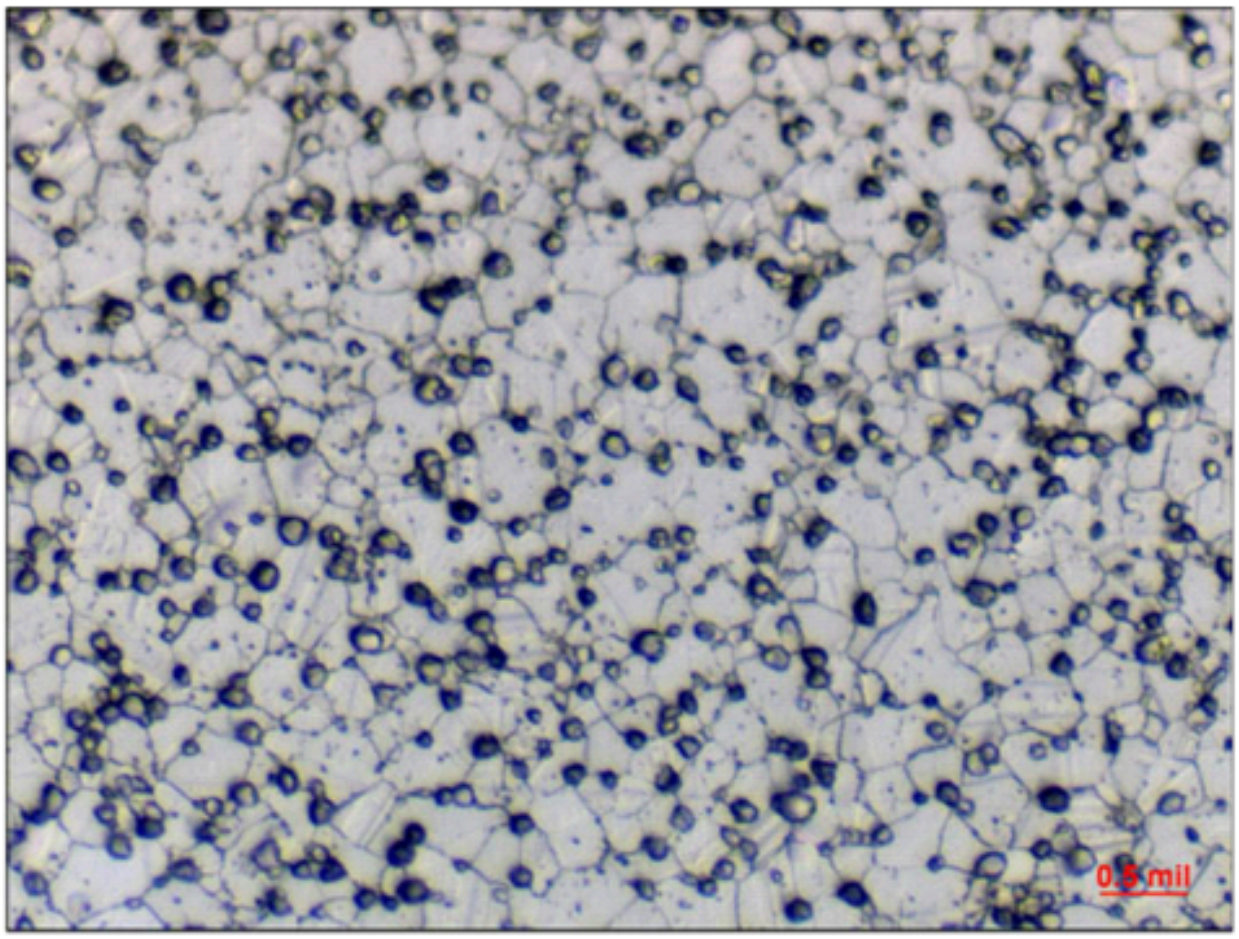
Figure 1 (Sheet 5) Normal Grain Structure from Replication

NORMAL RENE´65
500X MAGNIFICATION

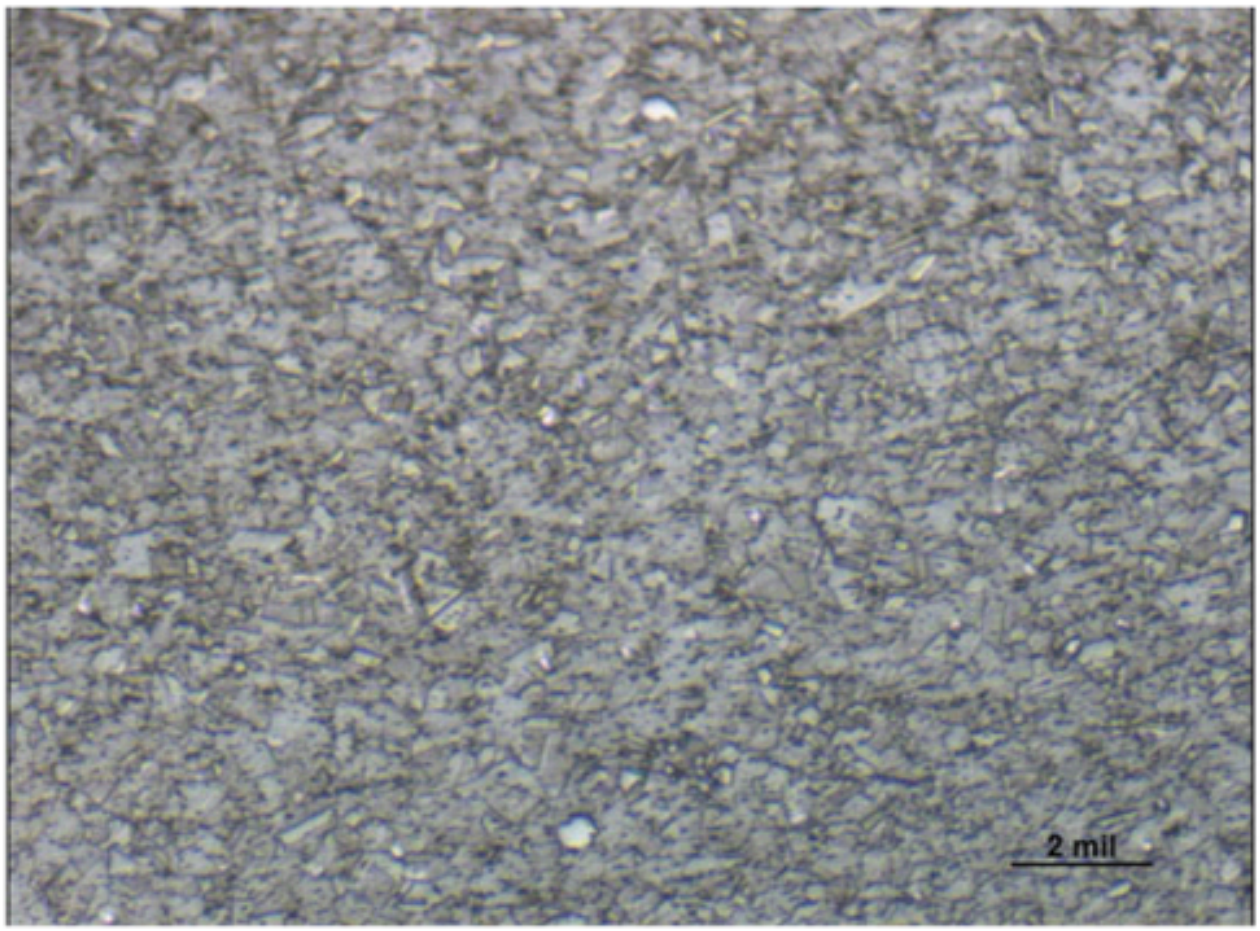
Figure 1 (Sheet 6) Normal Grain Structure from Replication

NORMAL DA718
200X MAGNIFICATION

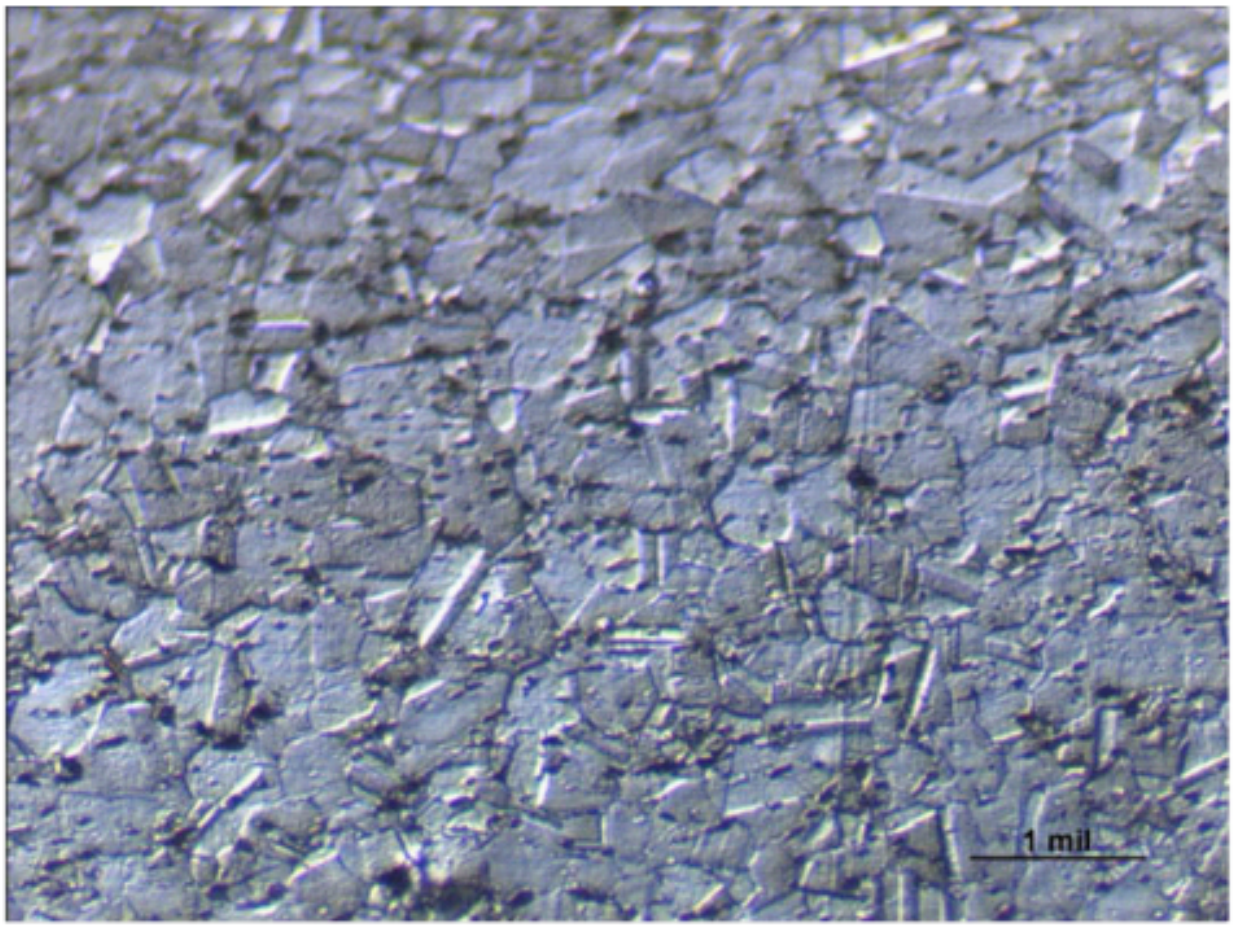
Figure 1 (Sheet 7) Normal Grain Structure from Replication

NORMAL DA718
500X MAGNIFICATION

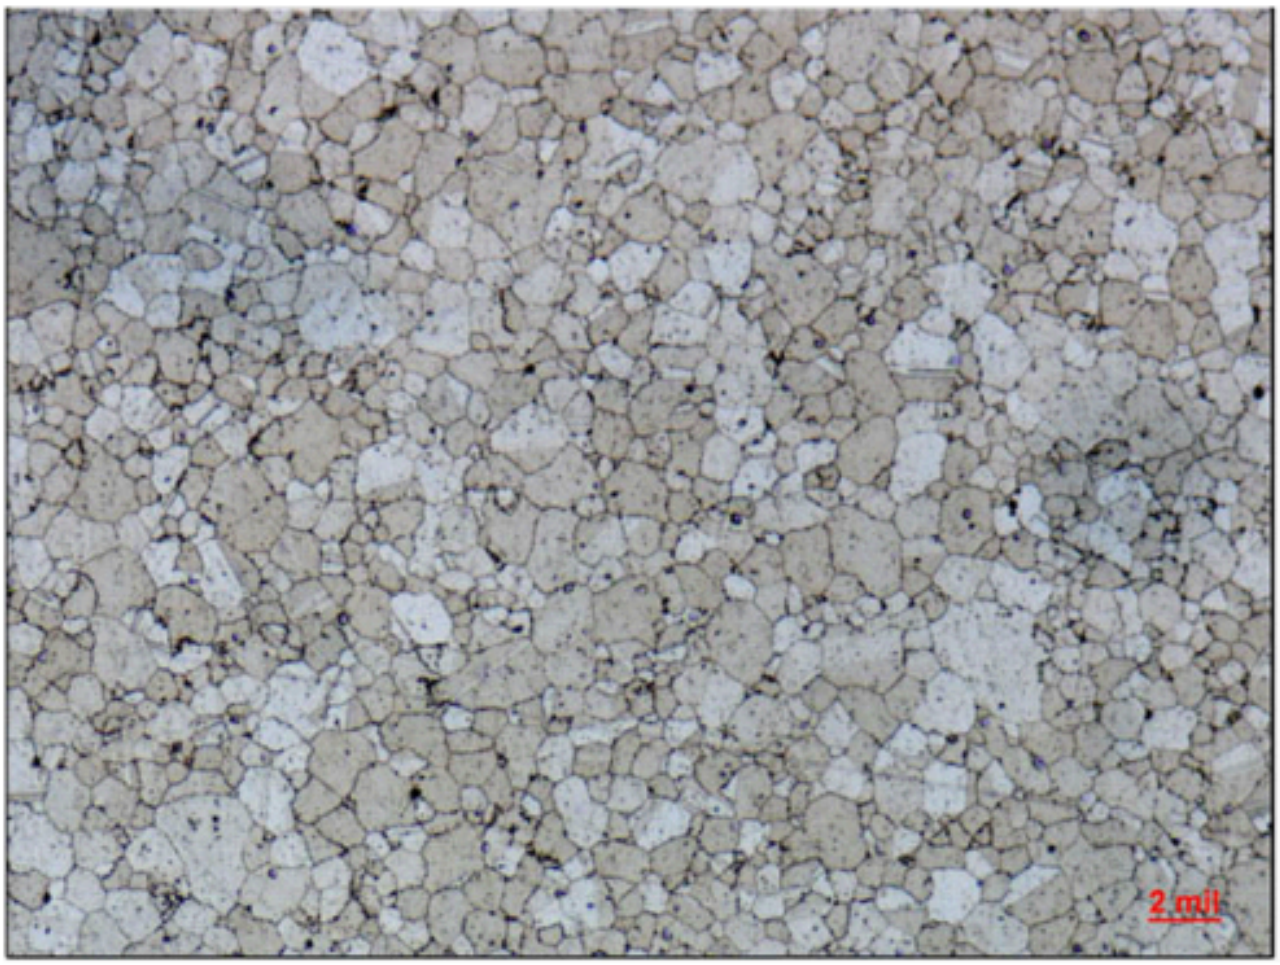
Figure 1 (Sheet 8) Normal Grain Structure from Replication

NORMAL RENE´ 104
100X MAGNIFICATION

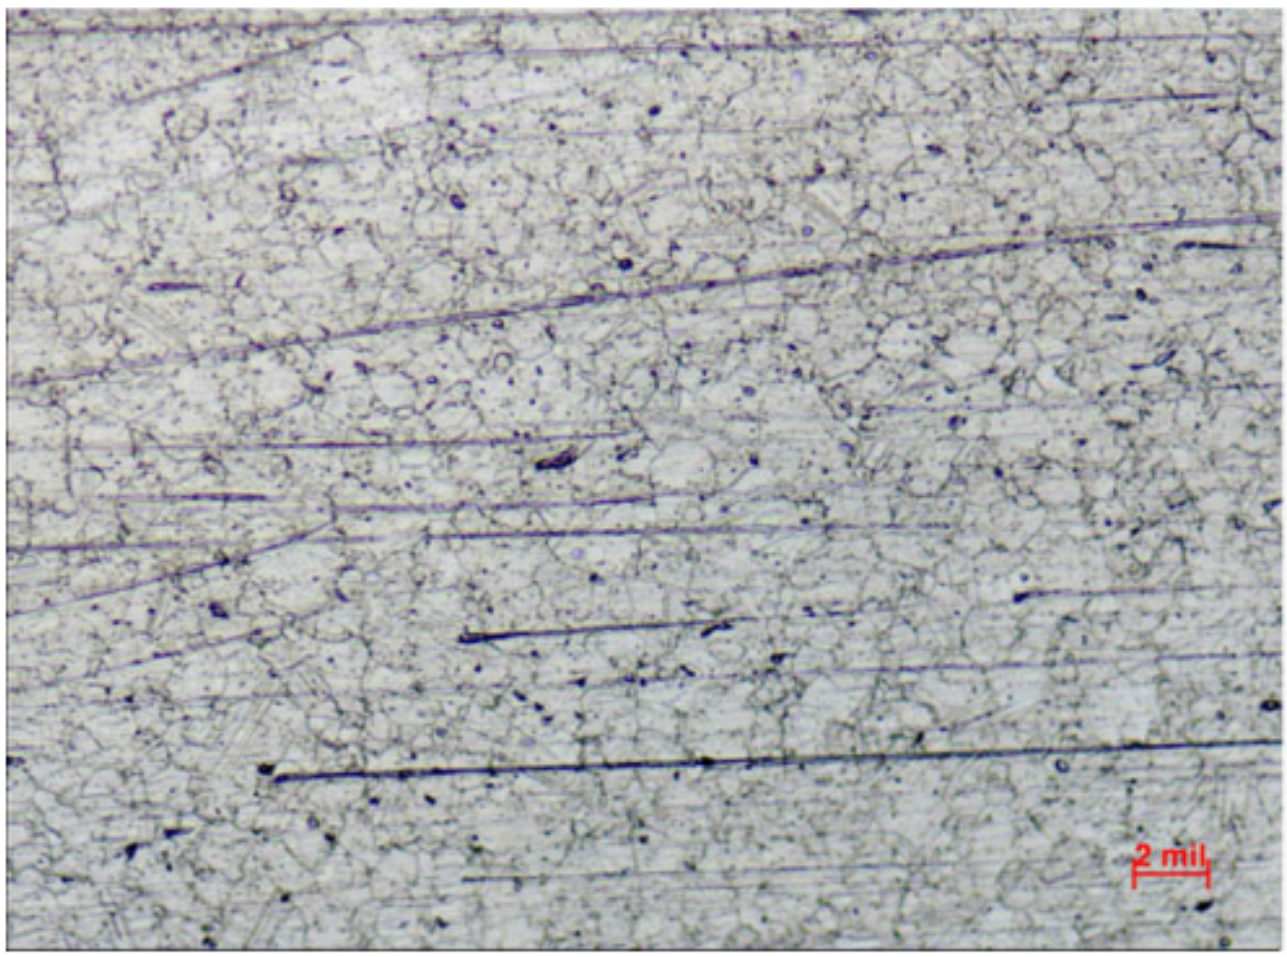
Figure 2 (Sheet 1) Grain Structure from Replication Rene'88DT with Scratches.

(3) Refer to Figure 2 for typical replica defects that are not indicative of foreign material. If these defects are excessive (i.e., they cover more than 1/4 of the replica area and

obscure the normal grain boundary structure of the material) the replica must be made again, or contact GE Engineering for further assessment.

SCRATCHES

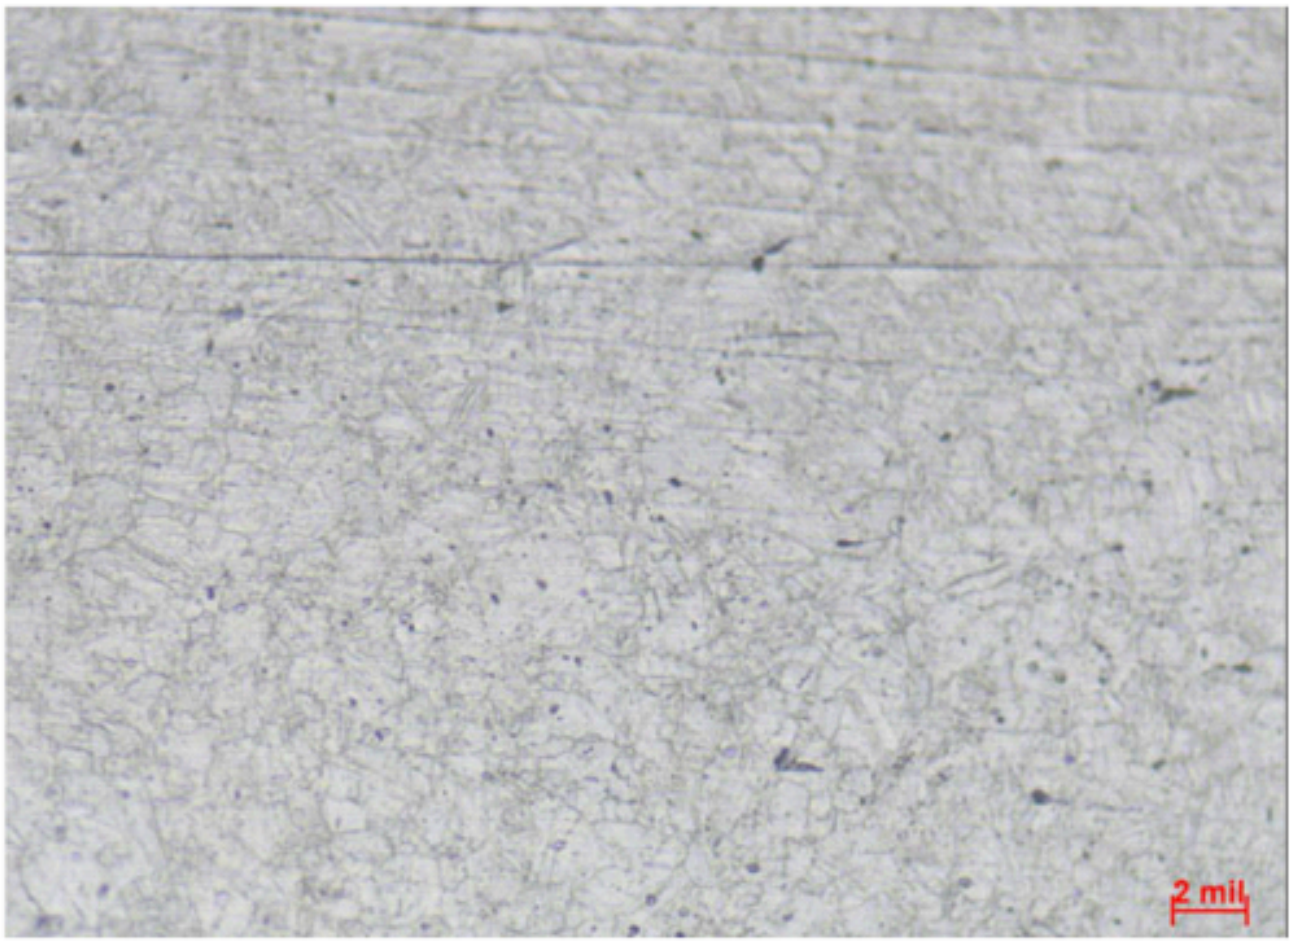
Figure 2 (Sheet 2) Grain Structure from Replication Rene'88DT Under Etched.

UNDER ETCHED

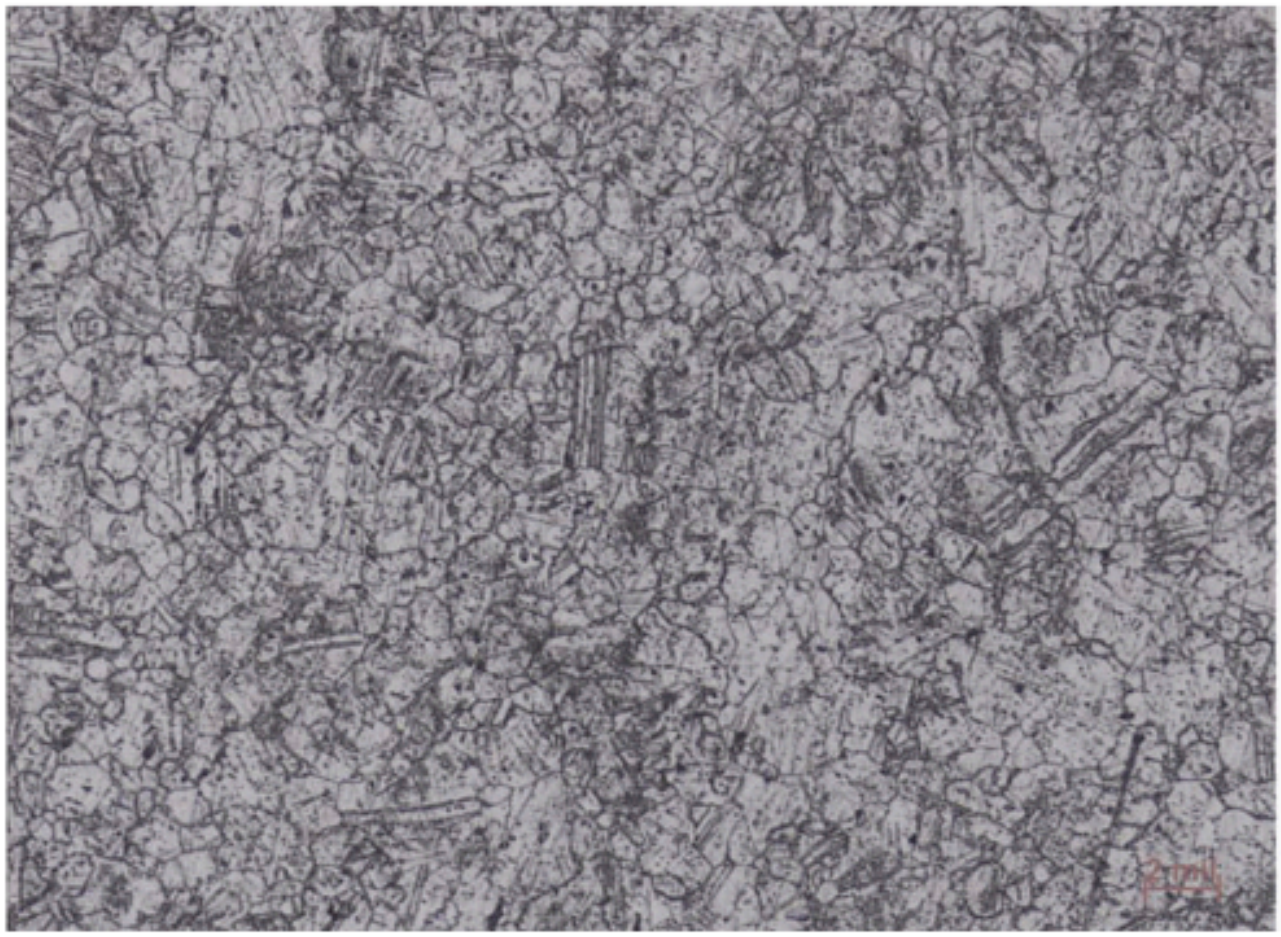
Figure 2 (Sheet 3) Grain Structure from Replication Rene'88DT Over Etched.

(1) Etch the polished area(s) for 60-90 seconds. Pay attention to any dark discoloration in the etched surface (this is a signal that the etchant has been applied too long or there is still evidence of foreign material).

OVER ETCHED

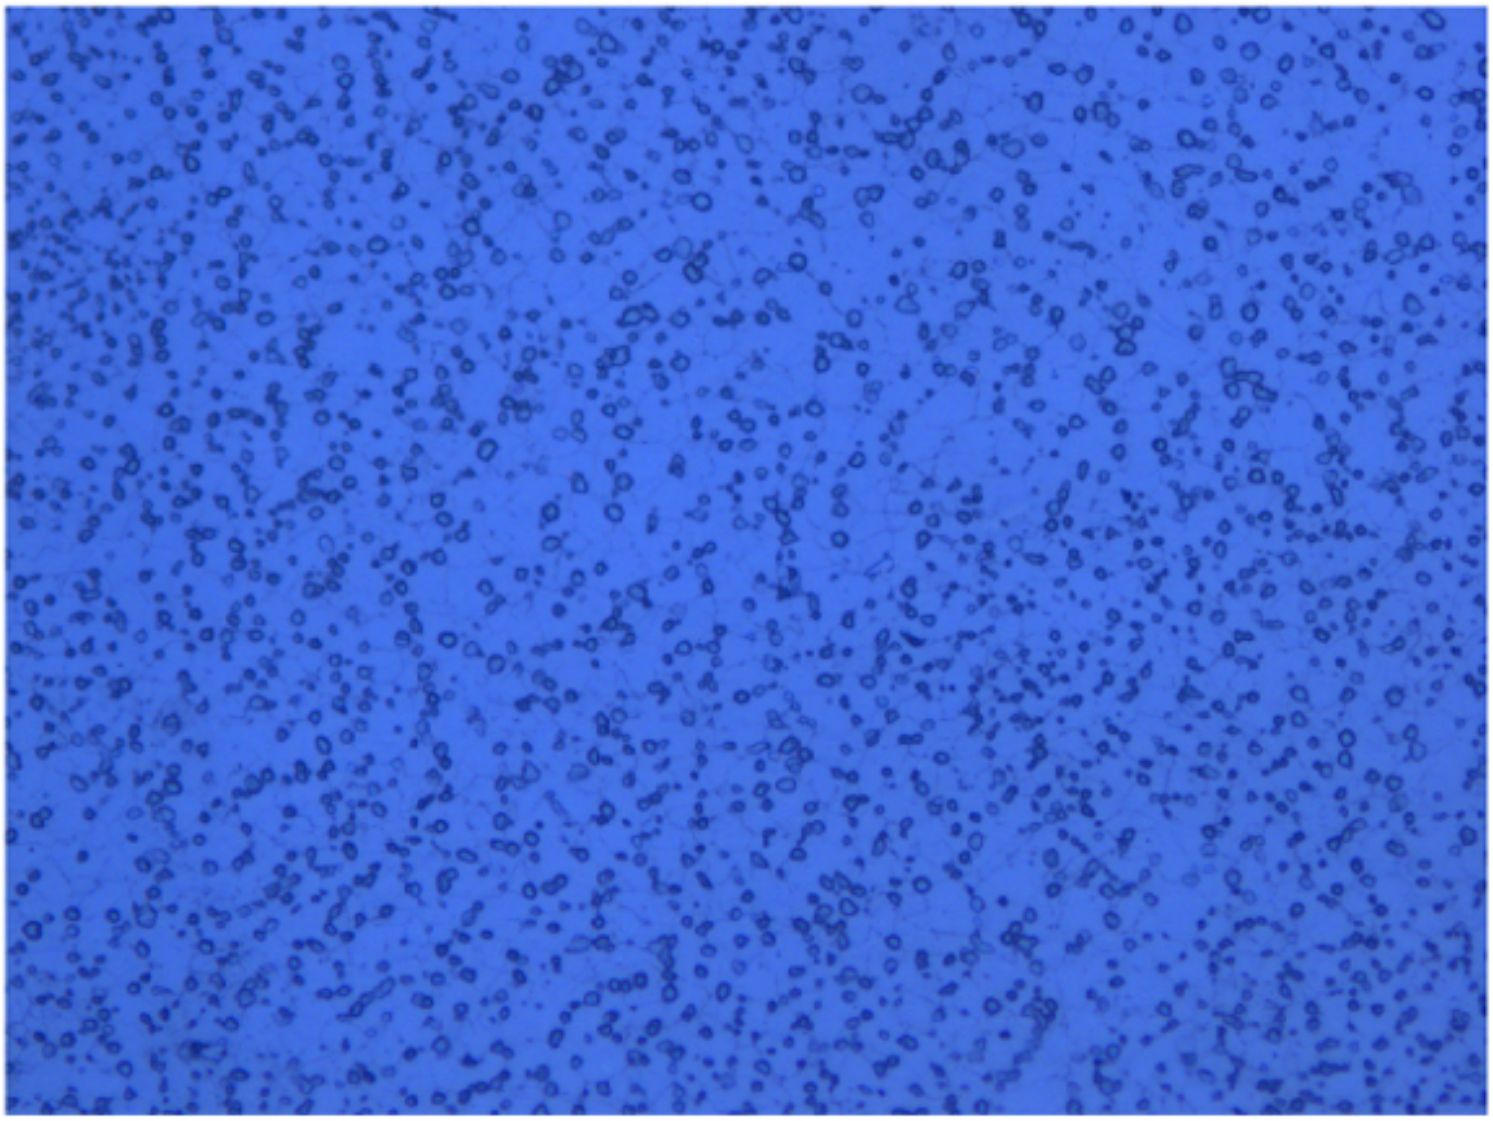
Figure 2 (Sheet 4) Grain Structure from Replication Rene'65 Under Etched

UNDERETCHED
RENE 65

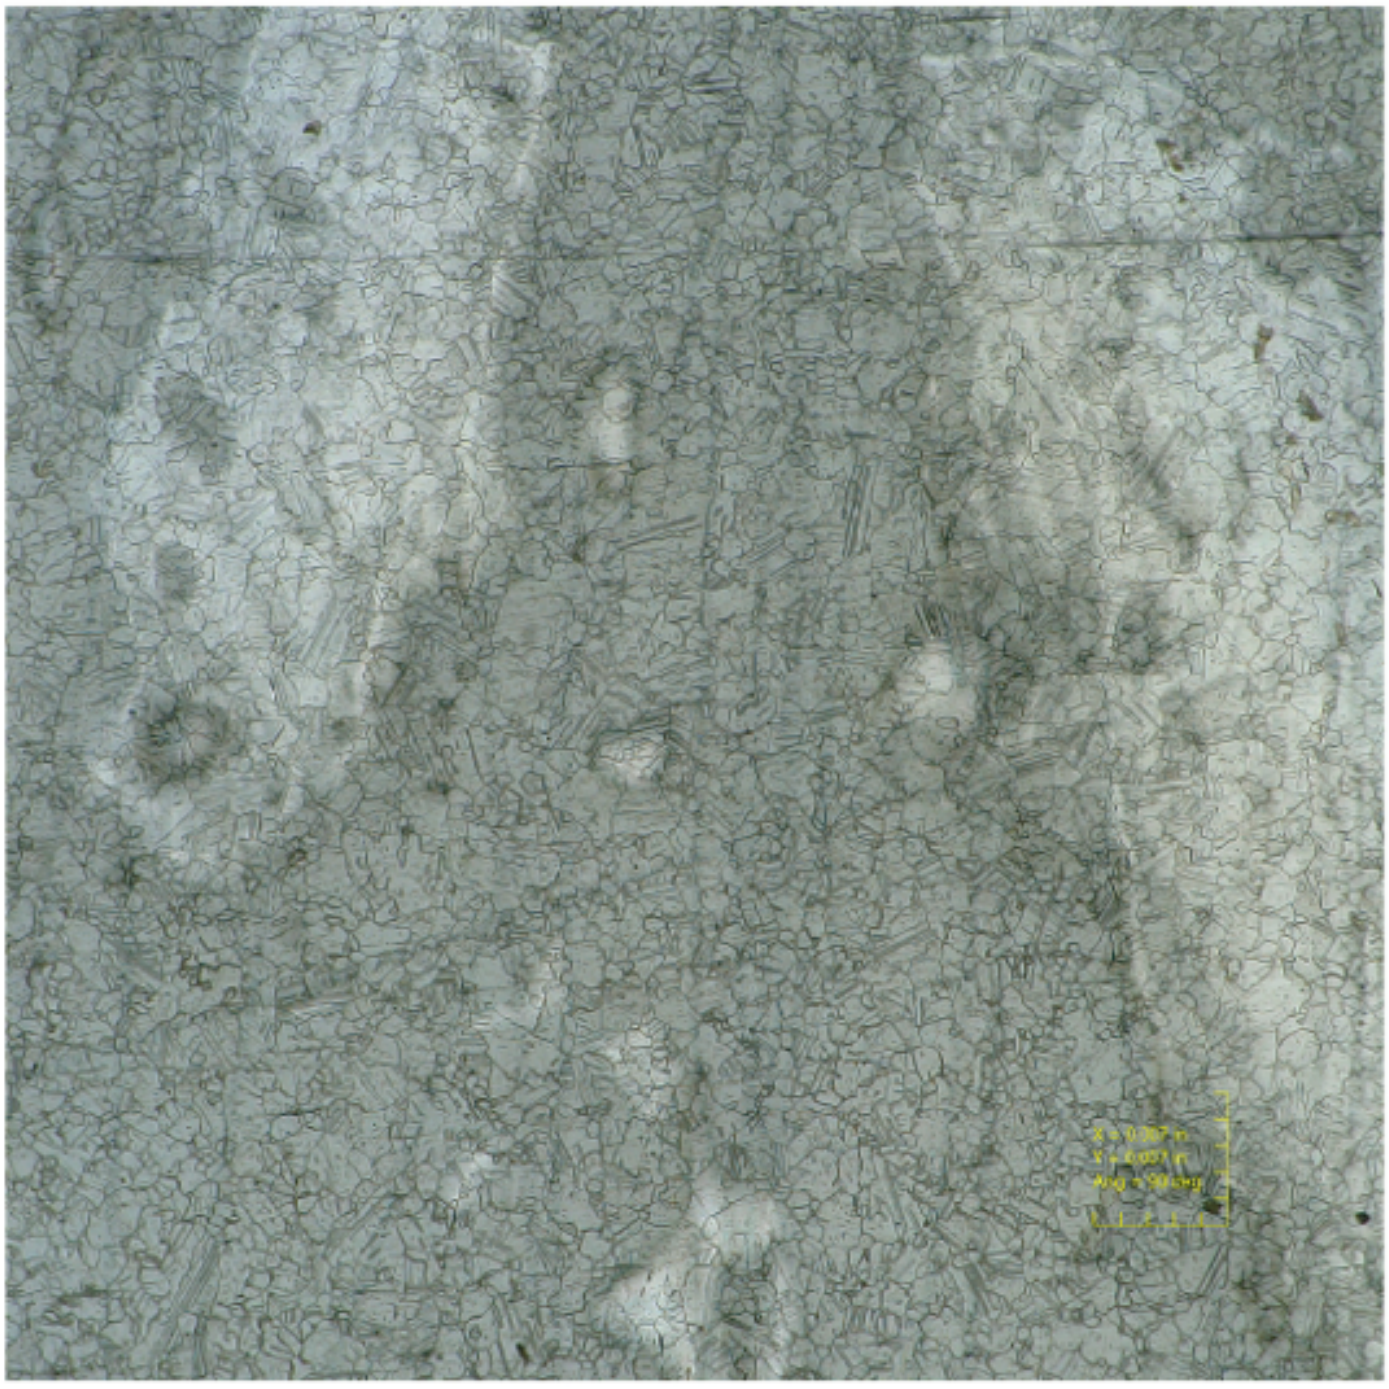
BUBBLE REPLICA DEFECT
RENE 88DT
100X

Figure 2 (Sheet 5) Replica with Region of Replica Tape that is Inadequately Adhered, that Produces a Bubbled Area

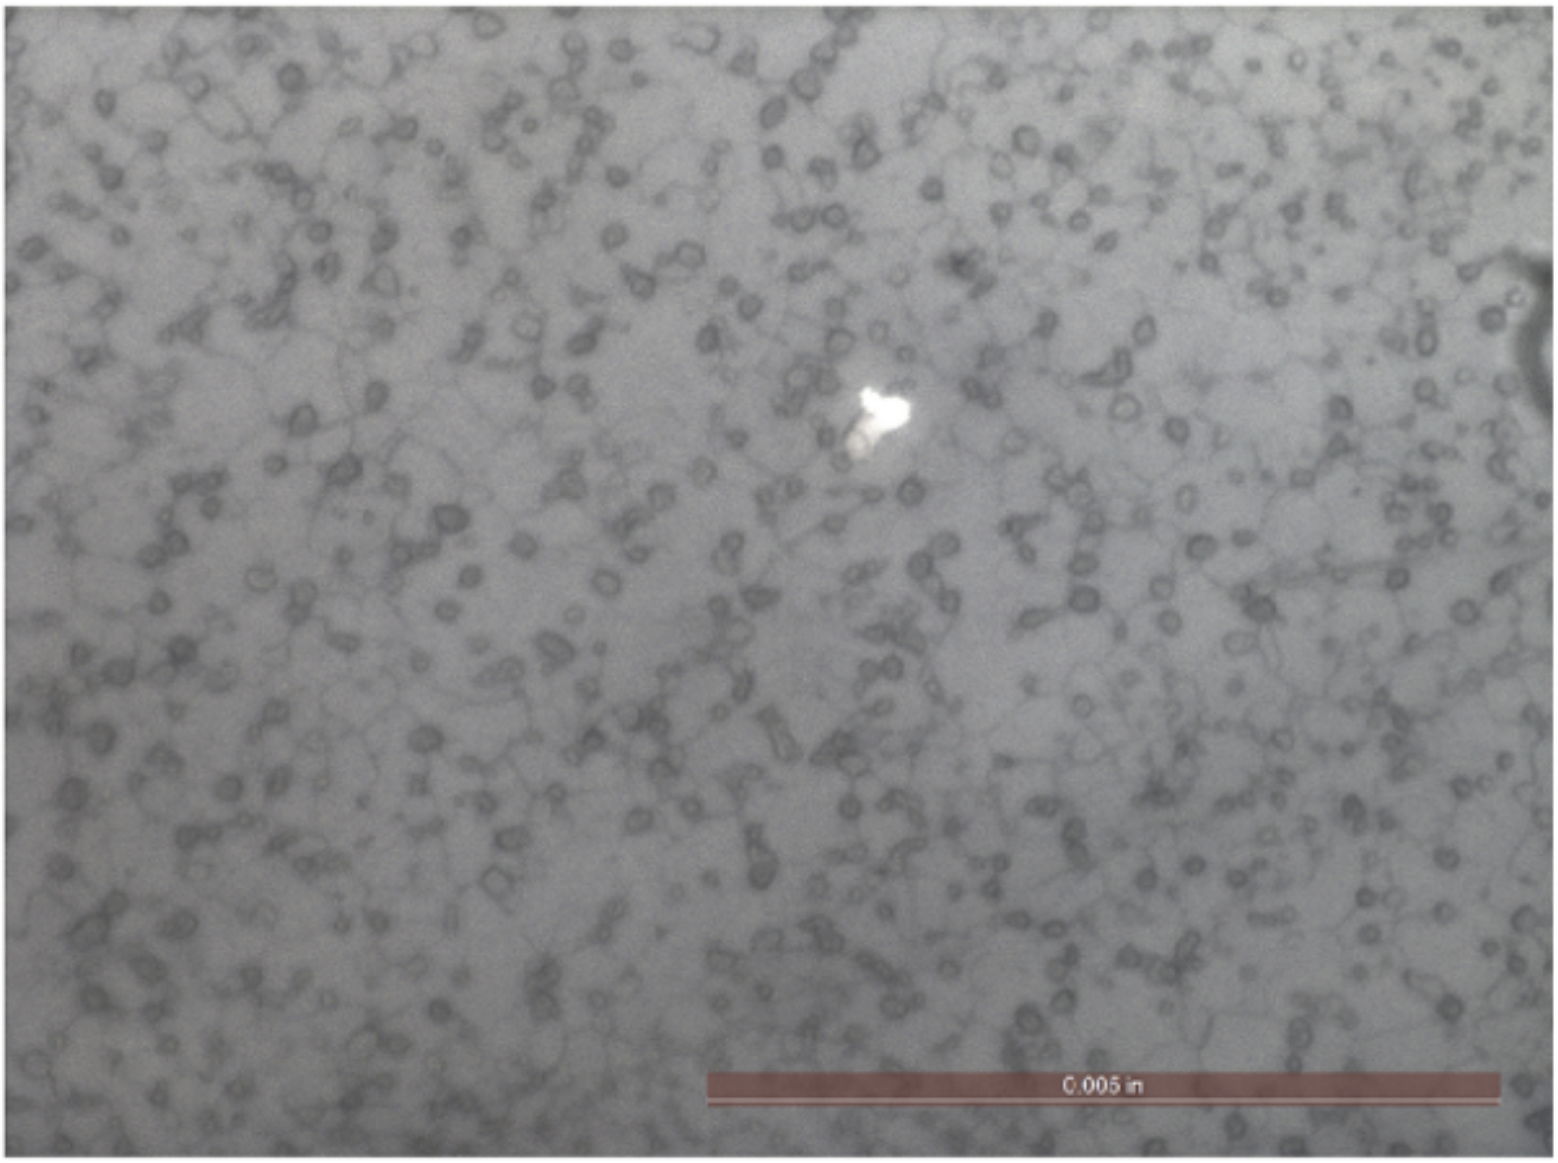
BRIGHT SPOT REPLICA DEFECT FROM DEBRIS
RENE 65
500X

Figure 2 (Sheet 6) Replica with Bright Spot due to Debris on the Surface Underneath the Replica Tape
