# **DEFECT REPORT**

## **LIGHTNING STRIKE ON AIRCRAFT**

| <b>Aircraft Type:</b> | BEEHCRAFT B300 (SUPER KING AIR 350) |
| <b>Aircraft Registration:</b> | 9M-PTB |

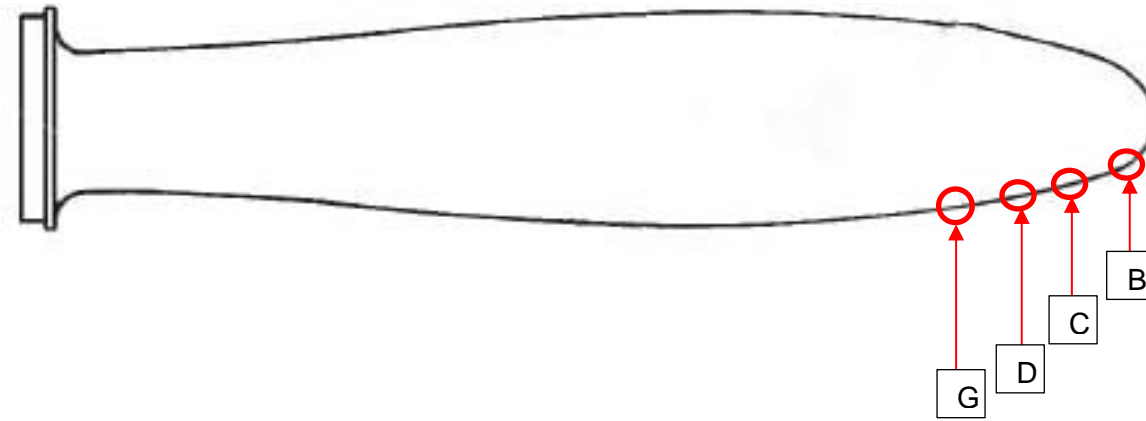
Figure B: Propeller blade

| NO. | COMPONENT | INSPECTION / CHECK | RESULT | REMARKS |
|---|---|--|---|--|
| 1. | PROPELLER | <ul style="list-style-type: none"> <li>• Inspect the propeller blades</li> <li>• Removed the propeller.</li> </ul> | <ul style="list-style-type: none"> <li>• Found <b>one pit</b> on the LH side and <b>three pits</b> on RH side propeller blade.</li> <li>• Propeller LH and RH side are <b>removed for overhaul.</b></li> <li>• Propeller governor are <b>removed for overhaul.</b></li> </ul> | <ul style="list-style-type: none"> <li>• Whenever the propeller has been struck by lightning, the propeller governor must be replaced or overhauled.</li> <li>• Refer to Woodward Service Bulletin 33574 or subsequent revision.</li> <li>• Textron recommend the propeller to be <b>SENT OUT</b> to manufacturer for overhaul as mention in AMM.</li> </ul> |

| NO. | COMPONENT | REMARKS |
|---|---|---|
| 1. | PROPELLER | <ul style="list-style-type: none"> <li>• Propeller to be inspect or replaced utilizing the Hartzell Standard practices manual 202A.</li> </ul> |
