WO No : 18255-1/7	ACFT REGN : 9M-PEC	SHEET NO: 1 of 1
DATE OPEN : 27/12/18	ACFT TYPE : BELL 429	
RAISED BY : HAZWAN	A/F HOURS : 1794.3

50 Hour Main Rotor Yoke Assembly.
(Refer to 429-MPI, Chapter 4 Table 2)

ALERT SERVICE BULLETIN

SUBJECT: MAIN ROTOR PITCH LINK ROD END BEARING INSPECTION, INTRODUCTION OF.

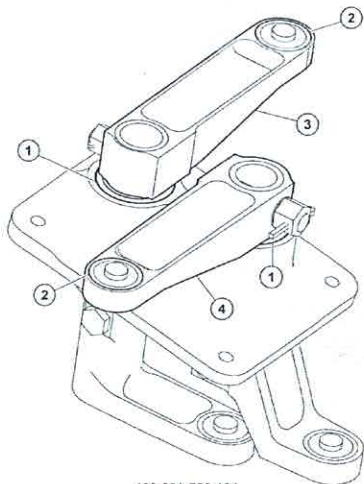
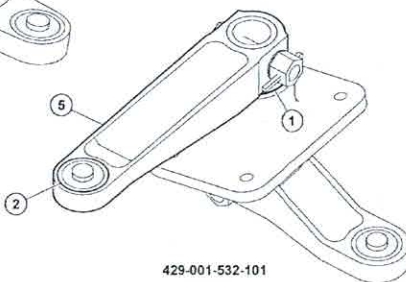
Figure 1 - Bellcrank Assemblies

6 MONTH BELLCRANK ASSEMBLY INSPECTION CARRIED
OUT AS PER ASB 429 - 15 - 21 REV B PART II.
FOUND SATISFACTORY.

3. Slowly move the cyclic stick fore/aft and laterally, and the collective stick up/down from stop to stop. If any roughness is detected in the flight control system, remove and replace the six MS27646-41 pivot bearings (Item 1, Figure 2) in the collective/lateral 429-001-523-101/-103, and longitudinal bellcrank 429-001-532-101/-103 (BHT-429-MM-1, Chapter 67).
4. Should discrepant pivot bearings be found that require replacement, contact Product Support Engineering to report findings.

If binding is detected in any MS27643-4 arm end bearings, all three arm bearings must be replaced per the BHT-ALL-SPM. If tooling and facilities are not available, the arms may be sent through Bell Helicopter CPR for bearing replacement. Alternatively, arm assemblies may be purchased through spares.
