WORK ORDER

A/C Reg	9M-LKE
A/C S/N	8297
A/C Type	AS350 B3 e

Modification Title: **Repair of LH Cargo Compartment Door**

SUBJECT: Repair of LH Cargo Compartment Door

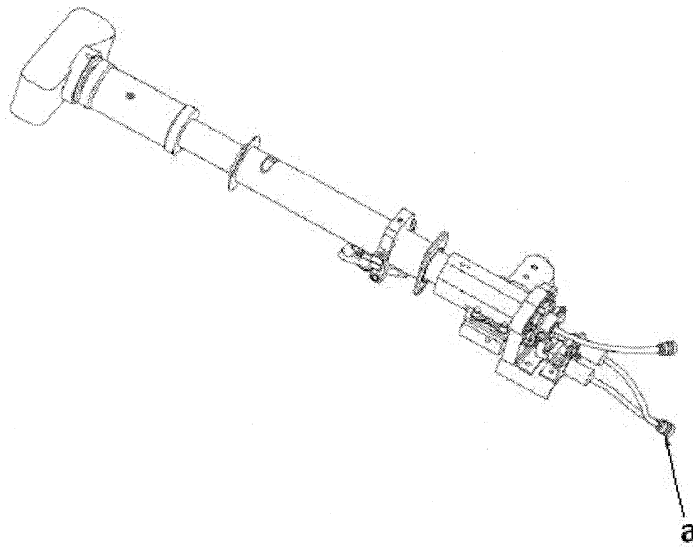
Figure 1

- Inspect the wiring side of microswitches (c), (d) and (e) in order to ensure that there are no marks, residues, corrosion or flaky varnish (DETAIL A - Figure 1).
- If there are marks, residues, corrosion or flaky varnish, comply with paragraph 3.B.2.
- If there are no marks, residues, corrosion or flaky varnish, comply with paragraph 3.B.3.

3.B.2. Procedure in the event of marks, residues or corrosion (Figures 1, 2, 3 and 4)
