WORK CARD

EASA AD NO.: 2018-0112R1 ISSUED: 04 JUNE 2018 (ASB 139-450 DATE: MAY 28, 2019 REV.: D) - ATA 62 - MAIN ROTOR DAMPER INSPECTIONS (PART III)

LEONARDO HELICOPTER ITALY (LHI)

9M-BGH

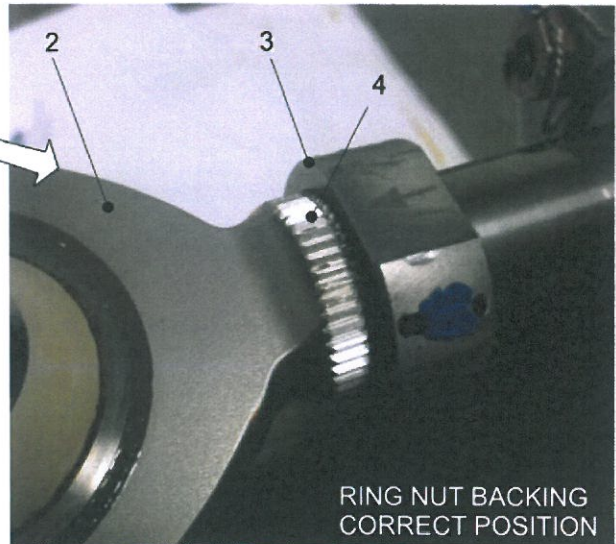
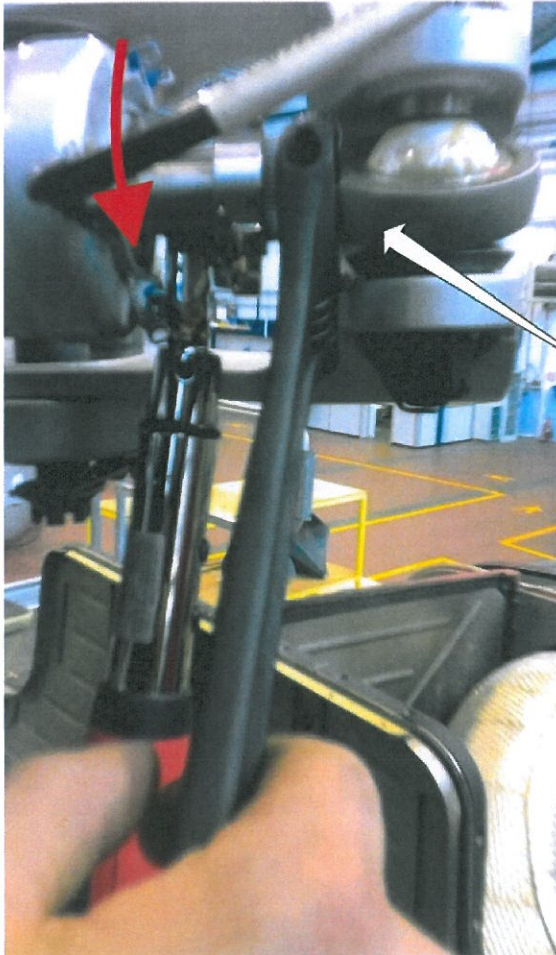
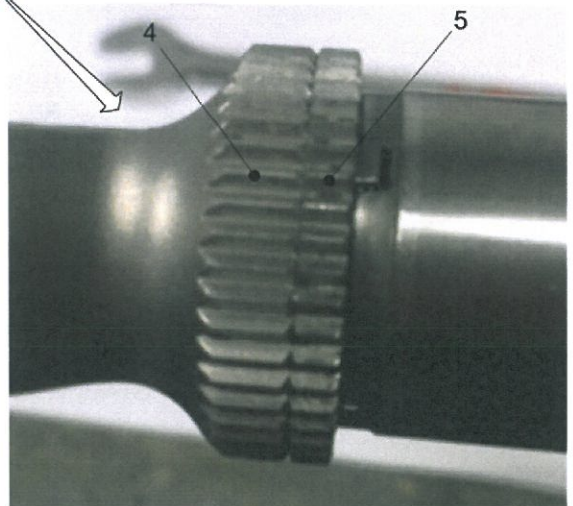
Figure 14

5. With reference to figure 14 section C-C, do a visual inspection of the damper rod end installation.
 - 5.1 Make sure that the special washer P/N 3G6220A05052 is installed.
 - 5.2 If the special washer P/N 3G6220A05052 is present, go to step 6.
 - 5.3 If the special washer P/N 3G6220A05052 is not present, do as follows:
 - 5.3.1 Remove the MR damper. Refer to AMP, see DM n° 39-A-62-22-02-00A-520A-A.
 - 5.3.2 Perform disassembly, inspections and assembly of the damper as prescribed by the compliance instructions (paragraph 8) in Annex A.

MOVE THE RING NUT (3) AWAY FROM THE BROACHING OF THE ROD END (2)

HOLD THE ROD END WITH A SPANNER, TORQUE THE RING NUT TO 63 Nm (558 lb in) AS SHOWN (RED ARROW) IN THE PICTURE (TWO OPERATORS REQUIRED)

MAKE SURE THAT THE BROACHED TEETH (4) OF THE ROD END (2) ARE PERFECTLY ALIGNED TO THE LOCK RING (5), IT IS NECESSARY TO MOVE THE RING NUT (3) BACKWARDS TO THE DAMPER TO DO THIS

IF THE BROACHED TEETH (4) ARE NOT CORRECTLY ALIGNED TO THE LOCK RING (5), INCREASE THE TORQUE VALUE UP TO A MAXIMUM OF 80 Nm (708 lb in)

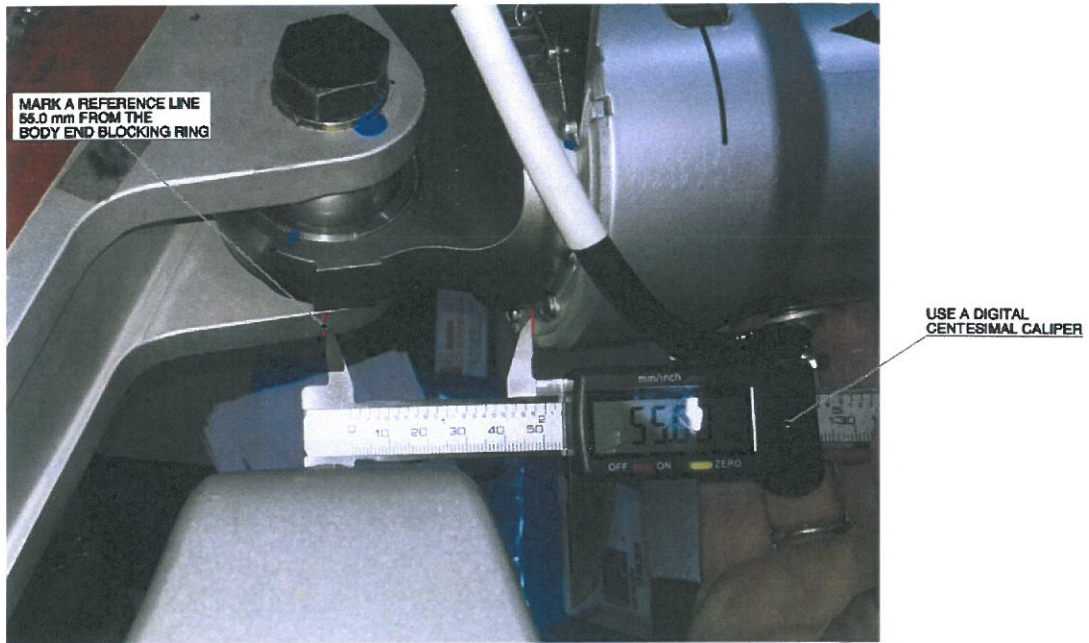
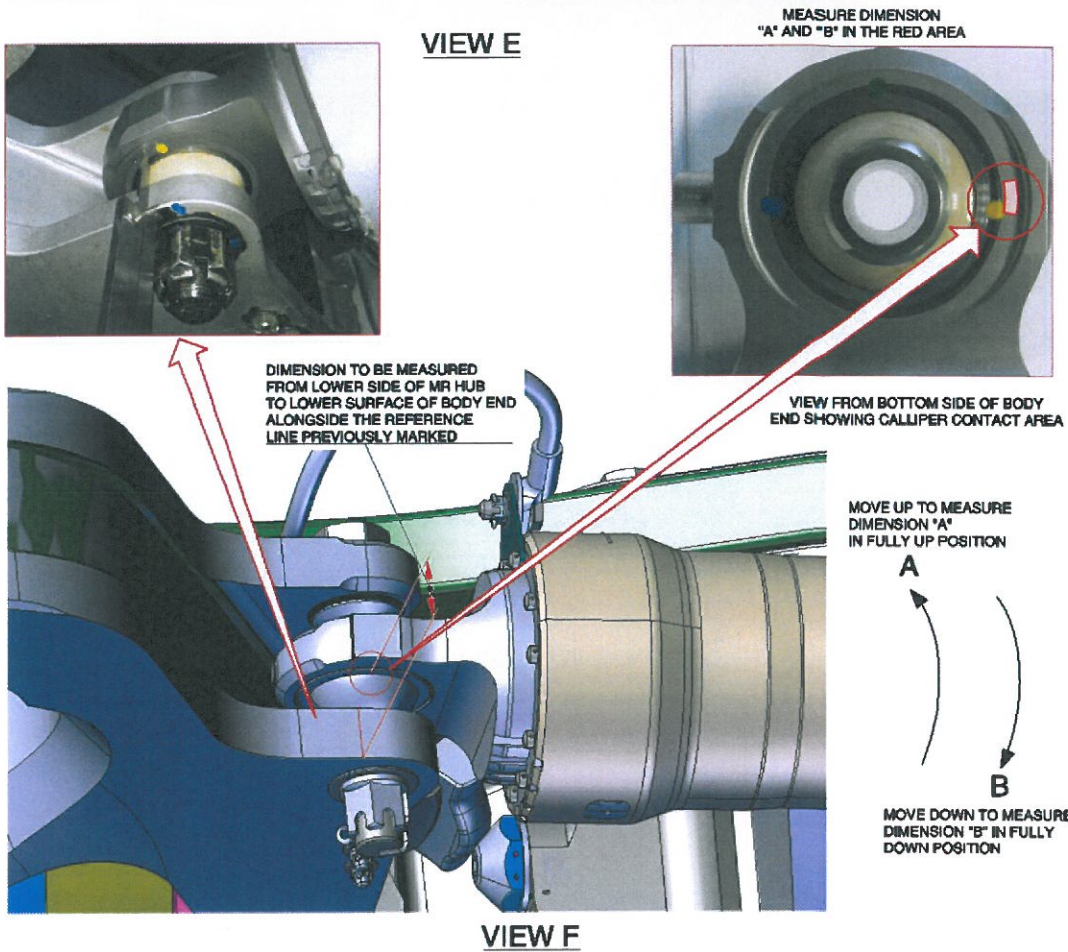
Figure 16

- 4.3 With reference to figures 16 and 17 do a detailed inspection for wear of the damper anti-rotation block as follows:
 - 4.3.1 Mark a reference line on the MR hub lower arm at a distance of 55 mm (2.16 in) from the body end blocking ring, according to figure 17 view E. Use a digital centesimal caliper to measure the distance and an erasable ink pen to mark the reference line.

- 4.3.2 With reference to figure 16 section D-D, move the body end to the fully up position using a torque wrench, in order to measure dimension "A".
 - 4.3.3 Measure dimension "A" from the lower surface of the MR hub arm to the lower surface of the body end, alongside the reference line previously marked, using a digital centesimal caliper, as shown in figure 17 view F.

- 4.3.4 Make sure that the measured dimension "A" is lower than 26.90 mm (1.06 in).
 - 4.3.5 With reference to figure 16 section D-D, move the body end to the fully down position using a torque wrench, in order to measure dimension "B".

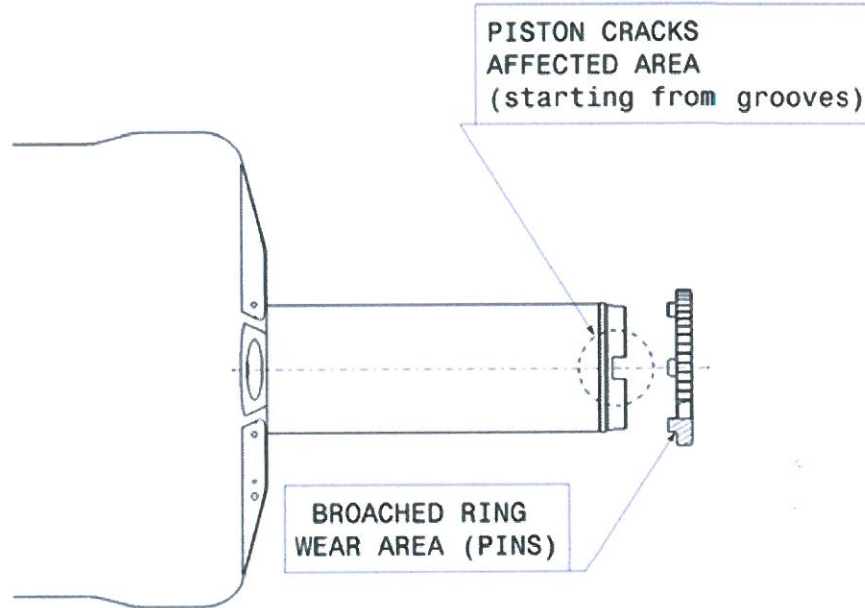
Figure 3 - Inspection details

10. With reference to Figure 3:
 - a. Inspect broached ring (1-50) for evidence of wear and damages, with particular attention to the four pins engaging the piston grooves. Refer to Figure 4 for an example of acceptable broached ring. In presence of wear or damages replace it with a new one.

- b. Visually inspect damper piston, in the locking grooves area, for wear, damages and cracks. Refer to Figure 4 for an example of acceptable piston. In presence of damages replace the damper.

- c. In case of rotation detected during verifications performed at steps 2 or 7, perform a fluorescent penetrant NDT inspection of piston extremity area, in accordance with ASTM E1417 using a solvent Class 2, a penetrant Type 1, Method C, Level 2 or 3 with a developer in Form D - no cracks are allowed.
