# WORKSHEET

SERVICE ORDER : 9 0 0 2 5 5 6 6 WORKSHEET NUMBER : 2022/31763/007-12

**AD No.:** 2021-0121

**ATA 63 - MGB BEARING LOCK-NUT REPLACEMENT**

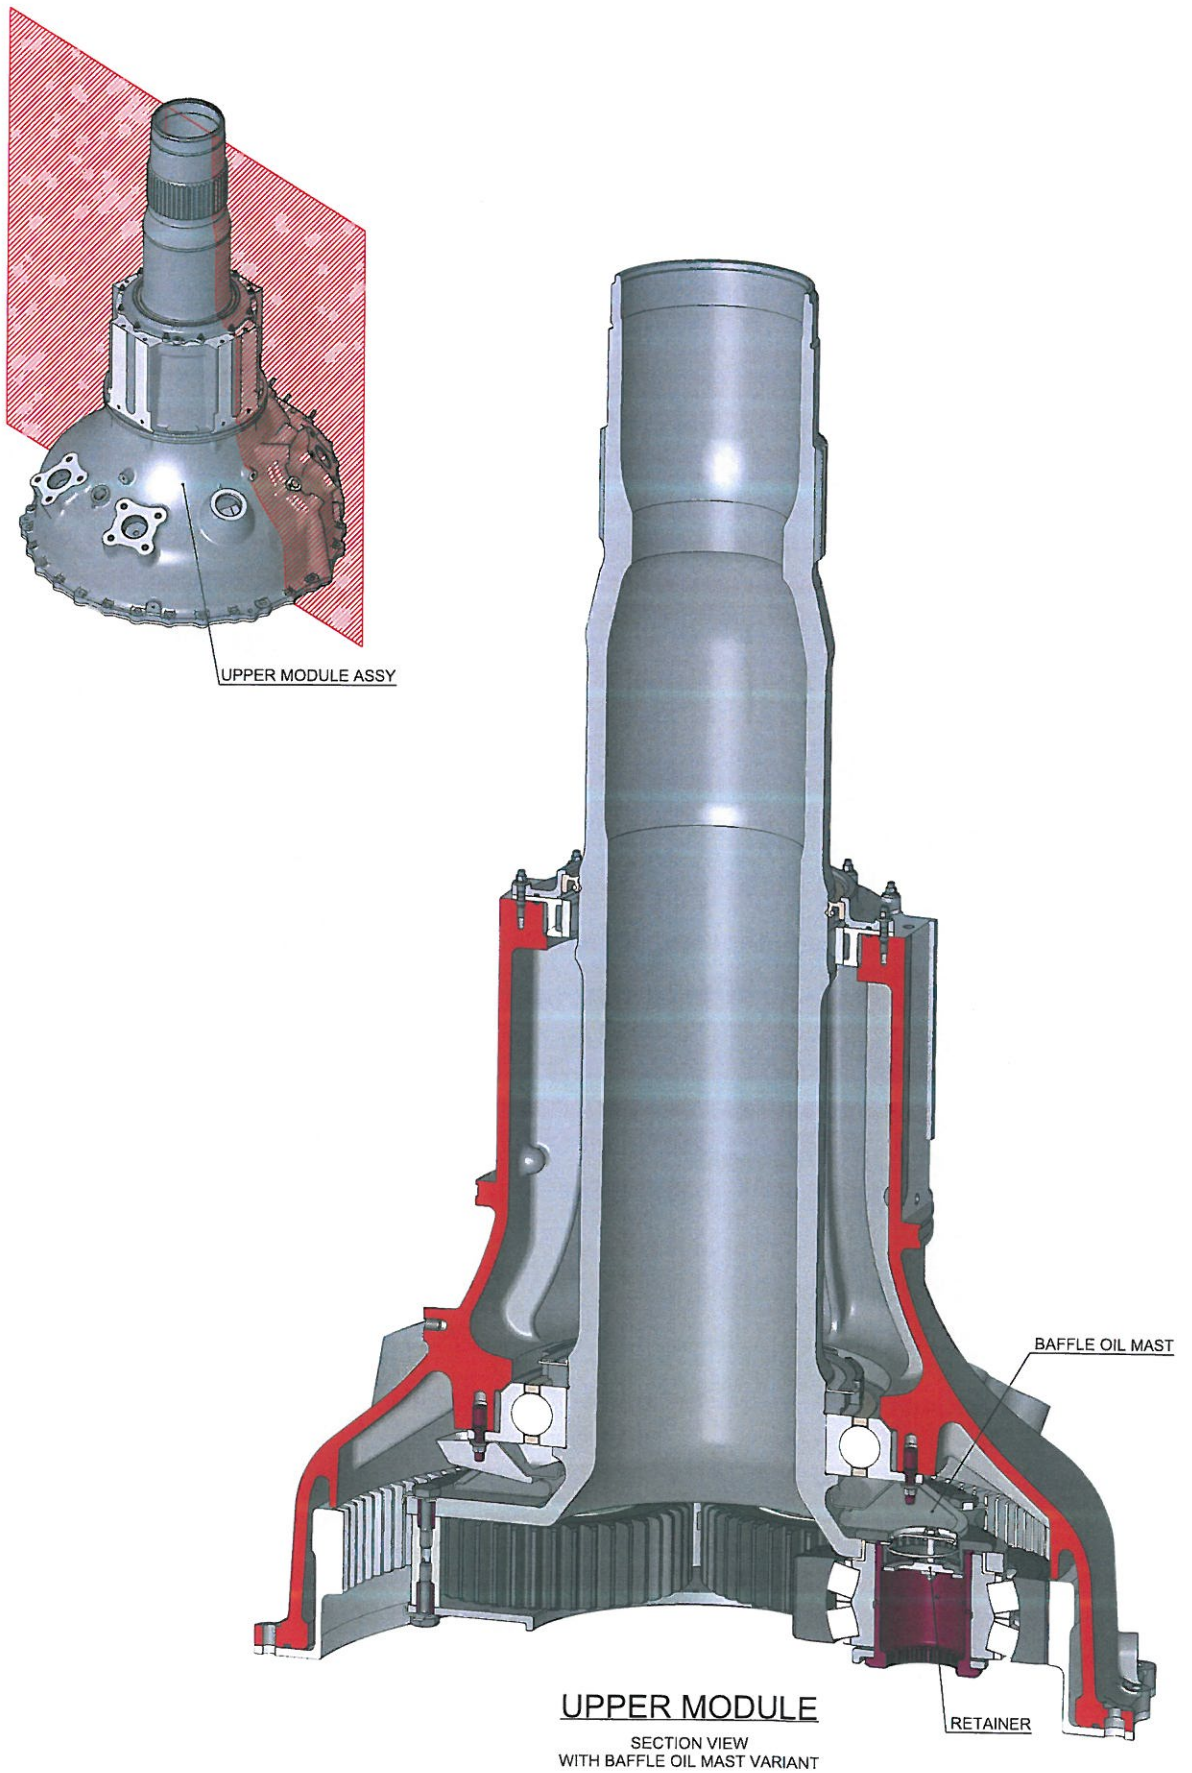
**Figure A7**

While performing step 16.8 thru 16.9, pay attention not to damage the baffle (25).

- 16.8 Loosen the ring nuts (9), using the wrench of tool P/N 3G6320A07231A023D.
- 16.9 Put the mast planetary assy on the work trolley P/N 3G6320A07231A188A and remove the ring nuts (9) using reaction tool P/N 3G6320A07231A023D.
- 16.10 With reference to Figures A7 and A8, remove the retaining plates (22).
- 16.11 Send the ring nuts to LHD.
17. With reference to Figures A1, A2 and A4, assemble the upper module assy, using new ring nuts P/N 3G6320A09152, as described in the following procedure:
  - 17.1 Clean the ring nuts threads and the pins (7) using loctite quick clean 703 (C023).
  - 17.2 Apply two drops of adhesive loctite 222 (C029) on the middle side of the thread of the ring nut (9). Apply the same quantity of adhesive also on the opposite side of the thread.
