LEONARDO MALAYSIA SDN.BHD.		WORK CARD		SERVICE ORDER NUMBER: 90025566		WORKCARD NUMBER: 2022/31763/004-05	
		TITLE: EASA AD NO.: 2021-0044R1 ISSUED: 12 MAY 2022 (ASB 139-661 DATE: MAY 9, 2022 REV.: B) - ATA 24 - OVERHEAD PANEL INSPECTION (PART II)		CUSTOMER: LEONARDO HELICOPTER ITALY (LHI)			
REGISTRATION: 9M-BGH	AIRFRAME HOURS: 300:40	#1 ENGINE	SERIAL NUMBER: PCE-KB1931	#2 ENGINE	SERIAL NUMBER: PCE-KB1885	APU	SERIAL NUMBER: N/A
SERIAL NUMBER: 31763	LANDINGS: 838		HOURS: 300:40		HOURS: 300:40		HOURS: 300:40

AD No.: 2021-0044R1

SERVICE BULLETIN**N° 139-661****ALERT****DATE:** February 4, 2021**REV. :** B - May 9, 2022

TITLE**ATA 24 – OVERHEAD PANEL INSPECTION****REVISION LOG**

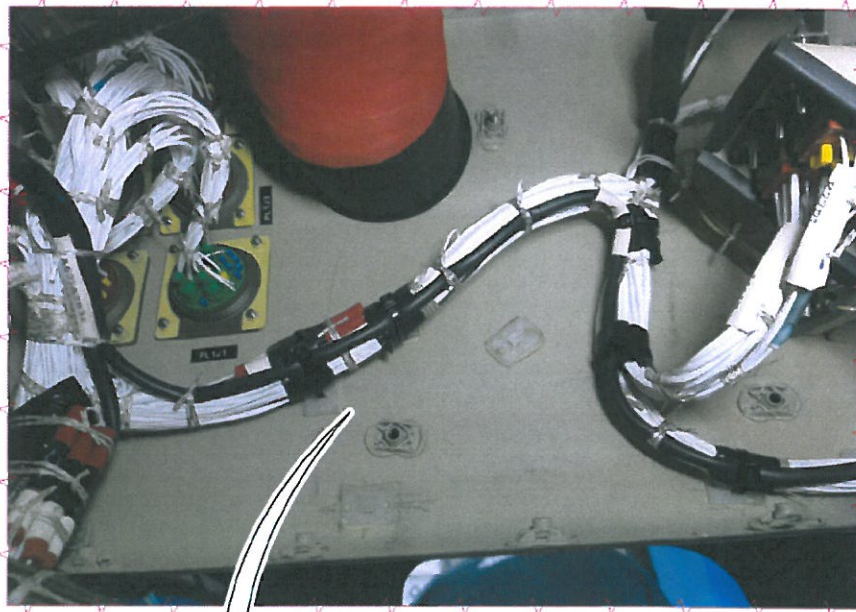
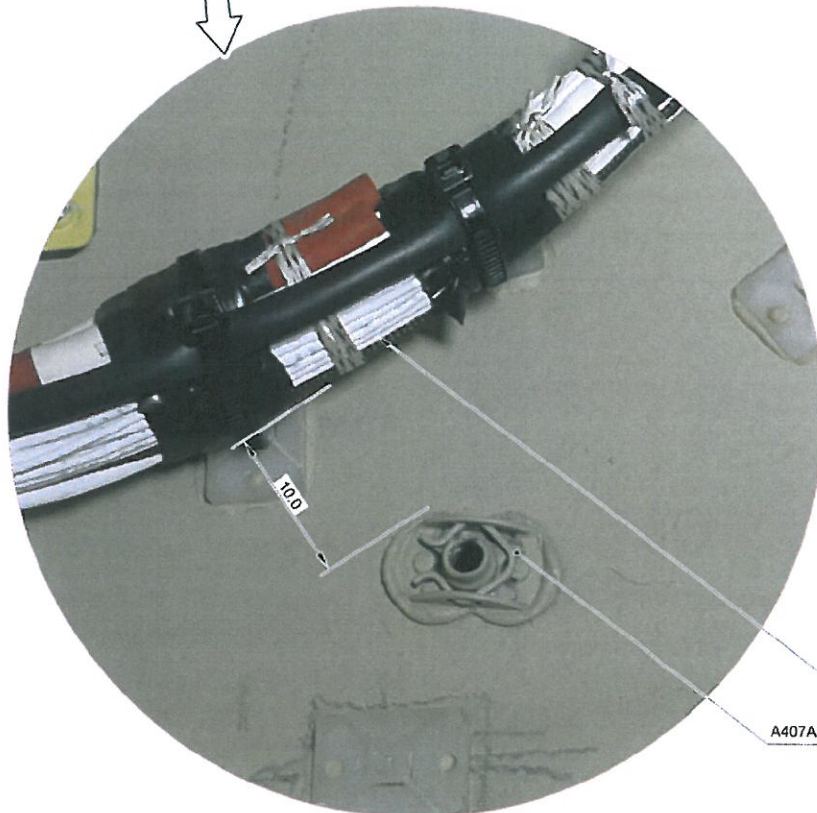
- 2.6 With reference to Figure 1 Detail A and View B, to Figure 2 View C and View D, check for the condition of the n°2 layers of the white tape P/N AW005ME04T05305 (or equivalent P/N listed in consumable list) on each of the n°6 anchor nuts P/N A407A3C2P (n°3 on the LH side and n°3 on the RH side).

- 2.9 With reference to Figure 2 View D, repeat step 2.8 for the RH side.
- 2.10 With reference to Figure 1 Detail A and View B, check for chafing damage of the cable harness and ensure that clearance exists between the cable harness and the anchor nuts P/N A407A3C2P and/or the screws at the indicated locations from n°1 thru n°16.

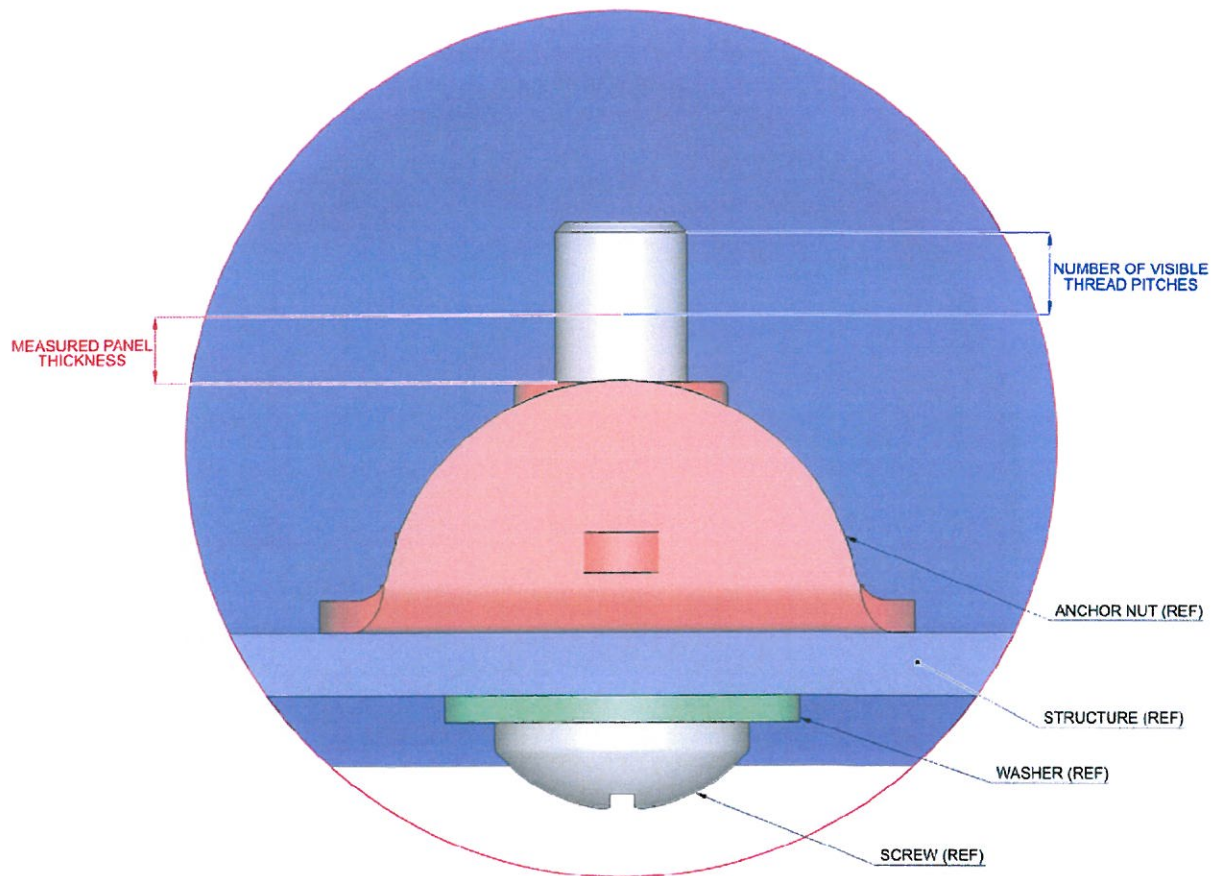
Figure 4

2.2.4.1 With reference to Figure 4, Table 2, measure the screw fastener length and verify the actual screw P/N installed.

2.2.4.2 With reference to Figure 4, Table 2, if less than 2 screw thread pitches more than the panel thickness previously measured remain visible, install one grip more than the identified screw.

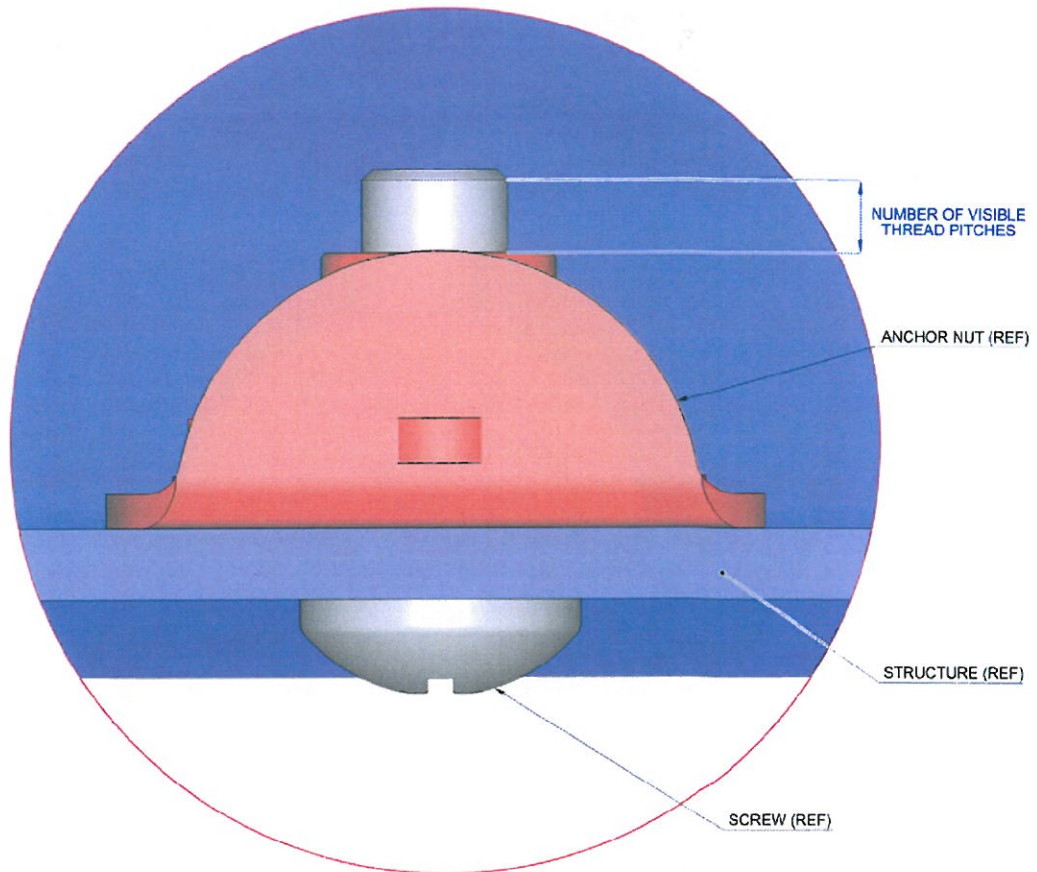
Figure 5

2.2.3 Visually check that the number of thread pitches remained visible out of the anchor nut is between 2 and 4 after having subtracted the panel thickness value previously measured (refer to Figure 5).
