WORK CARD

EASA AD 2022-0209-E ISSUED: 12 OCTOBER 2022 (EASB 139-731 DATE: OCTOBER 11, 2022 REV. : /) - ATA 00 – FORWARD CABIN ROOF CEILING HARNESS INSPECTION (PART I)

LEONARDO HELICOPTER ITALY (LHI)

REGISTRATION:	9M-BGH	AIRFRAME HOURS:	300:40	#1 ENGINE	SERIAL NUMBER:	PCE-KB1931	#2 ENGINE	SERIAL NUMBER:	PCE-KB1885	APU	SERIAL NUMBER:	N/A
SERIAL NUMBER:	31763	LANDINGS:	838		HOURS:	300:40		HOURS:	300:40		HOURS:	N/A

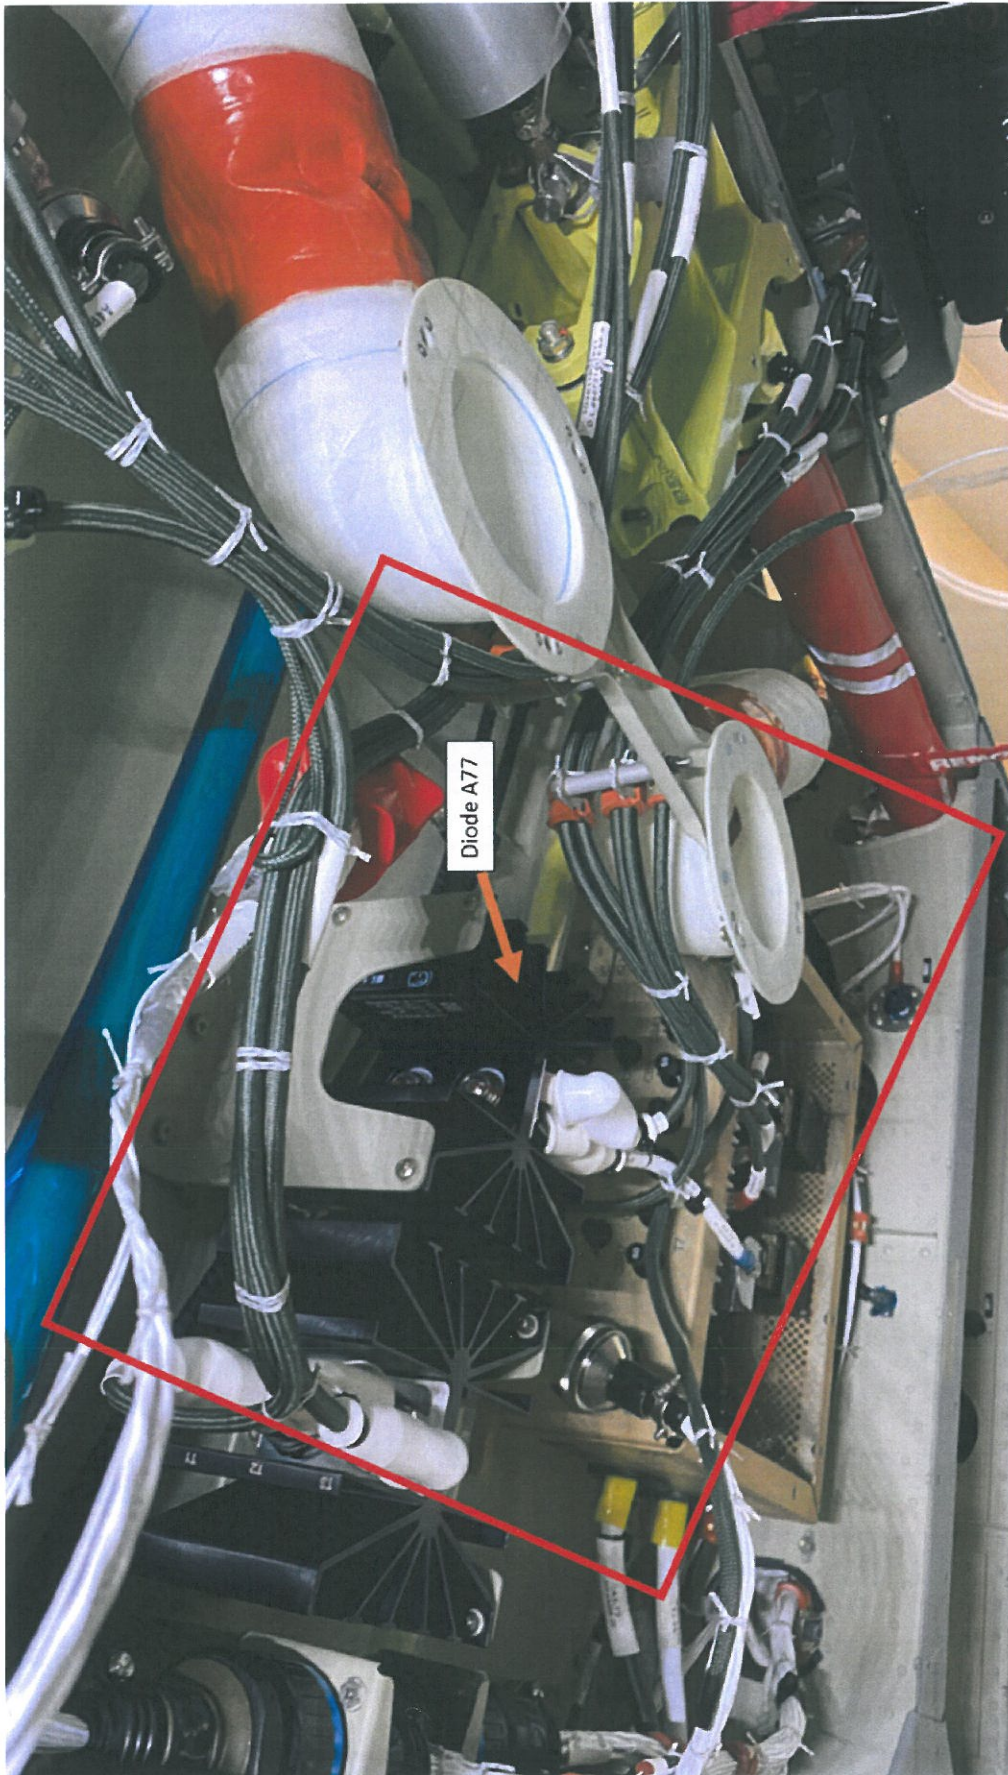
- 2.1.1 With reference to Figure 10, check for chafing or damage on the cable harness in the area showed.
 - 2.1.2 In case of any finding, contact Product Support Engineering (engineering.support.lhd@leonardo.com) in order to receive further instruction.

- 2.1.4 If necessary, in accordance with Figure 10 and Figure 11, re-route the cable harnesses (using if needed also lacing cord to fix the cables with each other) in order to respect the clearance of at least 10.0 mm from the diode or any other surrounding structure or component.

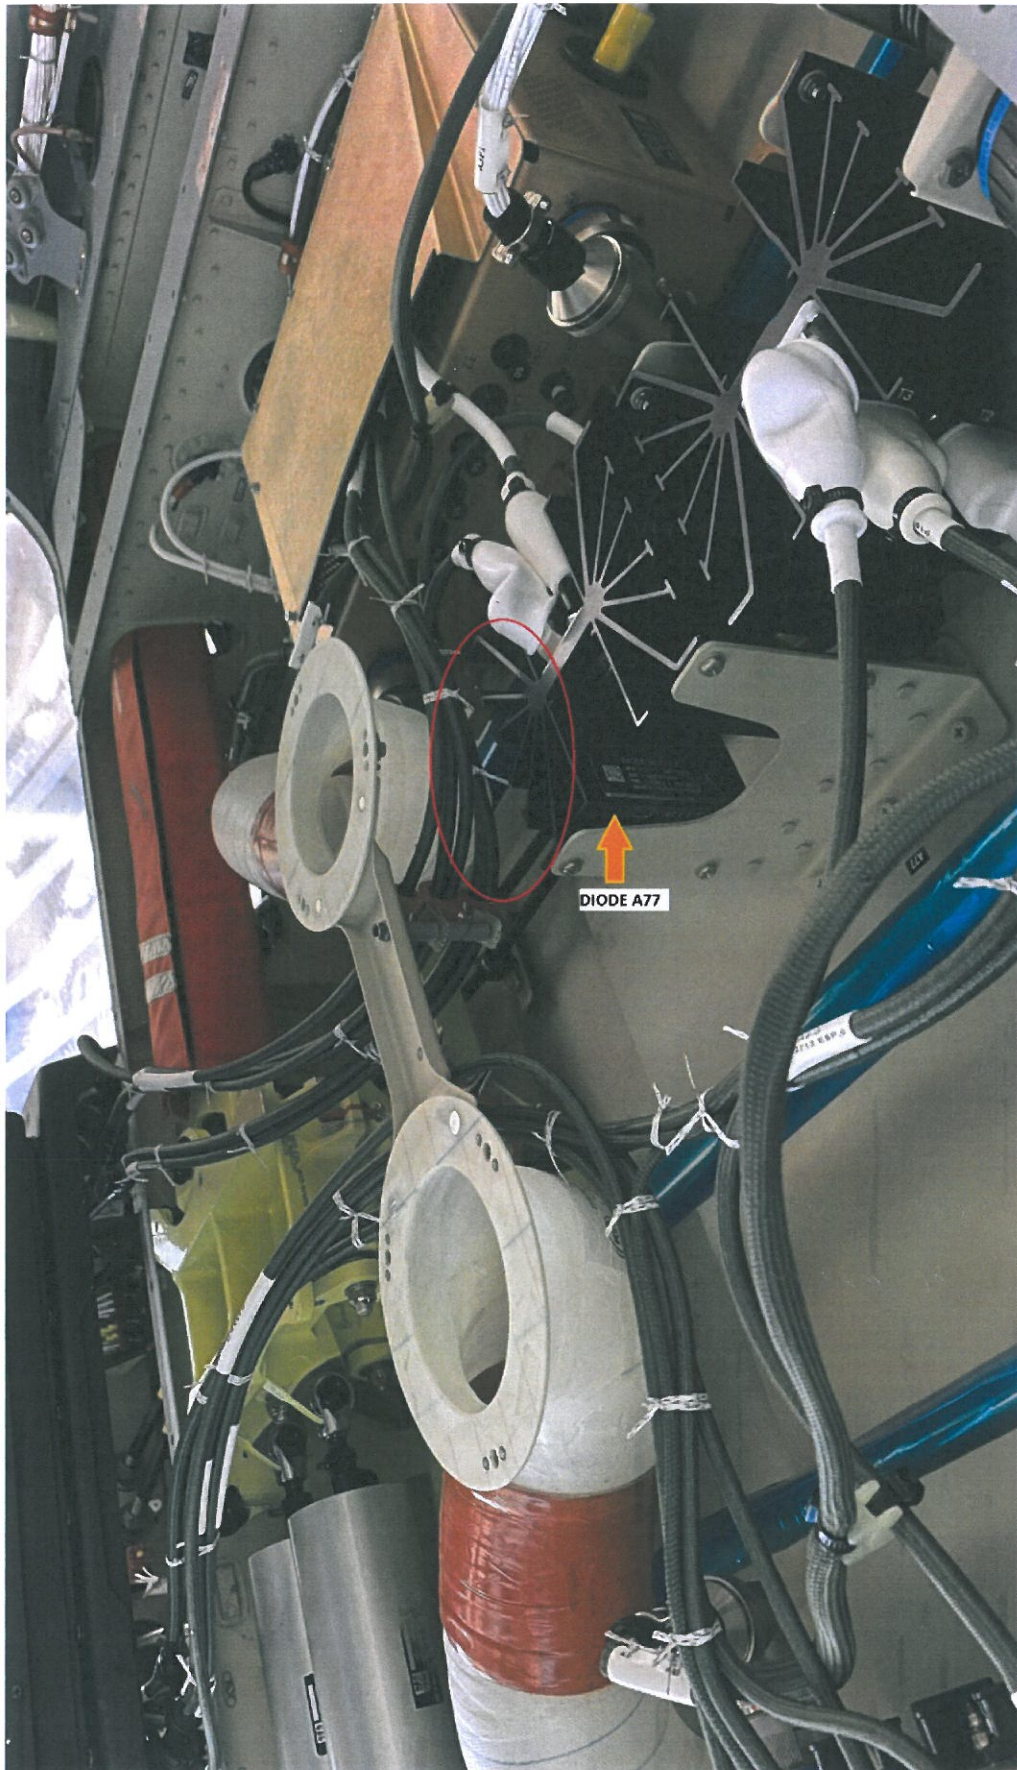
Figure 11

- 2.1.3 With reference to Figure 10 and Figure 11, ensure that clearance of at least 10.0 mm exists in the area inside the red circle shown in Figure 11, between the cable harness and Diode A77 P/N 3G2430V00352.

- 2.2 With reference to Figure 10 and 11, perform a visual inspection of the Diode A77. Make sure that no damage is present on the component.
 - 2.3 In case of any finding, contact Product Support Engineering (engineering.support.lhd@leonardo.com) in order to receive further instruction.
