A/C TYPE EC 155B
 A/C REGN 9M-SAS S/N 6583
 TYPE OF CHECK _____

DEFECT AND RECTIFICATION WORKSHEET/CERTIFICATE OF RELEASE TO SERVICE

No. 67-002

SUBJECT:	ROTOR FLIGHT CONTROLS
	Roll, Pitch and Yaw Series Actuators

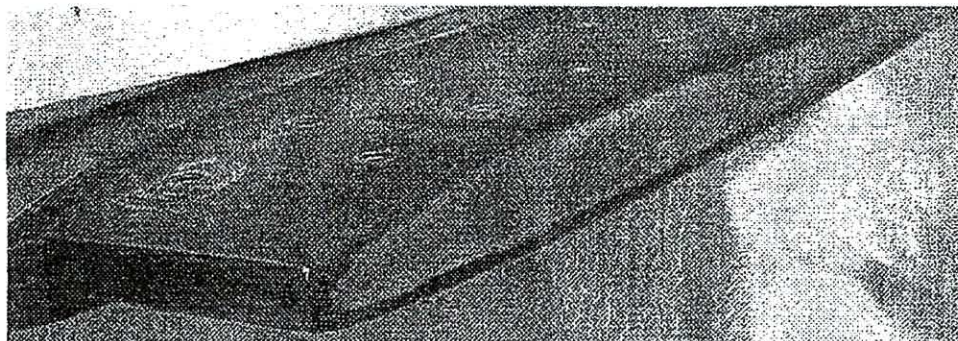
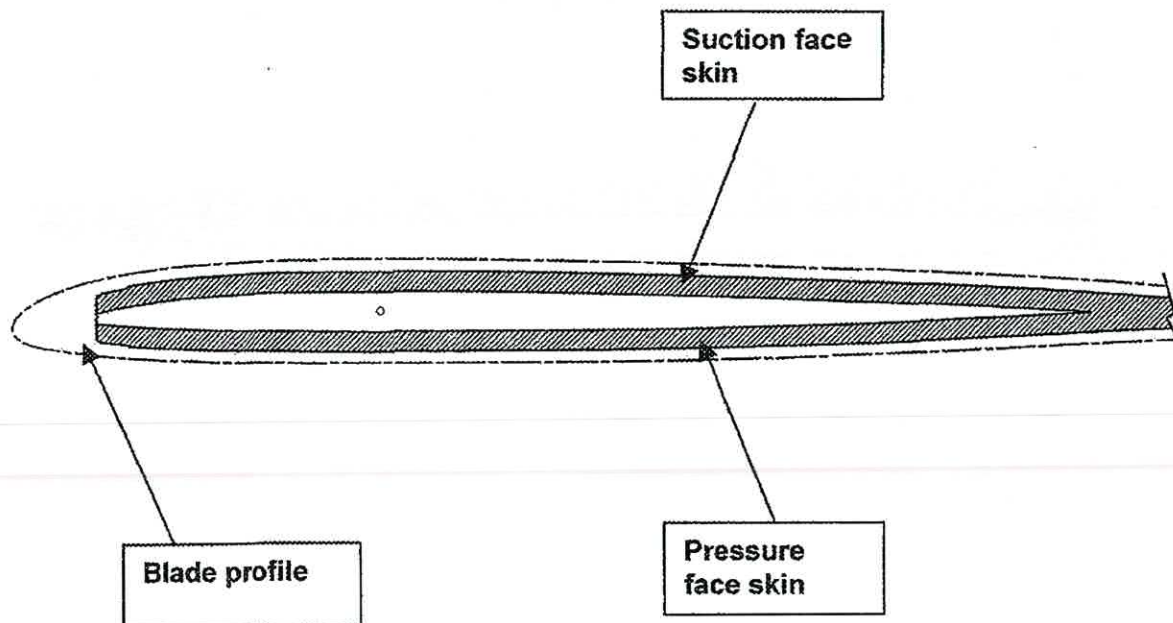
Figure 1

- . Correct positioning of the wedge is indicated by a symmetrical position of the wedge relative to the pressure and suction face skins (Refer to Figure 1).

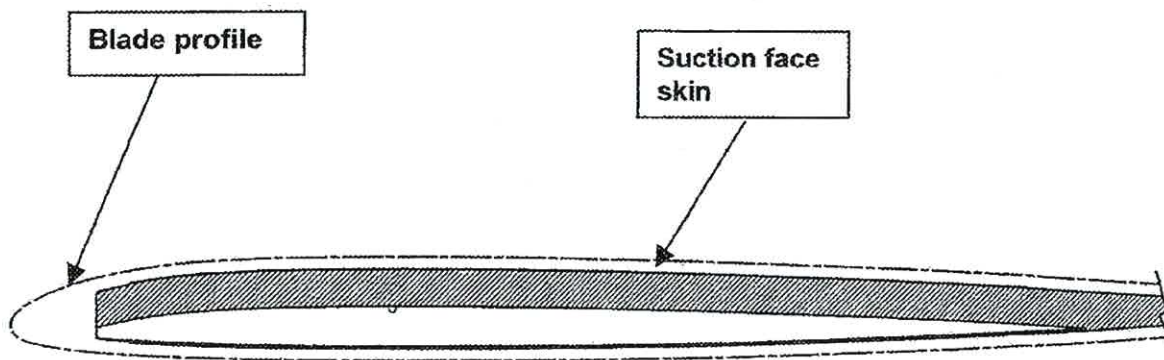
Figure 2

- . Faulty positioning of the wedge is indicated by a dissymmetrical position of the wedge relative to the skins on the blade pressure and suction faces. This dissymmetry can be determined by the fact that the (black) carbon skins do not exist on the pressure face side of the blade tip edge, yet they exist on the suction face side. (Refer to Figure 2).

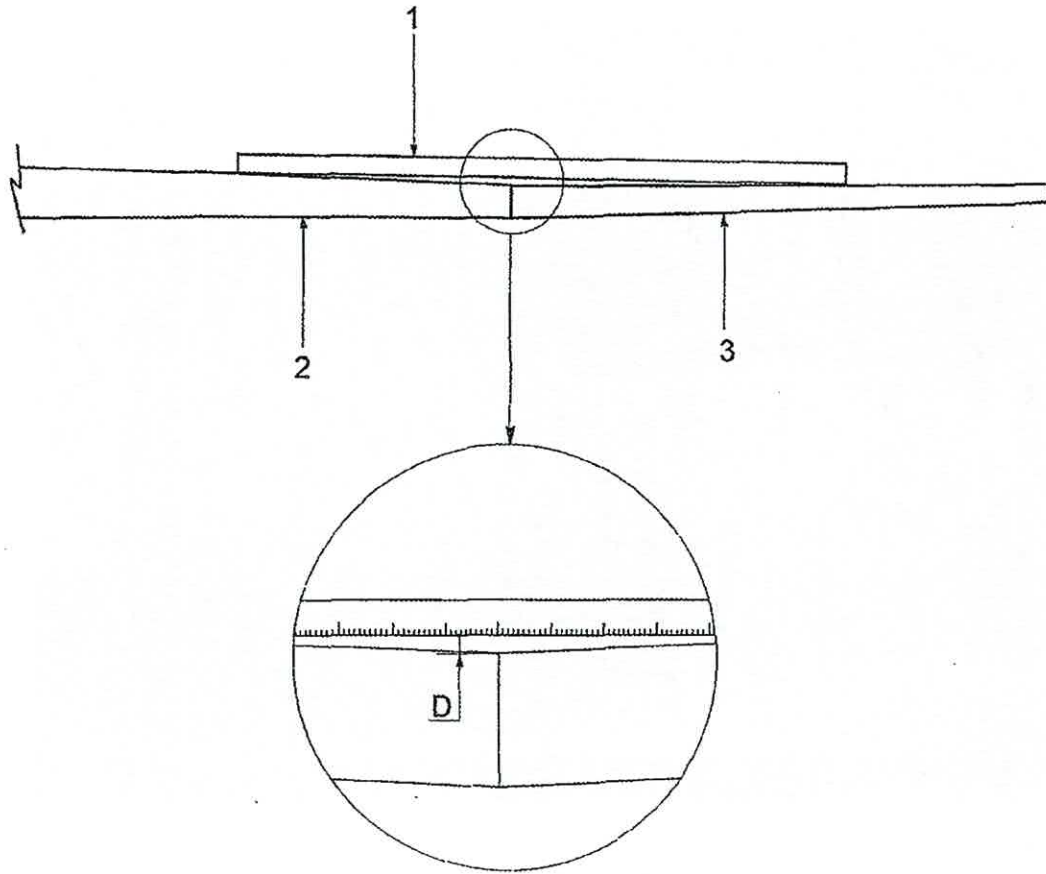
Figure 3

- Measure clearance "D" between the ruler (1) and the blade/tip cap junction, as shown on Figure 3.

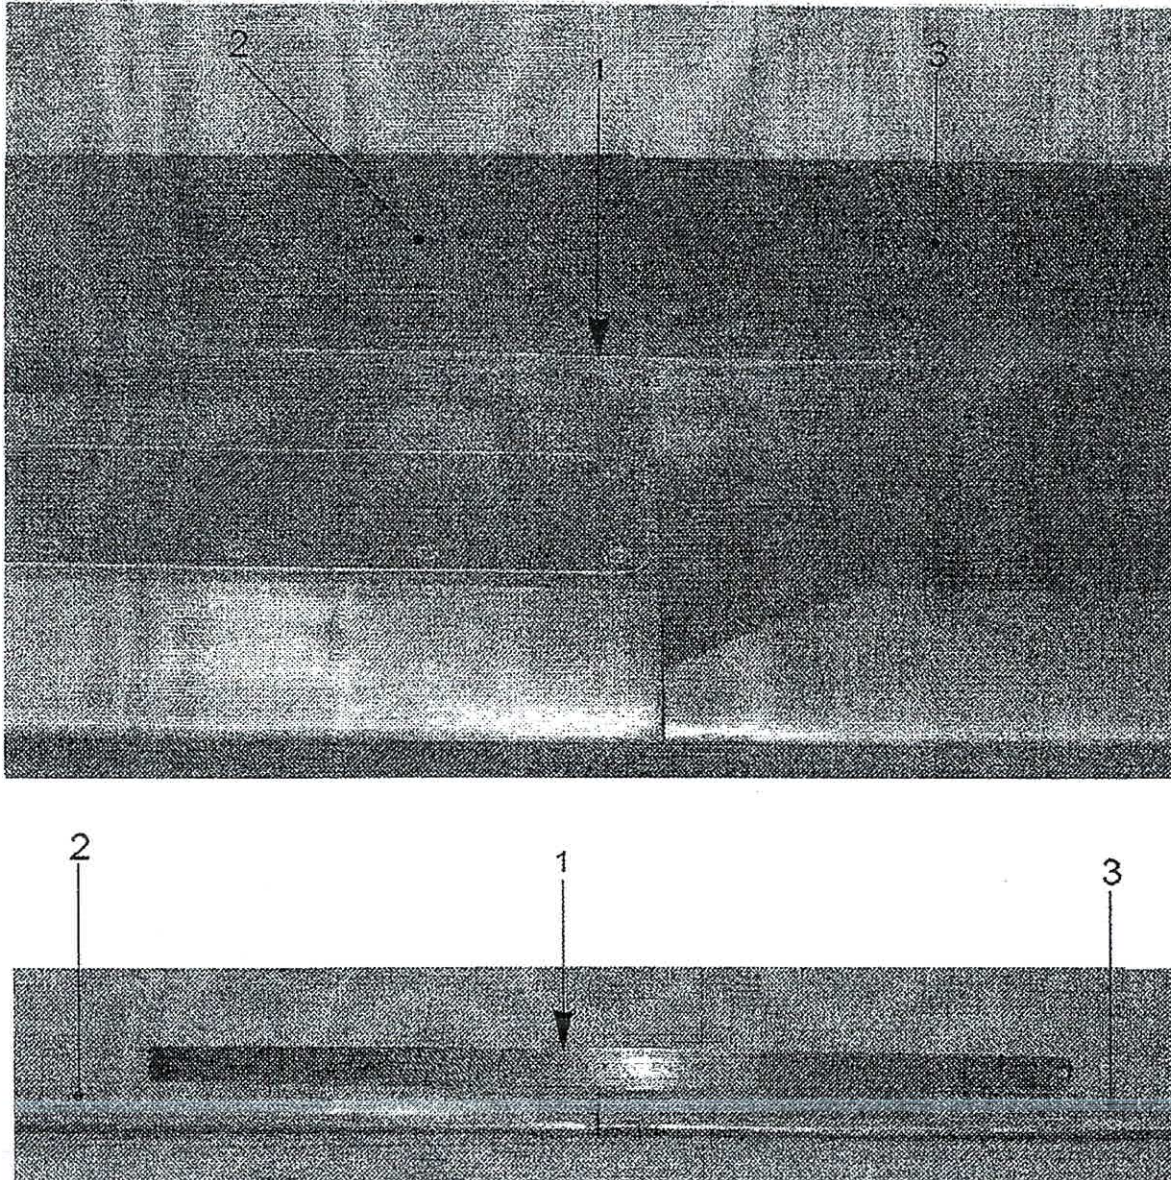
Figure 4

2. return the blade to flight configuration in accordance with paragraph 2.B.7.,
 3. on the blade suction face portion (2), position an approximately 500mm ruler overlapping the blade (2) and the blade tip cap (3), as shown on Figure 4, in such a way that the middle of the ruler (1) is positioned at the blade/tip cap junction. The ruler (1) must be parallel to the leading edge and located between the two hatches that include the balancing weights,

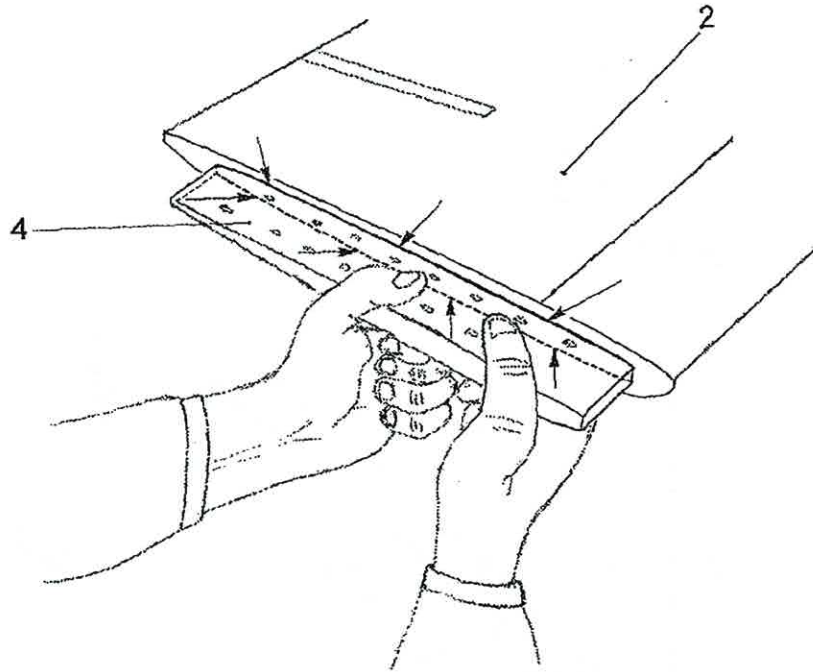
Figure 5

- On the blade pressure face, then on the blade suction face, closely inspect the embedded portion of tenon (4), shown on Figure 5, (use a magnifying glass if necessary):

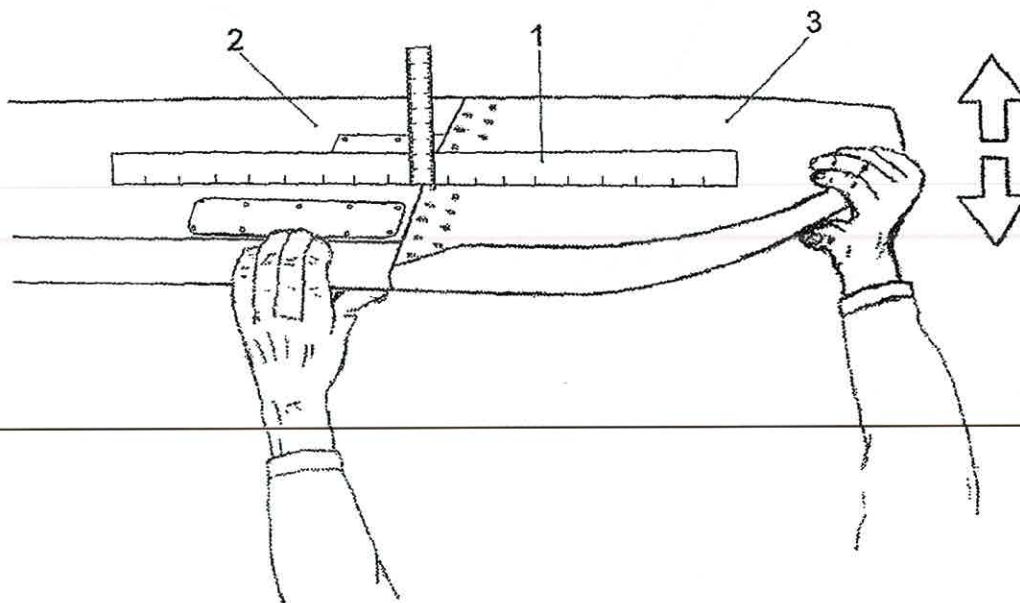
Figure 6

- Hold the leading edge of the blade (2) and apply an upward bending load to the blade tip cap (3), as shown on Figure 6.

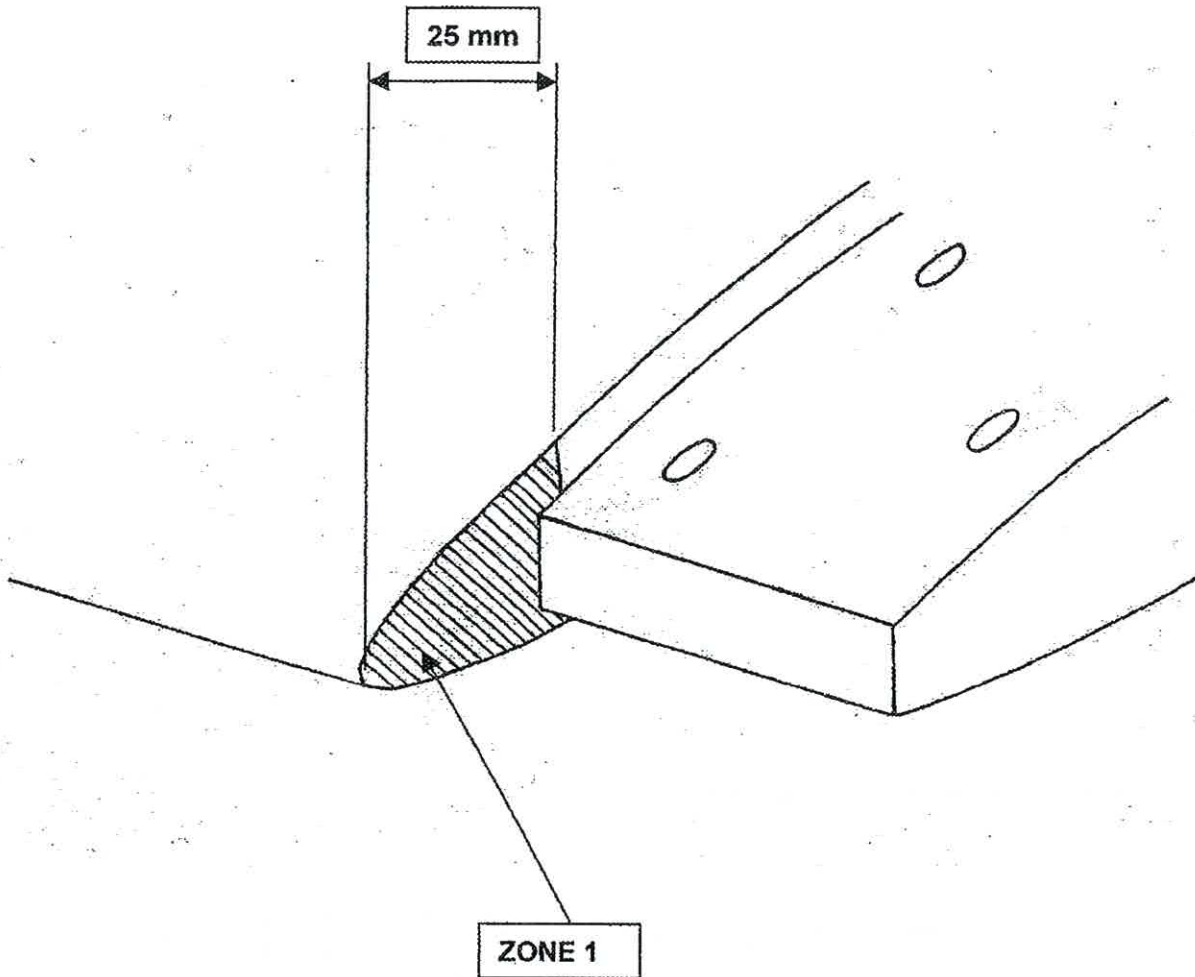
Figure 7

- Check that there is no erosion in leading edge zone 1 (Refer to Figure 7):
