A/C TYPE EC 155BA/C REGN 9M-SAS (6583)

## DEFECT AND RECTIFICATION WORKSHEET/CERTIFICATE OF RELEASE TO SERVICE

**SUBJECT: INDICATING AND RECORDING SYSTEMS**  
Modification of the Power Supply to Landing Gear PCB 10 and 11 ALPHA

<b>SUBJECT:</b> NAVIGATION
<p>PELICAN RACK - Improved Air Ventilation System</p> <p><i>TRACK P/N C1284TBA S/N 285 FITTED.</i></p> <p><i>FRE MOD 0739B98.</i></p>
Corresponds to MOD 0739B98

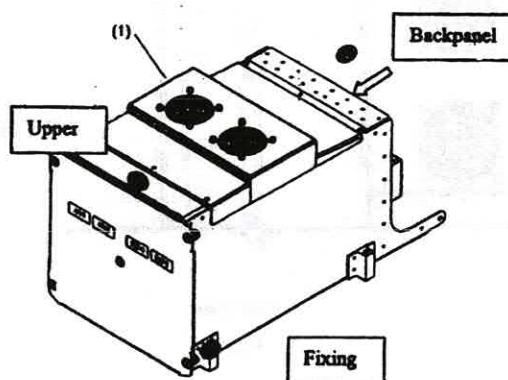
Fig. 1

Global View

- (1) Remove the connectors connected to J01 and J02 (Fig. 2).
- (2) Remove the six screws and washers attaching the cooling module to the rack (1) Fig. 1.
- (3) Remove the cooling module PN E13106AA (1) Fig. 1.

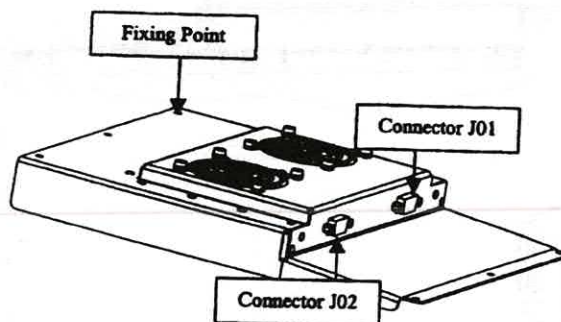
Fig. 2

Fan Module
